Allanburg Area Whistle Cessation Study Report - Draft

City of Thorold

Whistle Cessation Study

Rail Crossing Existing Condition Assessment

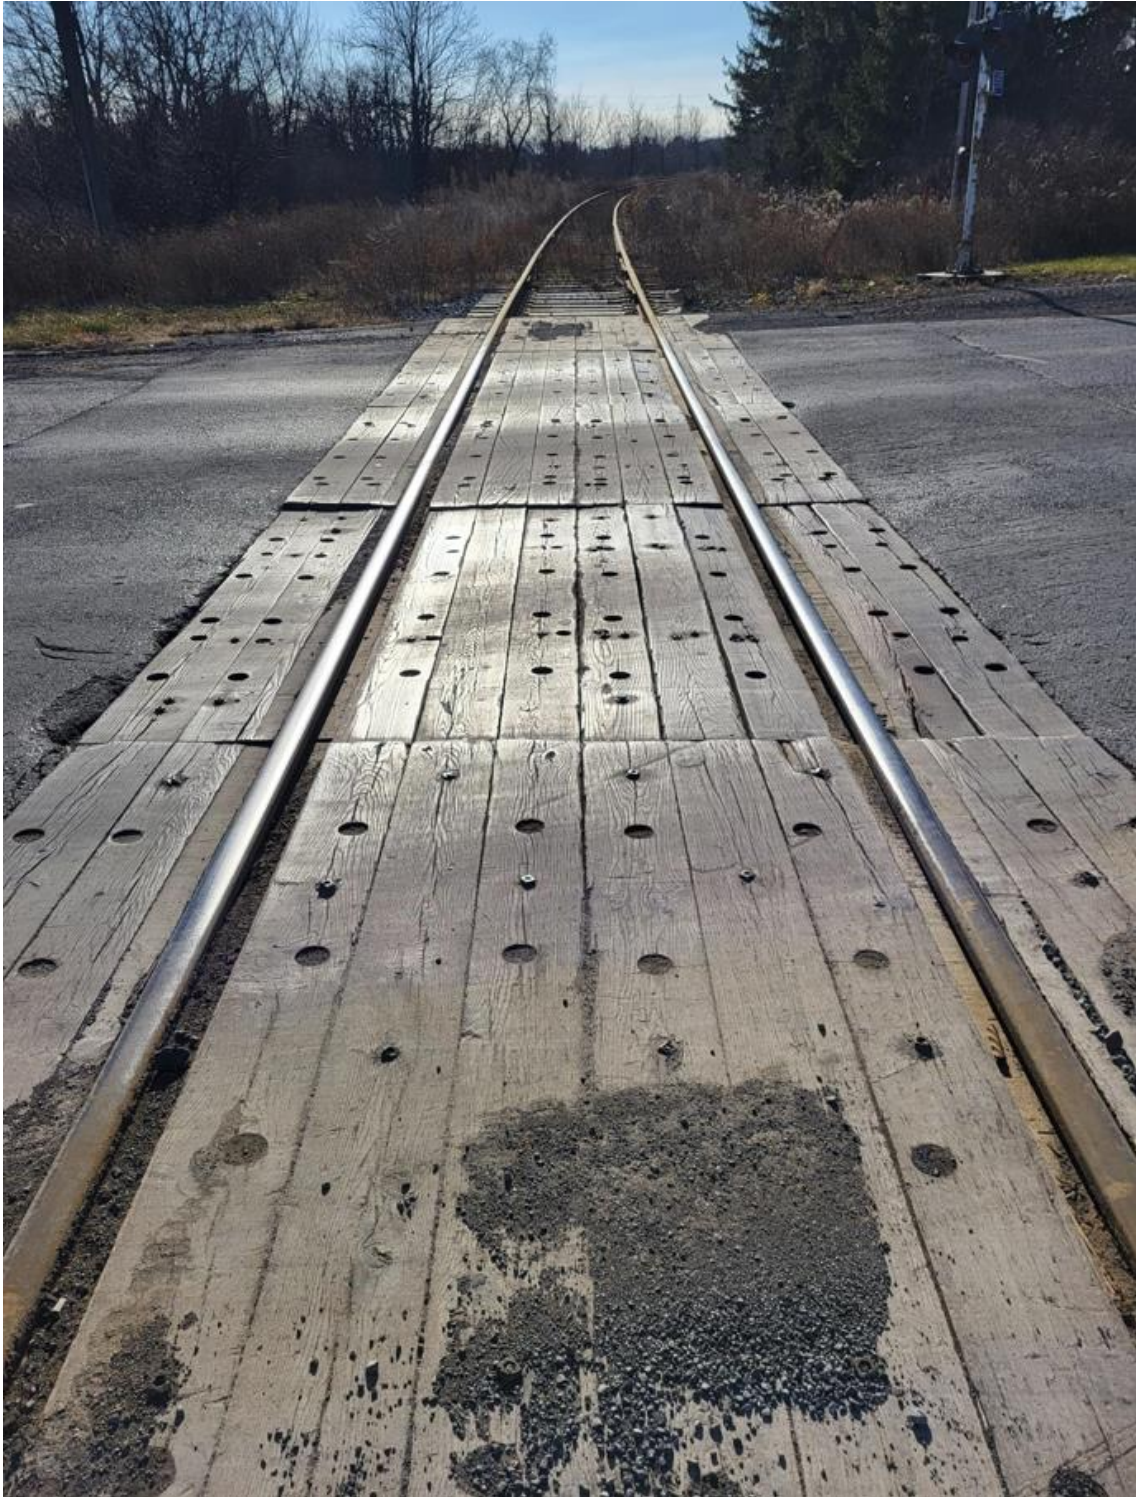
Grade Crossing Surface	<p>Material: Wood planks / Asphalt Minimum extension of crossing surface beyond shoulder: 0.0m Crossing Surface Condition: Wooden planks sag when cars drive over.</p>	<p>Material: Wood planks Minimum extension of crossing surface beyond shoulder or travelled way: 1.2m Crossing Surface Condition: Wooden planks are sagging in the middle.</p>	<p>Material: Wood planks / Asphalt Minimum extension of crossing surface beyond shoulder or travelled way: 2.2m Crossing Surface condition: Smooth and in good condition.</p>	<p>Material: Wood planks/ Asphalt Minimum extension of crossing surface beyond shoulder or travelled way: 2.7m Crossing Surface condition: Smooth and in good condition.</p>	<p>Material: Asphalt Minimum extension of crossing surface beyond shoulder or travelled way: 2.1m Crossing Surface condition: Asphalt is in good condition. Slight raised section on the paved shoulder.</p>

Figure A-1: Lundy's Lane Crossing – Crossing Material

- The crossing surface must be repaired and extended 0.5m beyond the road shoulder.
- Placement of advisory speed and stop ahead signs on each approach.
- Implementation of gates as part of the active warning system.
- Signal Pre-emption at the Allanport Road and Lundy's Lane Road intersection.

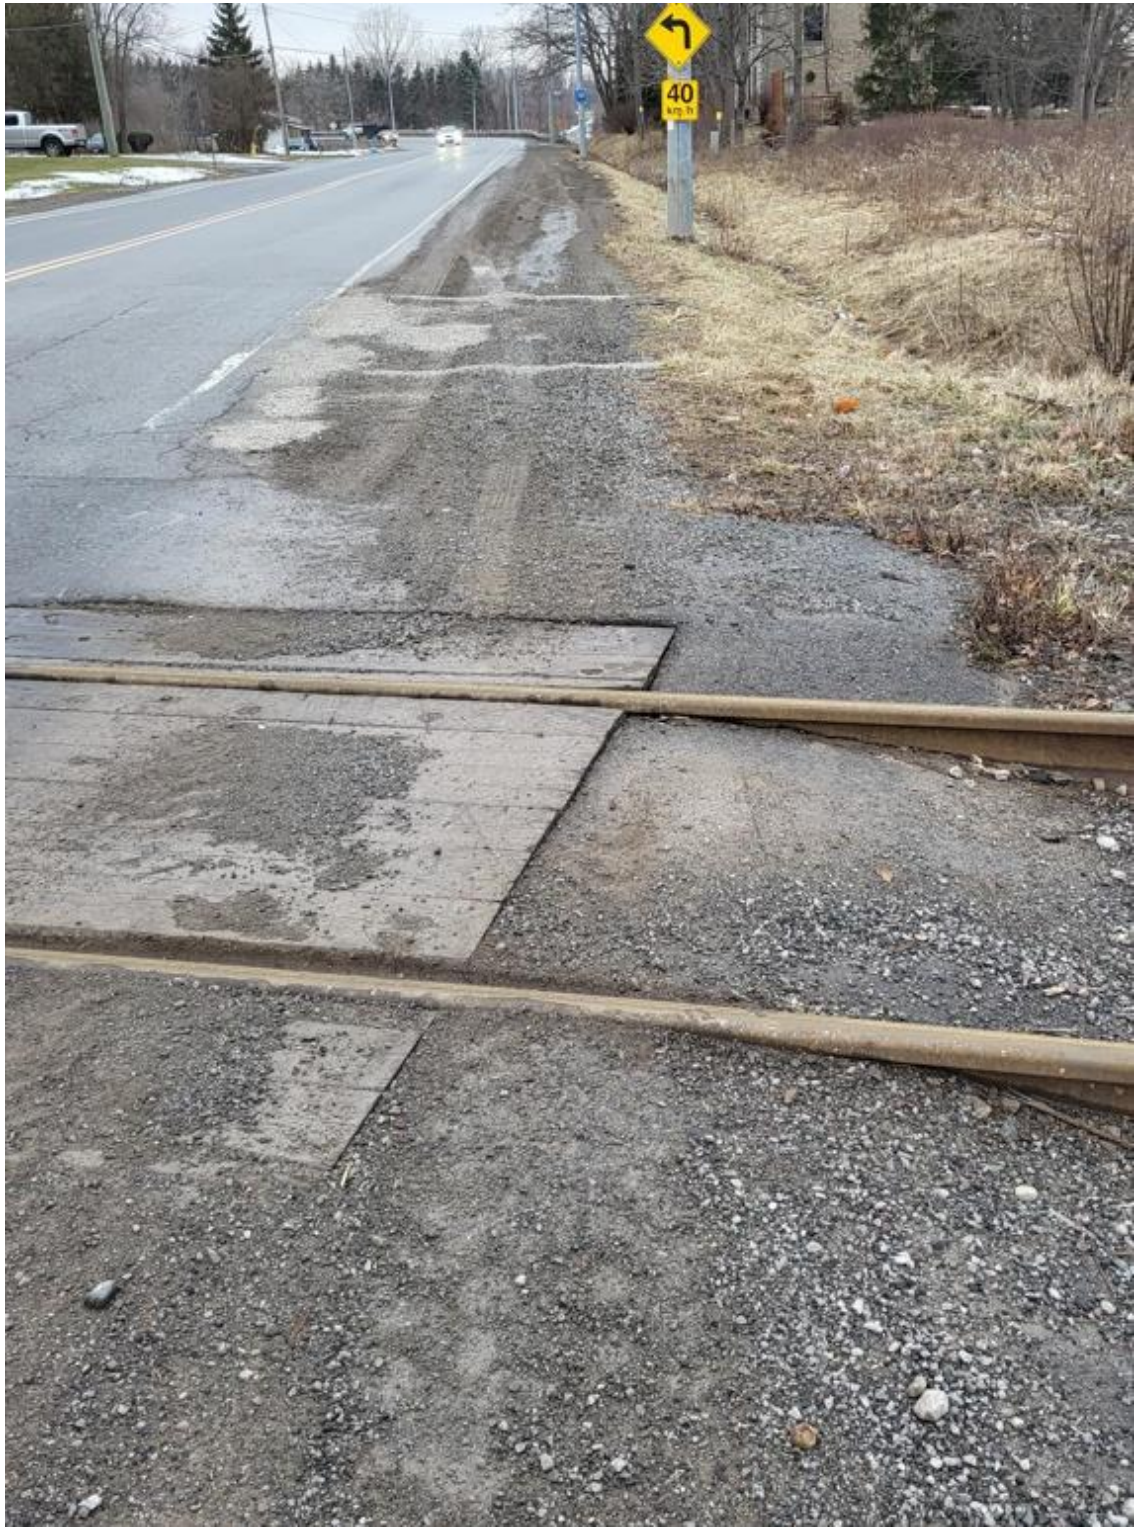
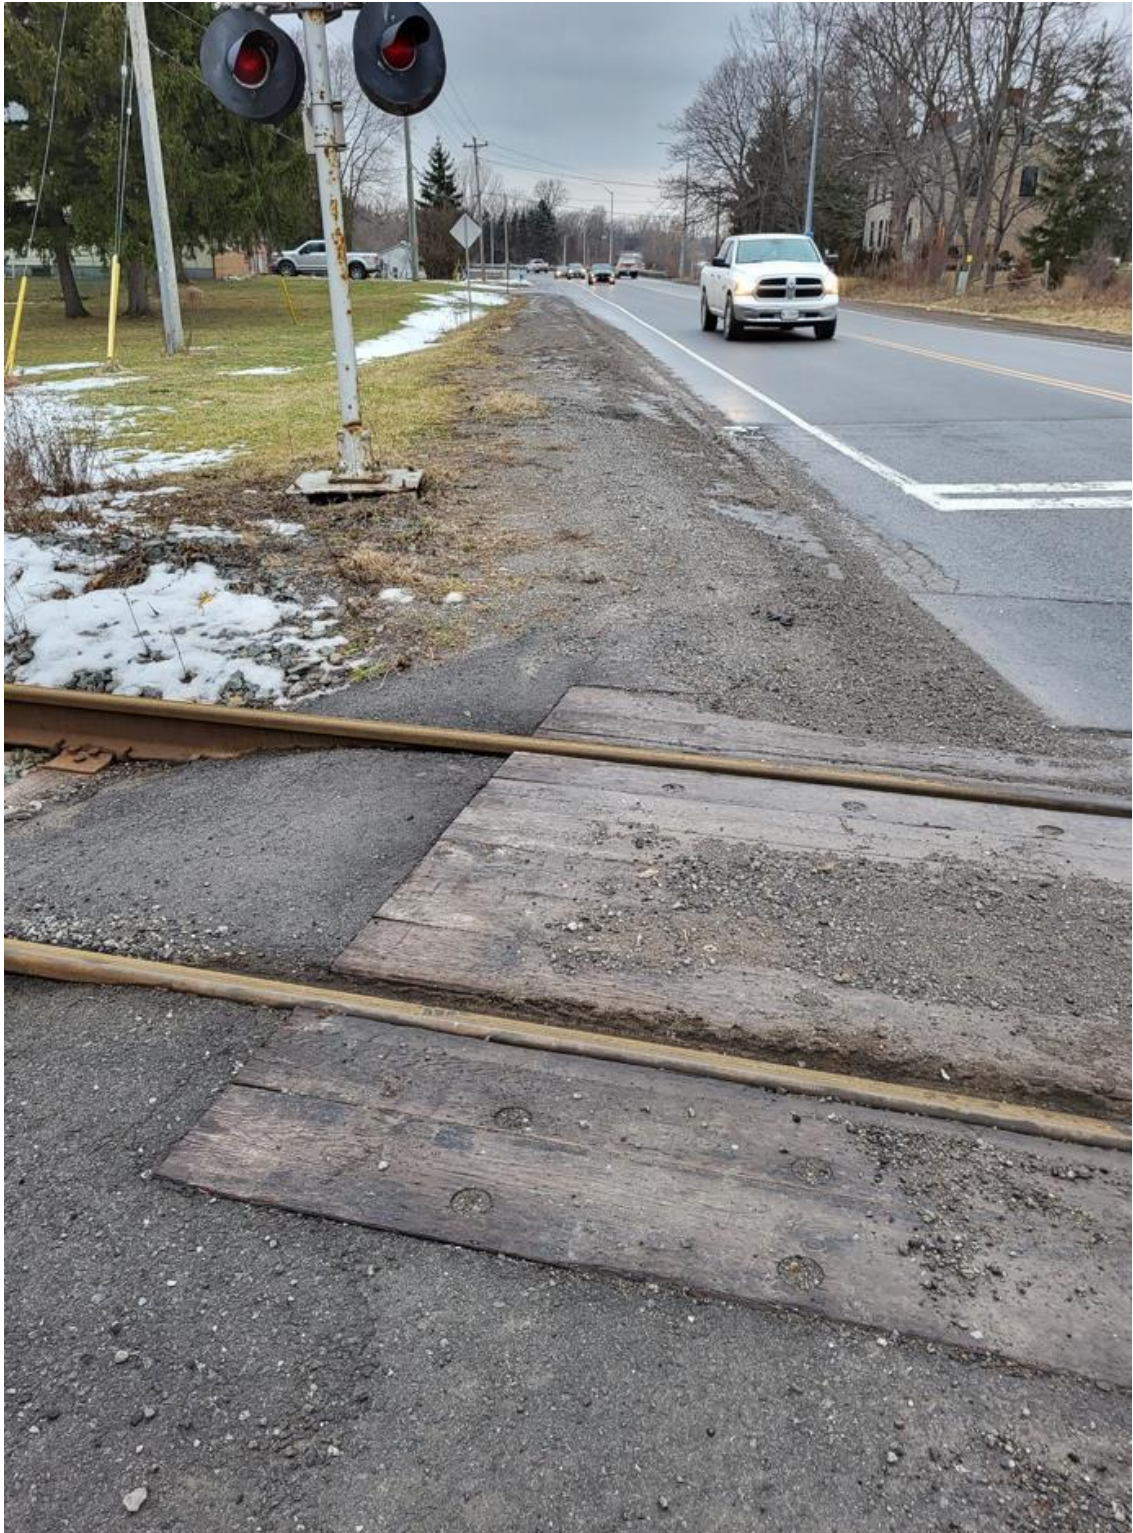
Criteria	Requirement	Lundy’s Lane Existing Conditions
Location	Rail Crossings within 400m	<ul style="list-style-type: none"> None
	Nearby Intersections and Accesses <ul style="list-style-type: none"> measured stop bar to stop bar not including railway access 	<ul style="list-style-type: none"> Lundy’s Lane and Allanport Road intersection – 250m Driveway at 13227 Lundy’s Lane – 70m
	Surrounding Land Uses	<ul style="list-style-type: none"> Commercial, Light Industrial, Residential
Grade Crossing Surface	Crossing Material & Condition	<ul style="list-style-type: none"> Wood planks and Asphalt Poor condition, planks sag as vehicle drive over, Figure A-1
	Condition of Roadway Asphalt	<ul style="list-style-type: none"> Good Condition
	Width of Crossing Surface	<ul style="list-style-type: none"> Distance between Tracks: 2.4m Distance between east and west stop bars (clearance distance): 12.4m
	Extension of Crossing Surface beyond edge of road or shoulder	<ul style="list-style-type: none"> 0.0m, Figures A-2 and A-3

Figure A-2: Grade Crossing Surface (North side)

Figure A-3: Grade Crossing Surface (South side)

<p>Based on existing conditions, the crossing surface should be repaired and extended 0.5m beyond the shoulder edge to meet the Grade Crossing Surface Requirement.</p>	<p>Based on existing conditions, the crossing surface should be repaired to meet the Grade Crossing Surface Requirement.</p>	<p>Based on existing conditions, this crossing meets the Grade Crossing Surface Requirement.</p>	<p>Based on existing conditions, this crossing meets the Grade Crossing Surface Requirement.</p>	<p>Based on existing conditions, this crossing meets the Grade Crossing Surface Requirement.</p>
Road Geometry	<p>Maximum Gradient between roadway and crossing: Level with the roadway Crossing Width: Approximately equivalent to the roadway width. Grade Crossing Angle: Skew requirements are not applicable at this</p>	<p>Maximum Gradient between roadway and crossing: Level with the roadway Crossing Width: Approximately equivalent to the roadway width. Grade Crossing Angle: Skew requirements are not applicable at this crossing location as the railway speed is less than 25km/h.</p>	<p>Maximum Gradient between roadway and crossing: Level with the roadway Crossing Width: Approximately equivalent to the roadway width. Grade Crossing Angle: Skew requirements are not applicable at this crossing location as the railway speed is less than 25km/h.</p>	<p>Maximum Gradient between roadway and crossing: Level with the roadway Crossing Width: Approximately equivalent to the roadway width. Grade Crossing Angle: approximately 30 degrees</p>	<p>Maximum Gradient between roadway and crossing: Level with the roadway Crossing Width: Approximately equivalent to the roadway width. Grade Crossing Angle: approximately 30 degrees</p>

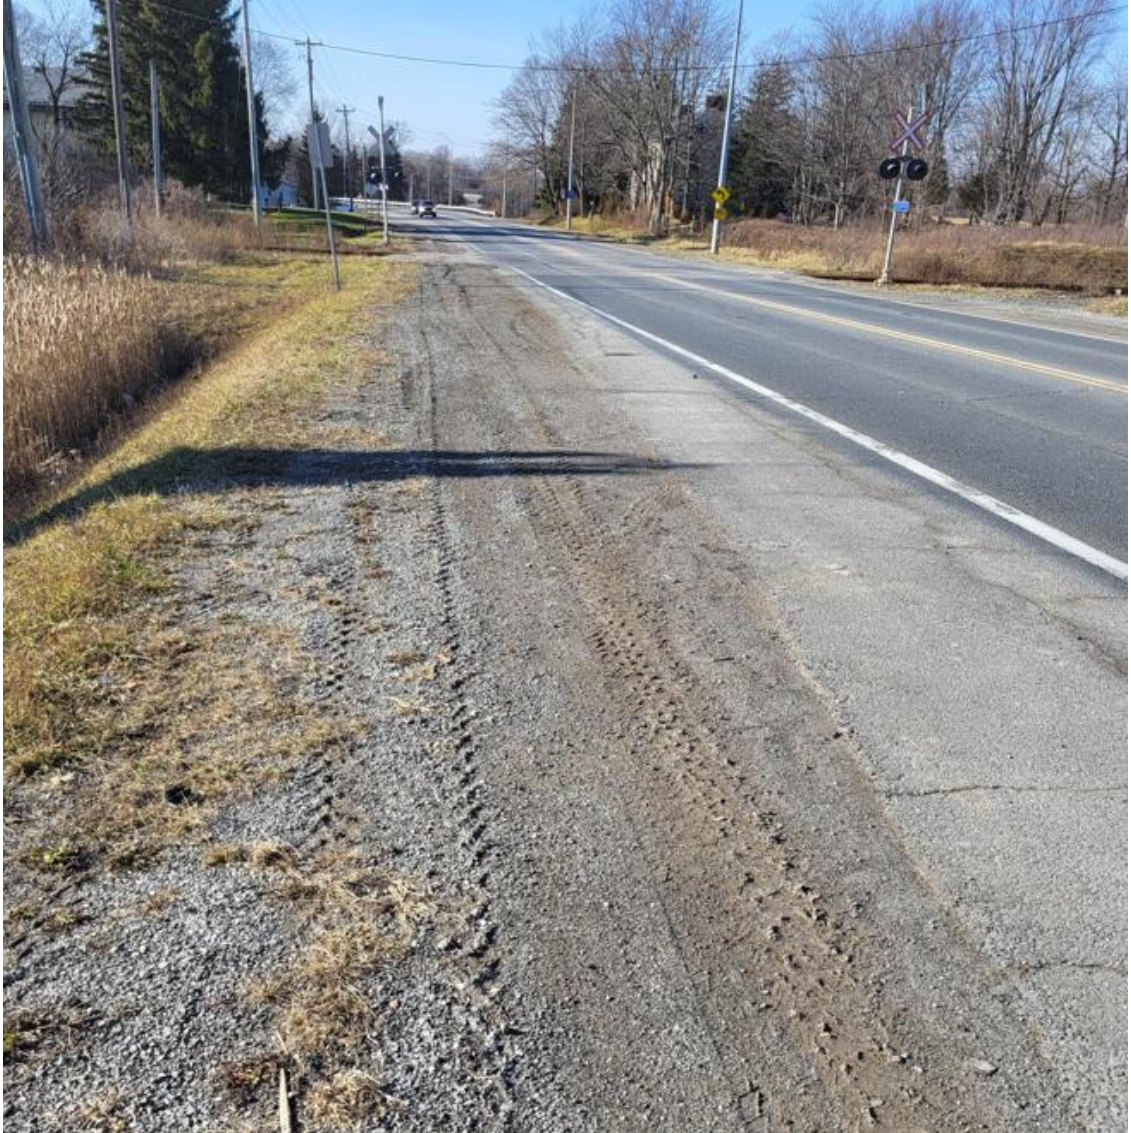
Criteria	Requirement	Lundy's Lane Existing Conditions	
	Roadway Width	<ul style="list-style-type: none"> 7.3m 	
	Shoulder	Eastbound (Width Varies, Figure A-4) <ul style="list-style-type: none"> North: 2.8m South: 3.5m 	Westbound <ul style="list-style-type: none"> North: 2.9m
Sightlines	Calculation Parameters	<ul style="list-style-type: none"> Clearance Distance: 12.4m Railway Design Speed: 17km/h Roadway Design Speed: 70km/h 	
	SSD	<ul style="list-style-type: none"> SSD = 105m Eastbound and westbound sightlines exceed the required SSD, Figure A-5 & Figure A-6 	
	$D_{Stopped}$	<ul style="list-style-type: none"> $D_{Stopped} = 55m$ Westbound approach: <ul style="list-style-type: none"> There are available sightlines for westbound vehicles exceeding the required $D_{Stopped}$ in each direction. (Figure A-7, Figure A-8) 	Eastbound approach: <ul style="list-style-type: none"> There are available sightlines for eastbound vehicles exceeding the required the required $D_{Stopped}$. (Figure A-9) Sightlines in the southern direction were somewhat obstructed by foliage; however due to its height, a train is likely to be seen. (Figure A-10)

Figure A-4: Lundy's Lane Crossing – Shoulder Width

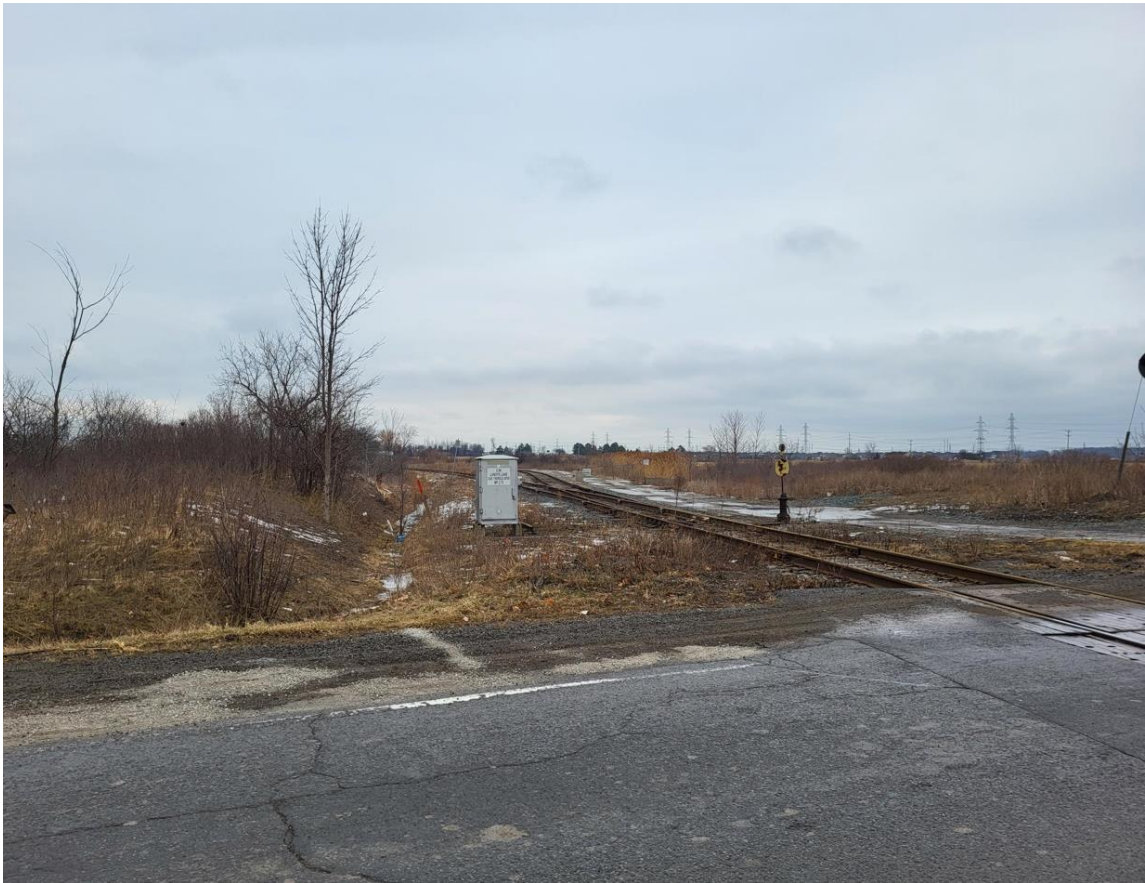
Figure A-10: Lundy's Lane Crossing Dstopped (eastbound approach facing northbound) – 50m

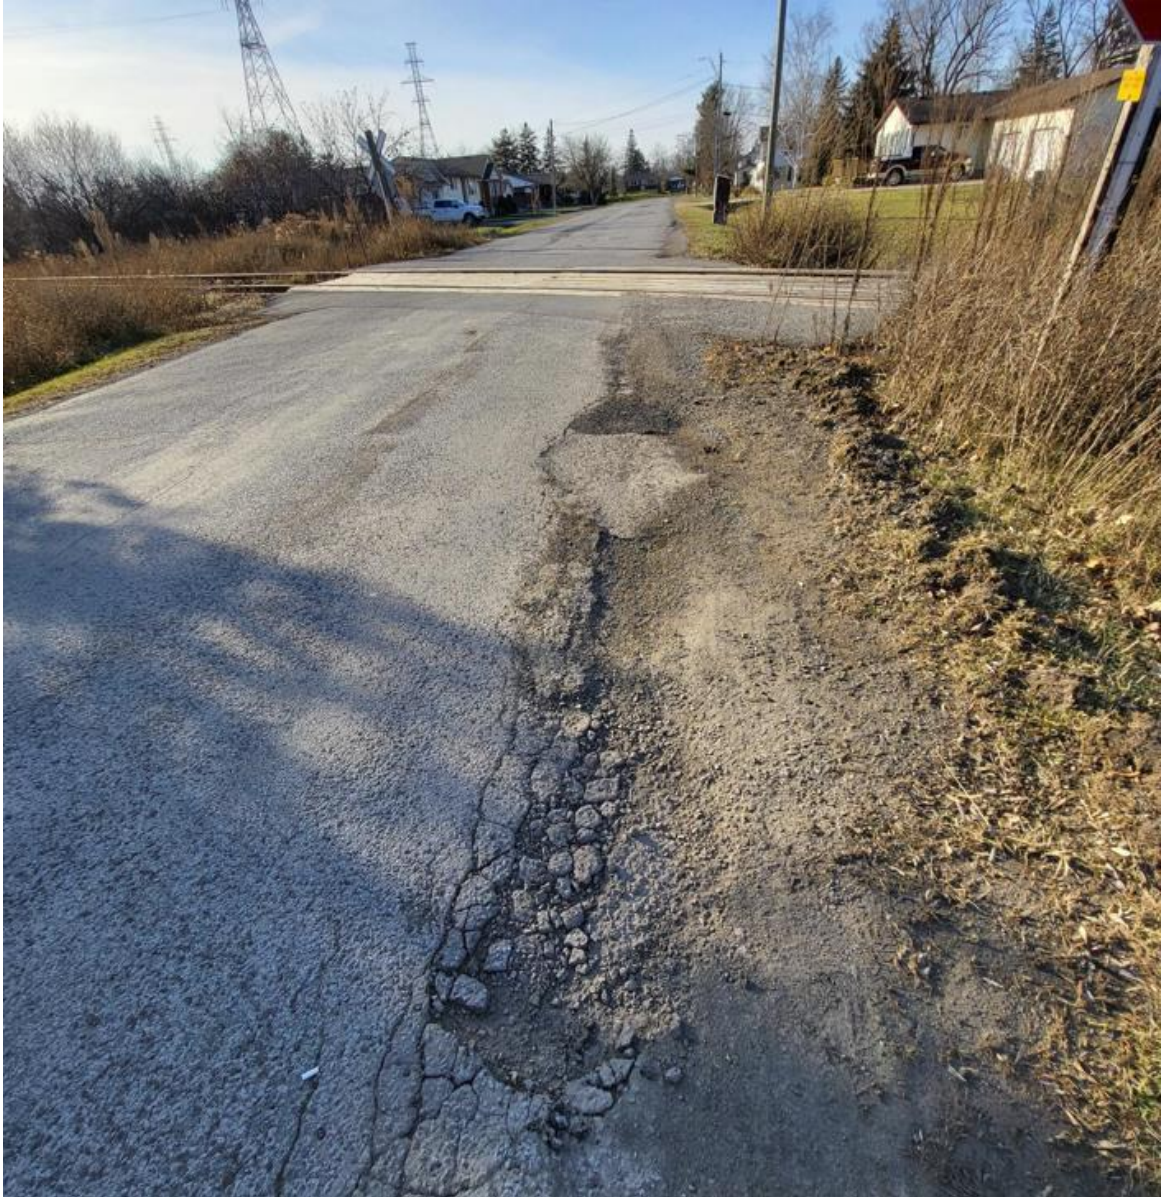
Criteria	Requirement	Henderson Street Existing Conditions	
	Roadway Width	<ul style="list-style-type: none"> 5.7m 	
	Shoulder	Eastbound (Width Varies, Figure B-2) <ul style="list-style-type: none"> North: 0.8m South: 0.6m 	Westbound <ul style="list-style-type: none"> North: 0.5m South: 0.6m
Sightlines	Calculation Parameters	<ul style="list-style-type: none"> Clearance Distance: 15m Railway Design Speed: 17km/h Roadway Design Speed: 40km/h (EB), 20km/h (WB) 	
	SSD	<ul style="list-style-type: none"> SSD = 50m (EB), 20m (WB) Eastbound and westbound sightlines exceed the required SSD, Figure B-3 & Figure B-4 	
	$D_{Stopped}$	Eastbound approach: <ul style="list-style-type: none"> $D_{Stopped} = 58m$ There are available sightlines for vehicles exceeding the required $D_{Stopped}$ in each direction. (Figure B-5, Figure B-6) 	Westbound approach: <ul style="list-style-type: none"> $D_{Stopped} = 58m$ There are available sightlines for vehicles exceeding the required $D_{Stopped}$ in the southern direction. (Figure B-7) Sightlines in the northern direction obstructed by foliage. (Figure B-8)

Figure B-2: Henderson Street Crossing – Shoulder Condition

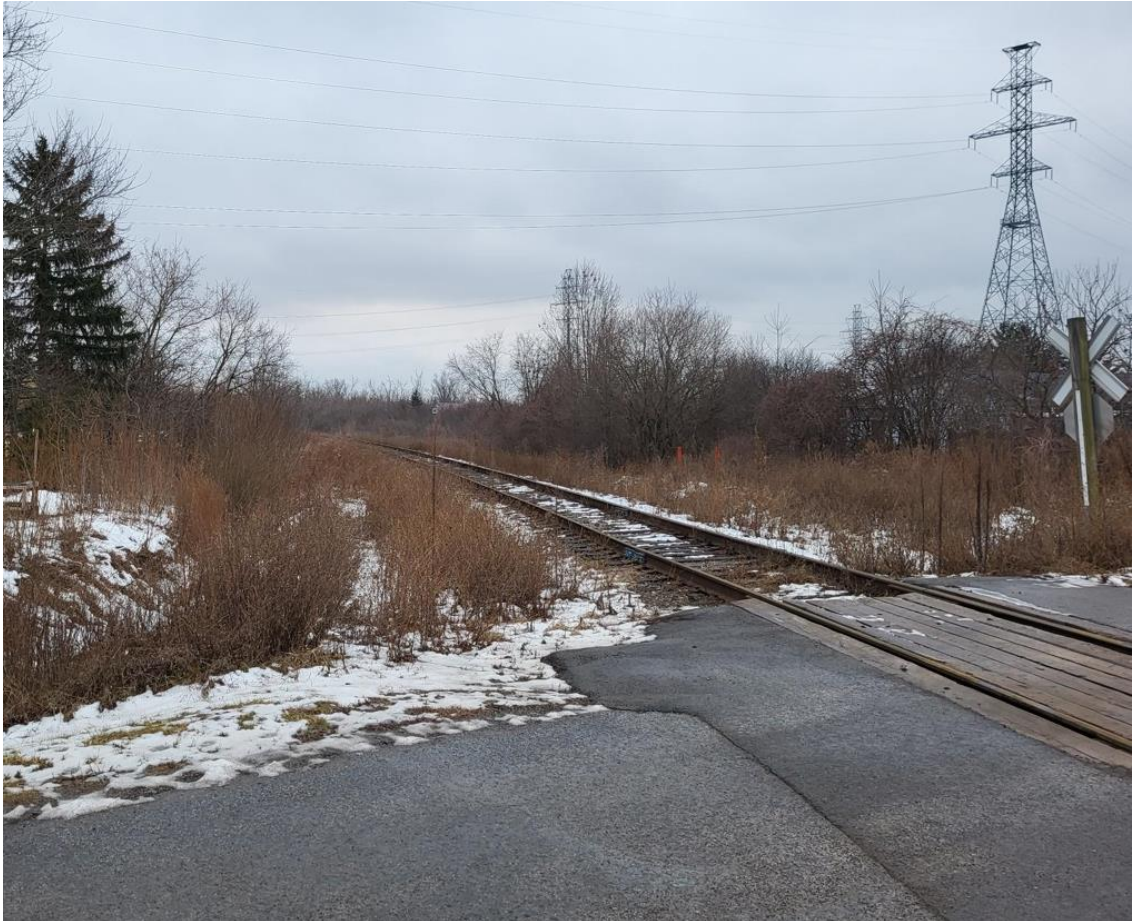
Figure B-7: Henderson Street Crossing (Dstopped) – Westbound Approach (facing southbound)

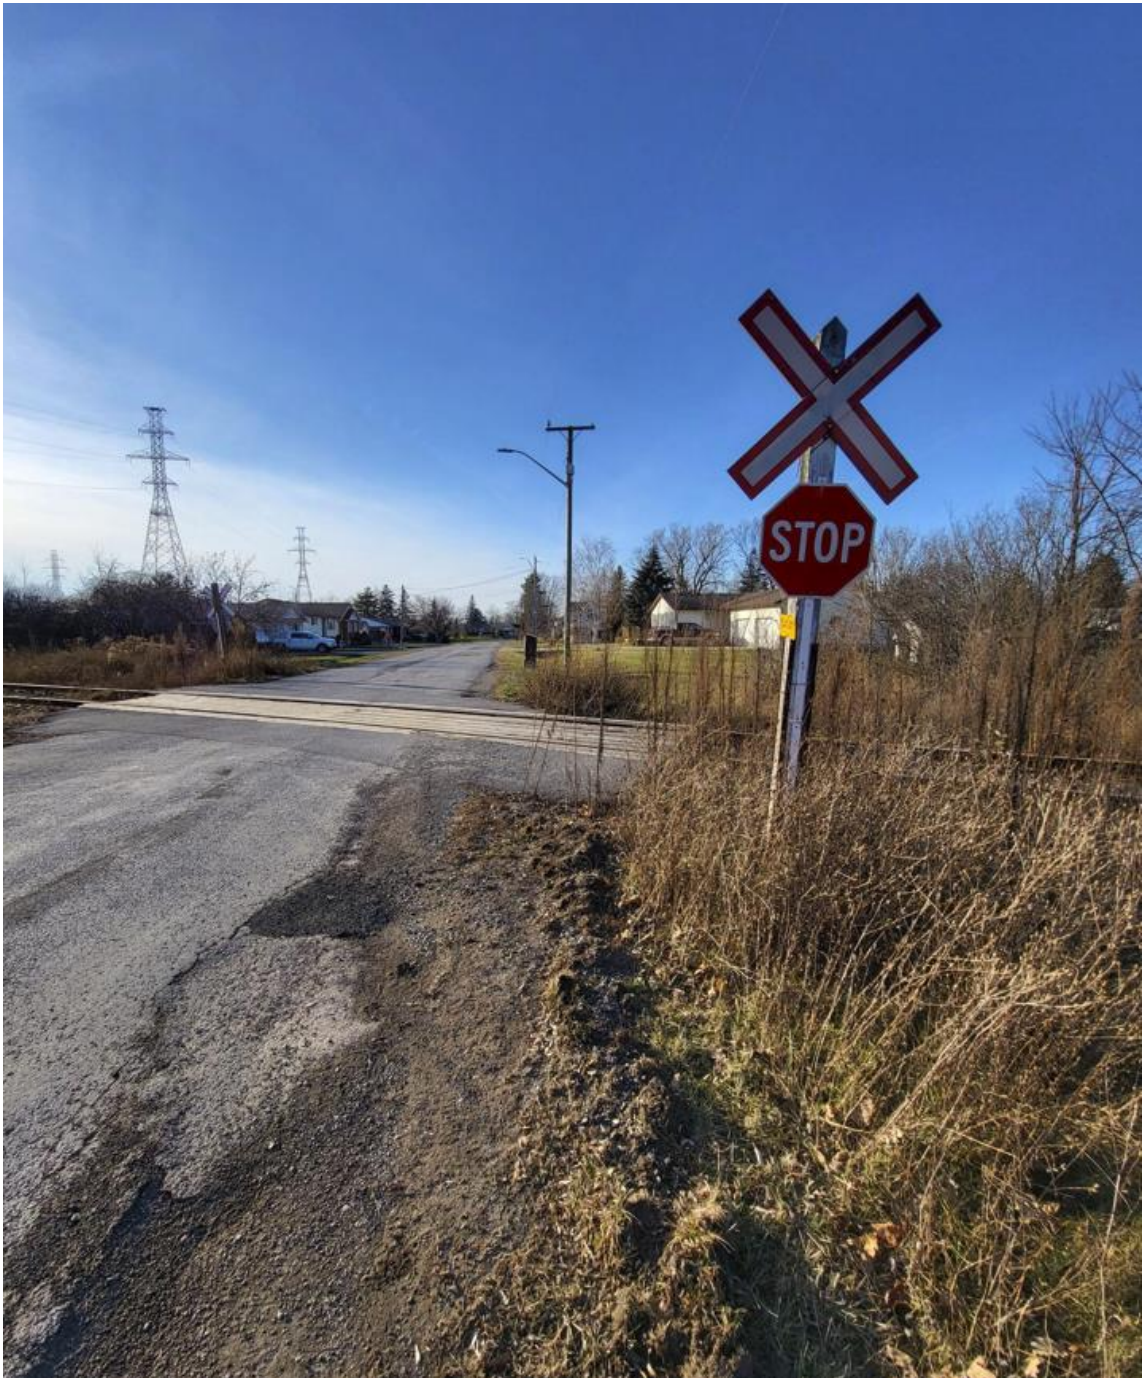
Criteria	Requirement	Henderson Street Existing Conditions	
		<ul style="list-style-type: none"> • $D_{SSD} = 40\text{m}$ • There are obstructed sightlines for vehicles in each direction. (Figure B-9, Figure B-10) 	<ul style="list-style-type: none"> • $D_{SSD} = 35\text{m}$ • There are available sightlines for vehicles exceeding the required D_{SSD} in the southern direction. (Figure B-11) • There are obstructed sightlines for vehicles in the northern direction. (Figure B-12)
	Other	<p>Movable or Immovable objects</p> <ul style="list-style-type: none"> • Community Mailbox east of rail-crossing <p>Visibility of warning system</p> <ul style="list-style-type: none"> • Visible from the intersection of Henderson Street at Clifton Street (60m from crossing) (Figure B-13) • Intersection of Henderson Street at Centre Street (180m from crossing) (Figure B-14) 	
Signage and Pavement Markings	Warning Signage	› None

Figure B-14: Henderson Street Crossing – Stop Sign Control

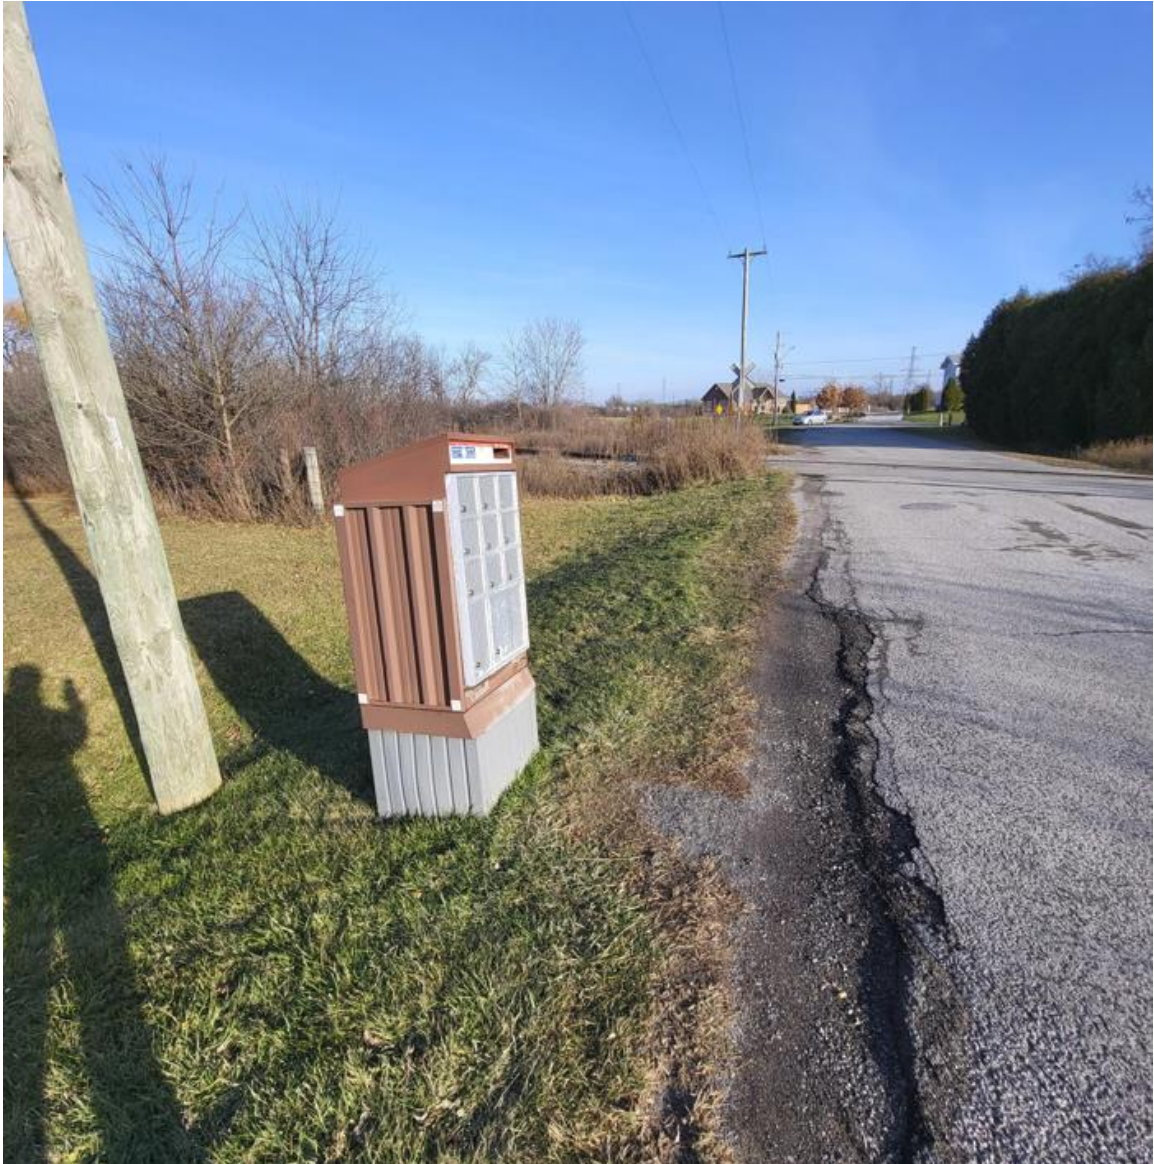
Criteria	Requirement	Henderson Street Existing Conditions	
		<ul style="list-style-type: none"> • 1.7m from the edge of the roadway • 4.0m from the edge of the tracks 	<ul style="list-style-type: none"> • 2.4m from the edge of the roadway • 4.5m from the edge of the rail tracks
Fencing	Fencing	<ul style="list-style-type: none"> • None 	
	Evidence of Trespassing	<ul style="list-style-type: none"> • None 	
Additional Comments	Parking	<ul style="list-style-type: none"> • No parked cars within the vicinity of the crossing during the site visit. • The mailbox is a potential generator of parked vehicles near the crossing. (Figure B-16)

Figure B-15: Henderson Street Crossing – Other Considerations (Potential Generator of Parked Vehicles)

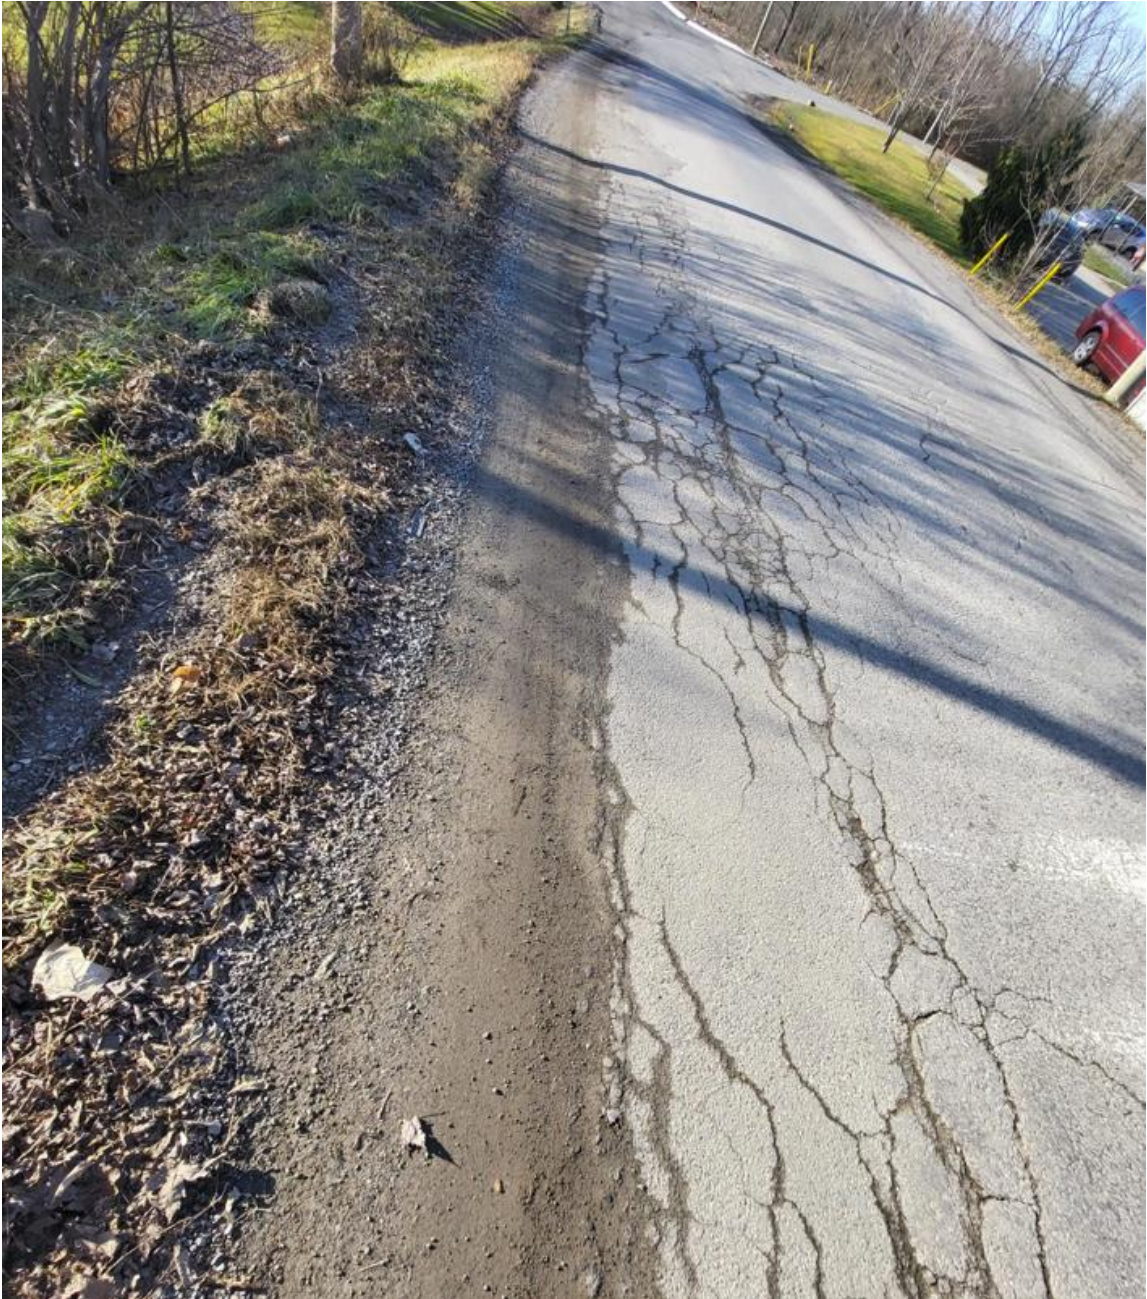
Criteria	Requirement	Barron Road (W) Existing Conditions	
	Shoulder	Eastbound (Width Varies, Figure C-5) <ul style="list-style-type: none"> North: 0.7m South: 0.9m 	Westbound <ul style="list-style-type: none"> North: 1.1m South: 1.8m
Sightlines	Calculation Parameters	<ul style="list-style-type: none"> Clearance Distance: 14.8m Railway Design Speed: 17km/h Roadway Design Speed: 60km/h 	
	SSD	<ul style="list-style-type: none"> SSD = 85m Eastbound and westbound sightlines exceed the required SSD, Figure C-6 & Figure C-7 	
	$D_{Stopped}$	<ul style="list-style-type: none"> $D_{Stopped} = 60m$ Eastbound approach: <ul style="list-style-type: none"> There are available sightlines for vehicles exceeding the required $D_{Stopped}$ in each direction. (Figure C-8, Figure C-9) 	Westbound approach: <ul style="list-style-type: none"> There are available sightlines for vehicles exceeding the required $D_{Stopped}$ in each direction. (Figure C-10, Figure C-11)

Figure C-5: Barron Road (West) Crossing – Shoulder Condition

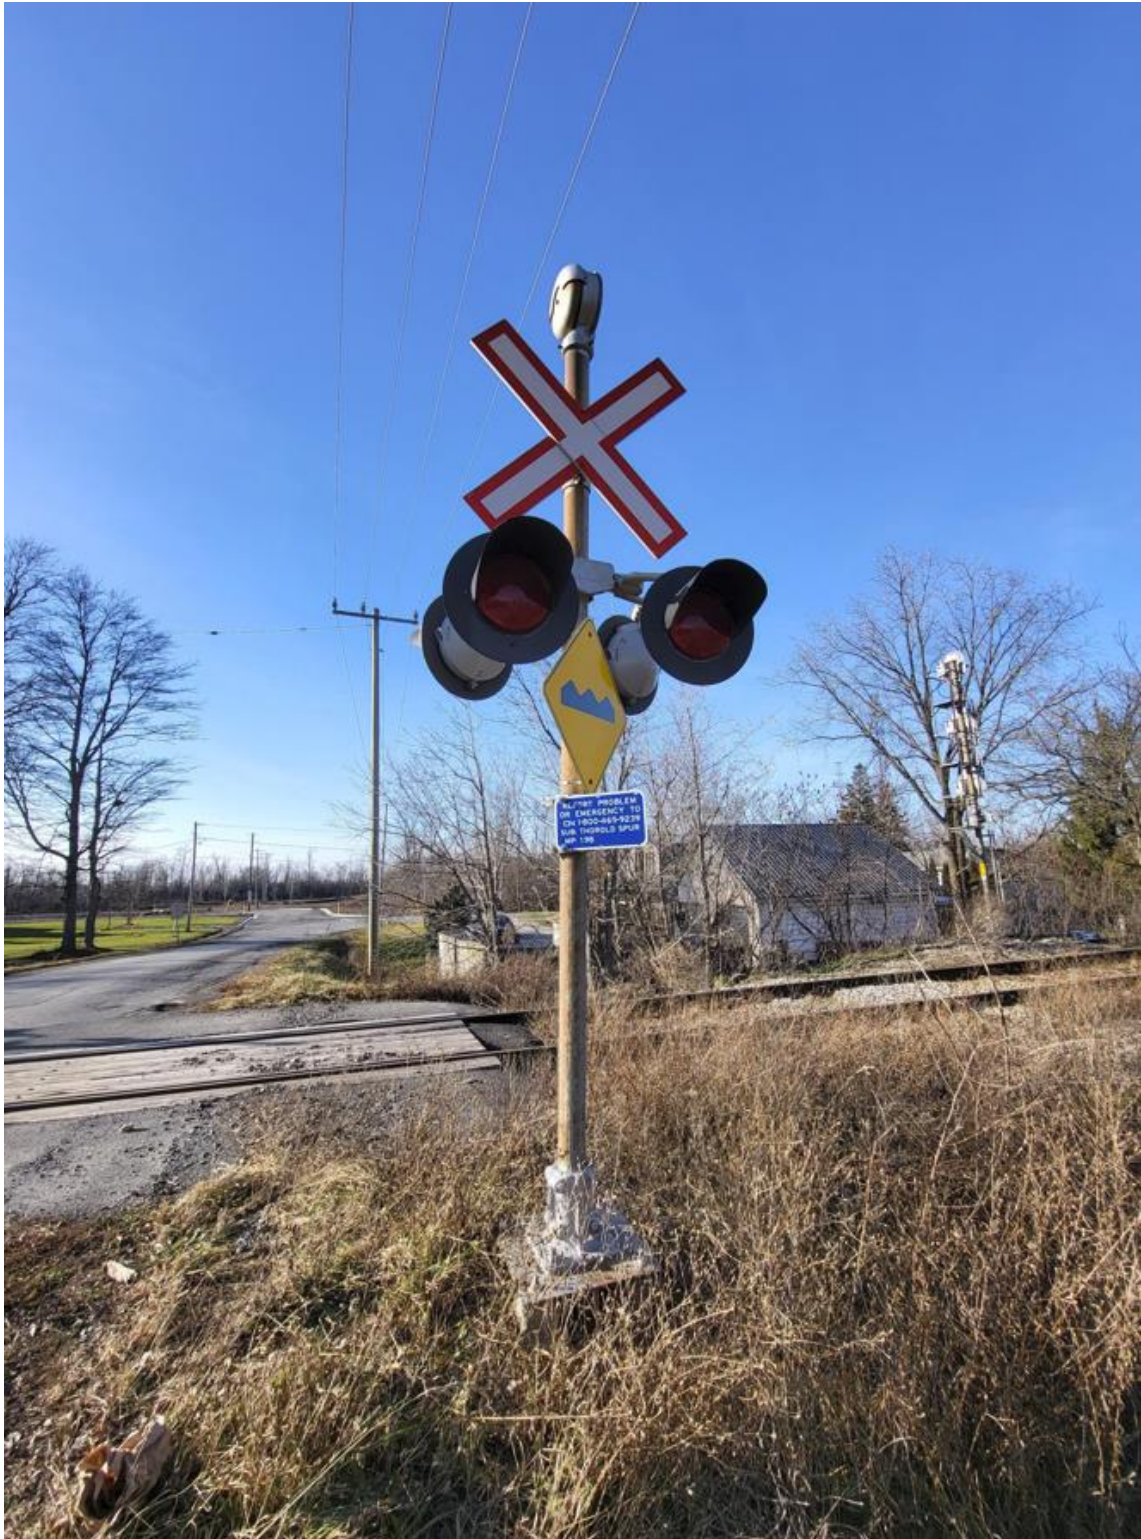
Figure C-12: Barron Road (West) Crossing – “Watch for Bumps” Sign Condition

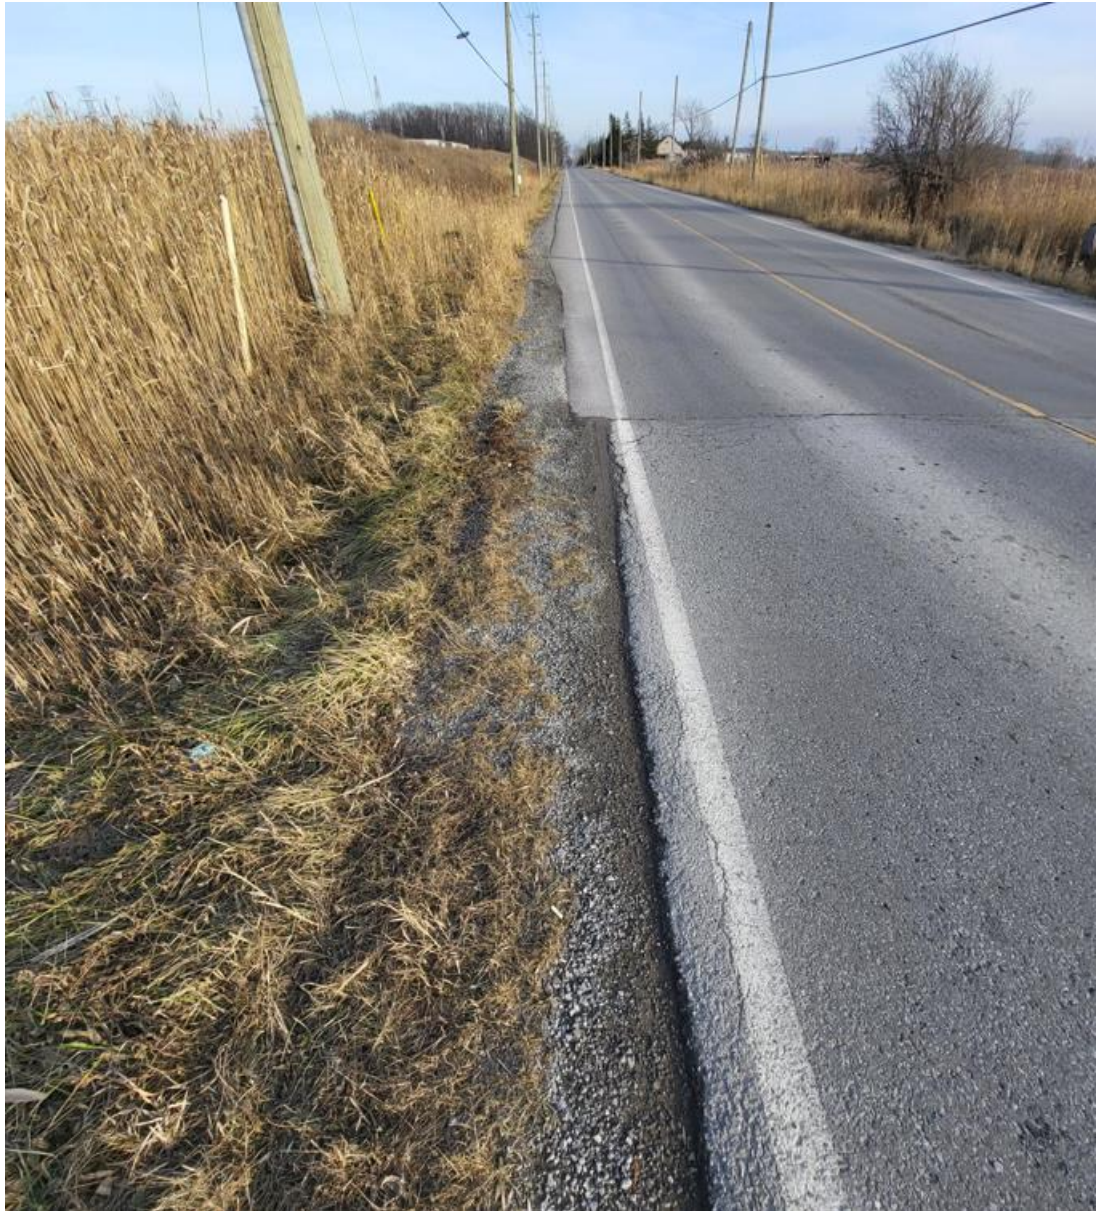
Criteria	Requirement	Barron Road (E) Existing Conditions	
	Shoulder	Eastbound (Width Varies, Figure D-4) <ul style="list-style-type: none"> • North: 0.7m • South: 0.9m 	Westbound <ul style="list-style-type: none"> • North: 1.1m • South: 1.8m
Sightlines	Calculation Parameters	<ul style="list-style-type: none"> • Clearance Distance: 32m • Railway Design Speed: 97km/h • Roadway Design Speed: 70km/h 	
	SSD	<ul style="list-style-type: none"> • SSD = 105m • Eastbound and westbound sightlines exceed the required SSD, Figure D-5 & Figure D-6 	
	$D_{Stopped}$	<ul style="list-style-type: none"> • $D_{Stopped} = 710m$ • Not applicable due to the presence of a warning system with gates. 	
	D_{SSD}	<ul style="list-style-type: none"> • $D_{SSD} = 210m$ • Not applicable due to the presence of a warning system with flashing lights and bells. 	
	Other	Visibility of warning system <ul style="list-style-type: none"> • Visible from driveway – approximately 20m west of crossing, Figure D-7

Figure D-4: Barron Road (East) – Shoulder Condition

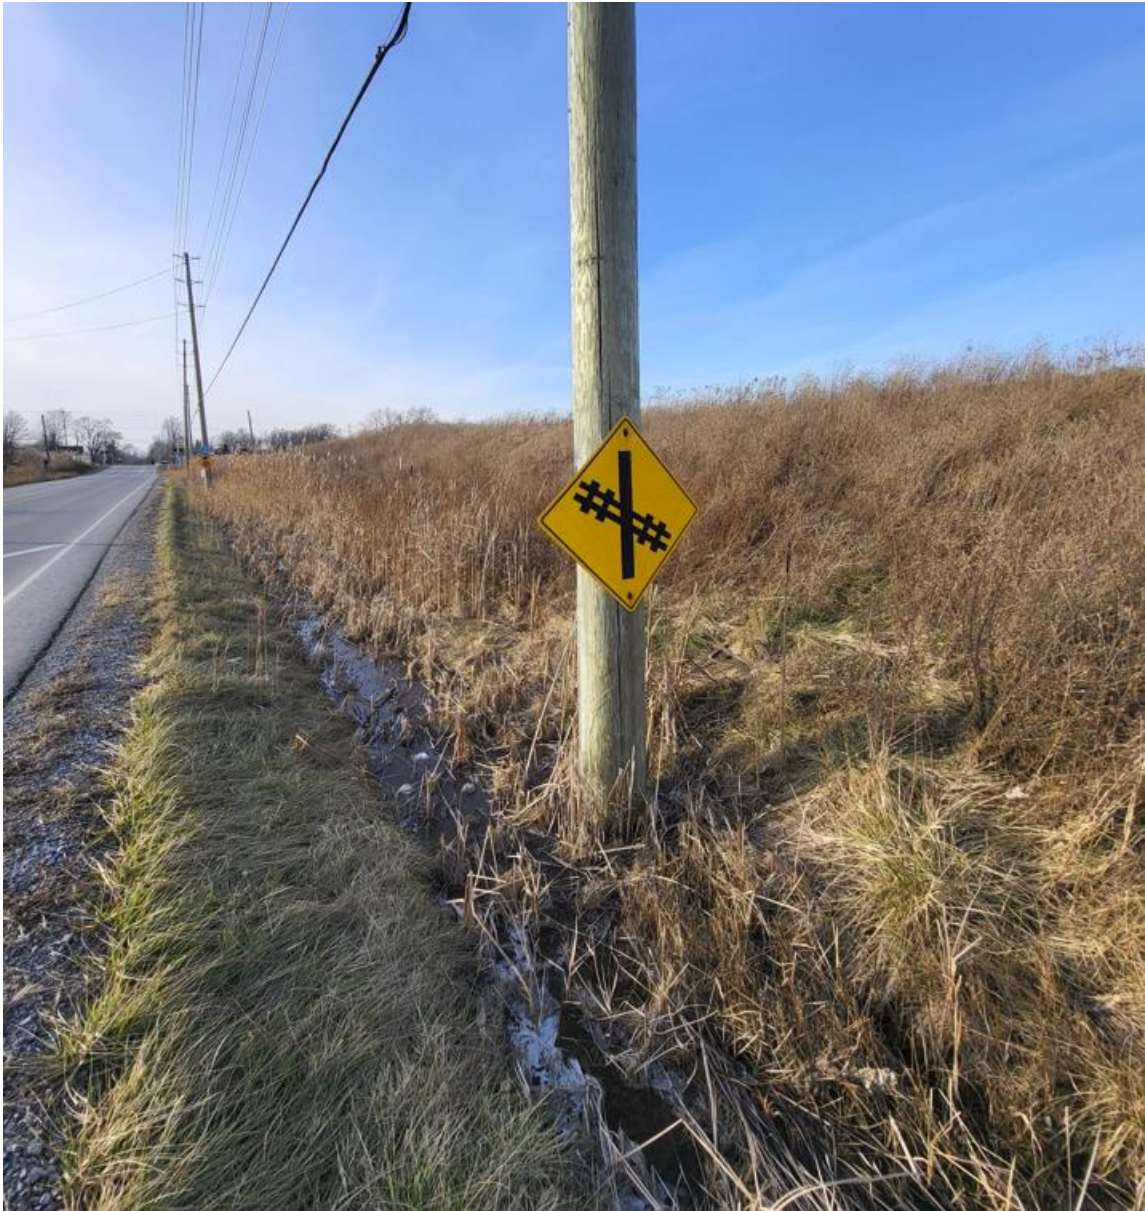
Signage and Pavement Markings	Warning Signage	<ul style="list-style-type: none"> • W-10a located 102m from stop bar, good condition, Figure D-8 	
	Pavement Markings	<ul style="list-style-type: none"> • Painted 'X' on westbound approach located 93m from stop bar, Poor condition and faded, Figure D-9 • Road Centreline, good condition • Road Edge Markings, good condition

Figure D-8: Barron Road (East) – Warning Signage
