Allanburg Area Whistle Cessation Study Report - Draft

City of Thorold

Whistle Cessation Study

Rail Crossing Existing Condition Assessment

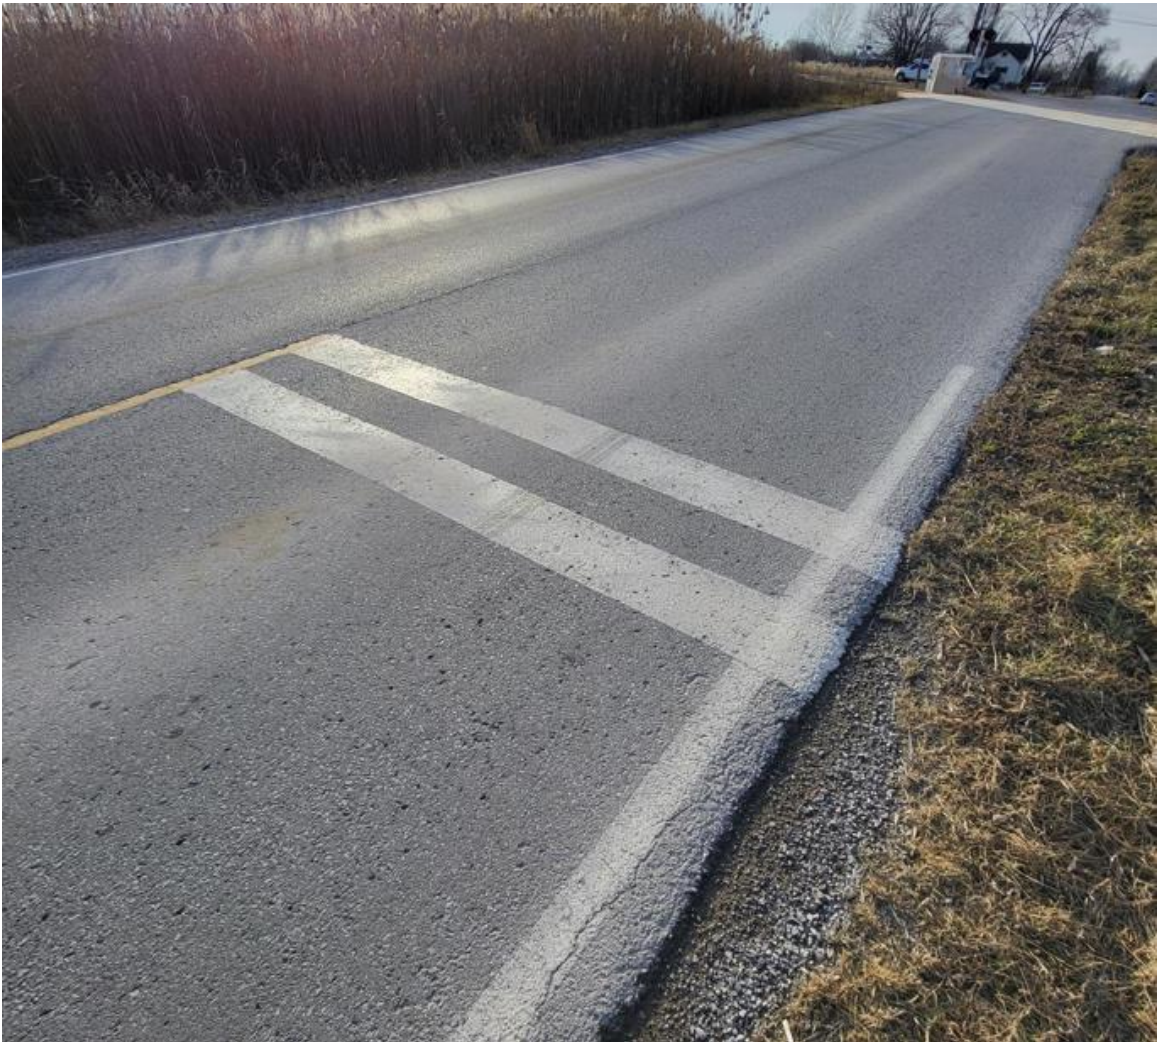
Criteria	Requirement	Barron Road (E) Existing Conditions	
		<ul style="list-style-type: none"> • Stop Bar, Figures D-10 & Figure D-11 <ul style="list-style-type: none"> › Eastbound: 14.3m from edge of tracks, faded › Westbound: 14.9m from edge of tracks, good condition 	
Warning System	Warning System	<ul style="list-style-type: none"> • Warning System with Flashing Lights, Bells, and Gates Figure D-12 	
	Location of Warning System	Eastbound <ul style="list-style-type: none"> • 2.6m from the edge of the roadway • 3.3m from the edge of the tracks 	Westbound <ul style="list-style-type: none"> • 2.7m from the edge of the roadway • 3.3m from the edge of the rail tracks
Fencing	Fencing	<ul style="list-style-type: none"> • None 	
	Evidence of Trespassing	<ul style="list-style-type: none"> • None 	
Additional Comments	Parking	<ul style="list-style-type: none"> • No parked cars within the vicinity of the crossing during the site visit.

Figure D-10: Barron Road (East) Stop Bar – Westbound Approach

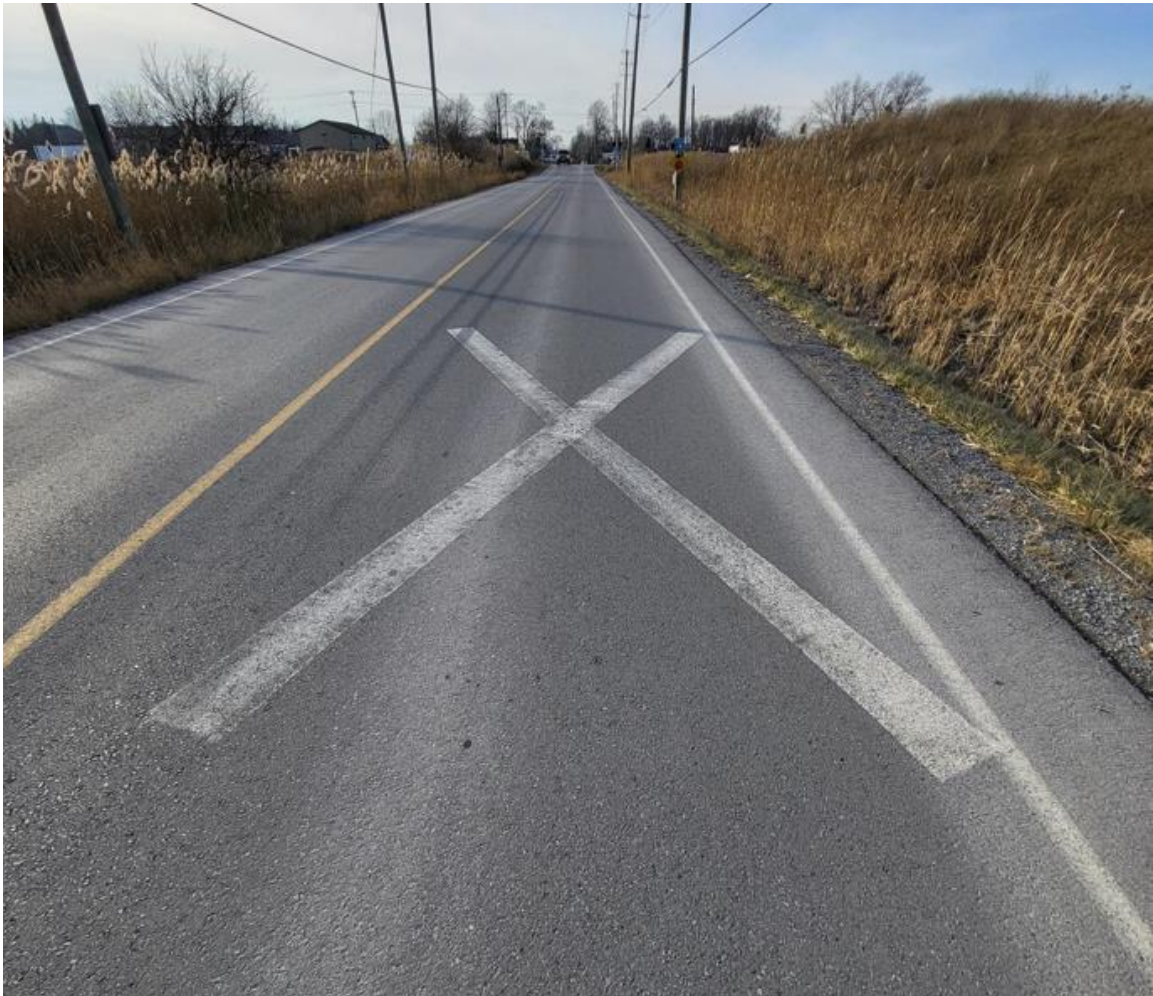
Figure D-11: Barron Road (East) – Painted “X”

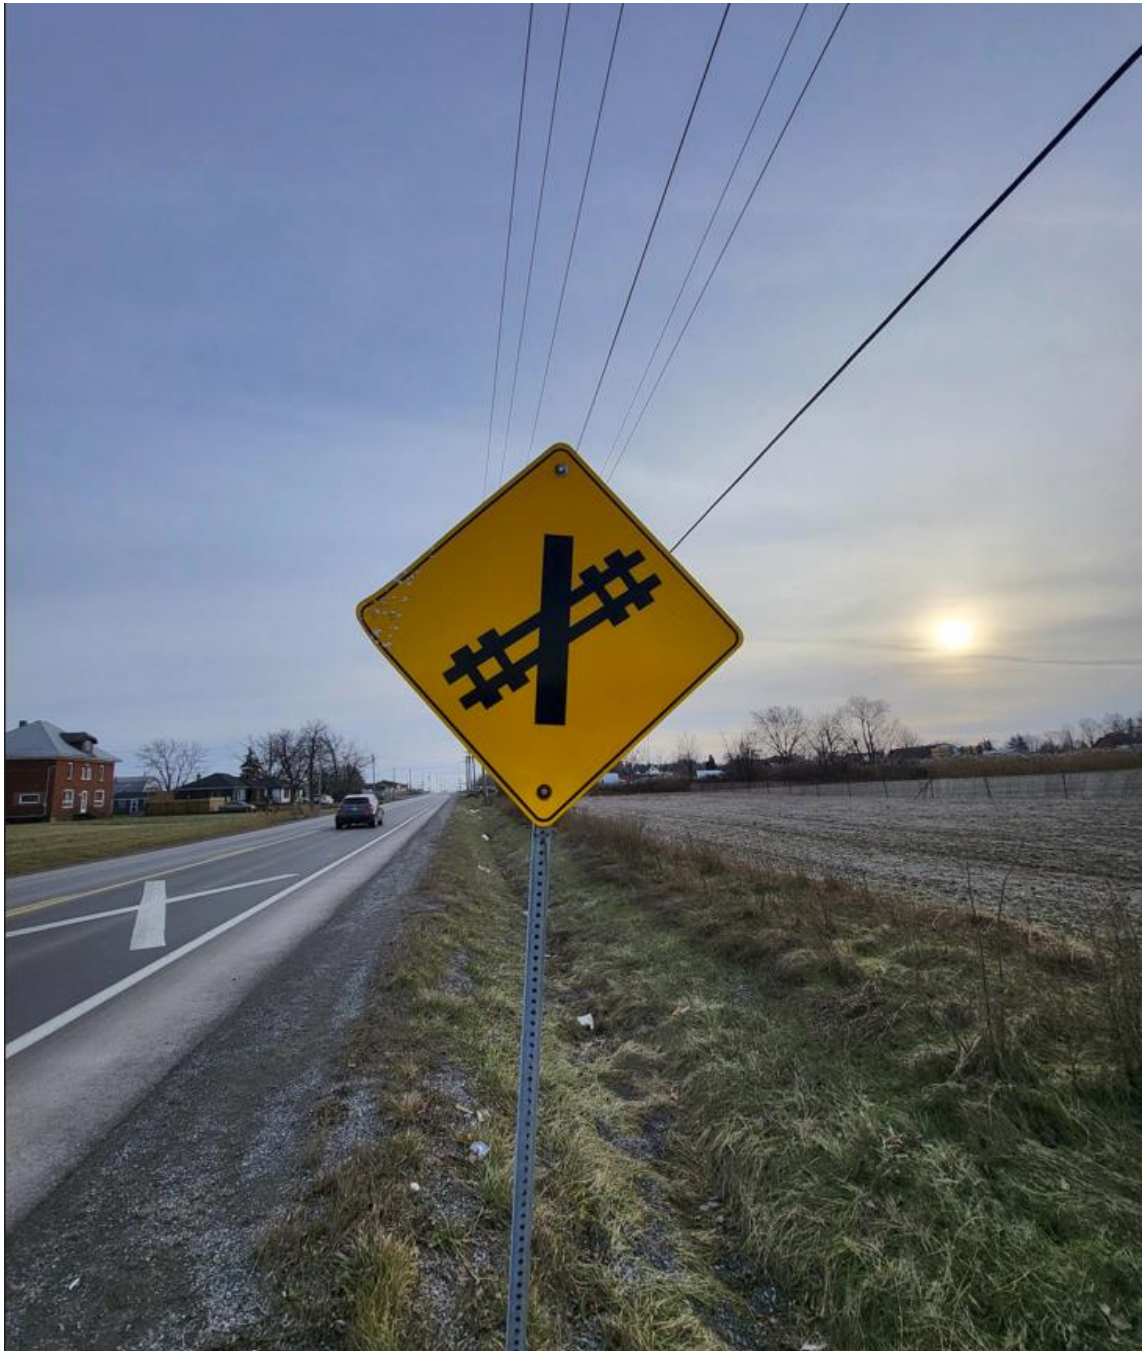
Figure E-8: Allanport Road Crossing Warning Sign Condition – Southbound Approach (Front of Sign)

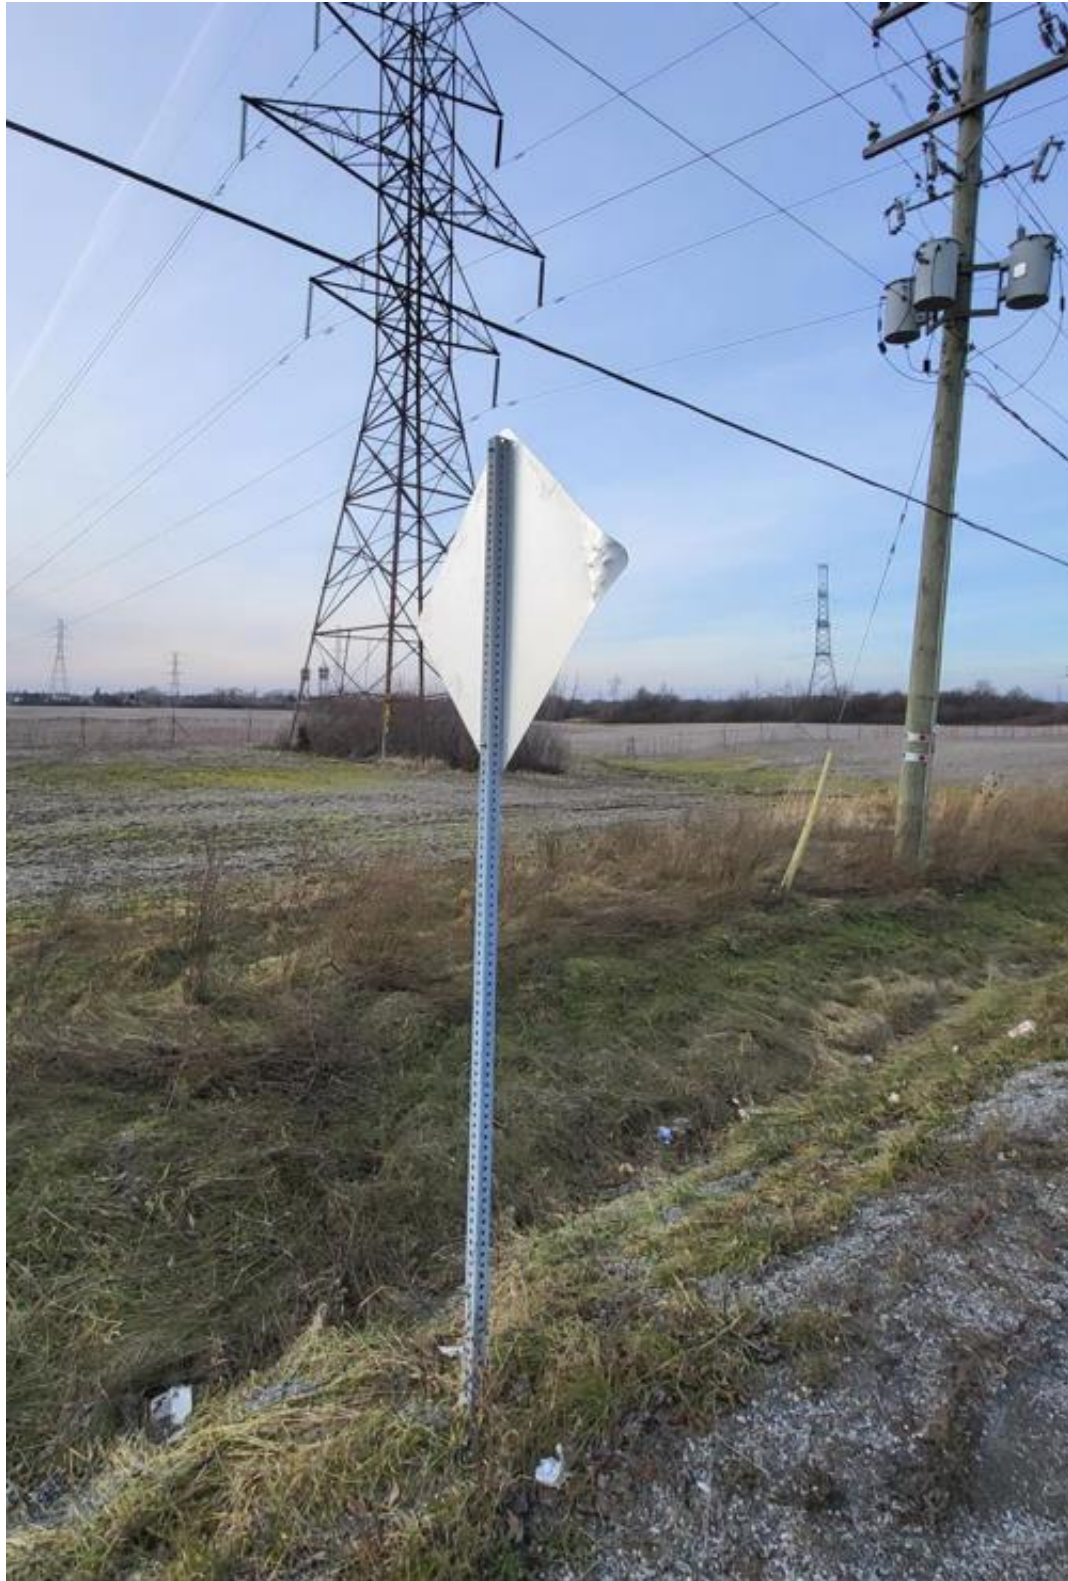
Figure E-9: Allanport Road Crossing Warning Sign Condition – Southbound Approach (Back of Sign)
