BUILDING CONDITION ASSESSMENT

JAMES WHYTE ARENA

70 Front Street North, Thorold

Report Date: November 8, 2024

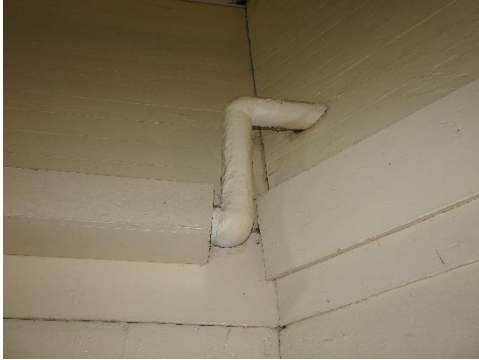
The 2016 Asbestos Materials Survey by Ontario Environmental & Safety Network Ltd. Indicates that asbestos containing materials (ACM) are found in older vinyl floor tile, transite wall and ceiling panels, pipe fitting insulation, and cement transite piping.

Our assessment noted that some of the transite paneling, and vinyl floor tile/sheeting are damaged. Pipe fittings were also not marked (painted) where asbestos containing. Other hazardous materials are known to be present including lead, mercury, and silica.

It is recommended that a complete Designated Substance Survey (DSS) be provided to accompany this report and that the ACM be removed when renovating areas over the short term.

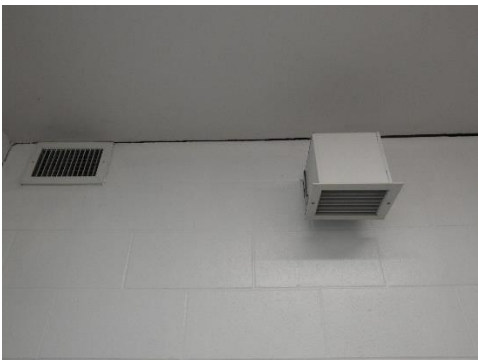
The building is equipped with point-source exhaust fans for the washrooms, change rooms, and arena bowl. Heating is by gas-fired furnaces and conventional ducting. Ventilation of rates were not measured but are anticipated to be less than adequate (not performing to meet the minimum ASHRAE standards).

It is recommended that the aging furnaces and fans be replaced, ducting and accessories be cleaned, and a full balancing and commissioning program be initiated to ensure proper ventilation rates are being provided to the building.
