Thorold Fire and Emergency Services

Headquarters Review

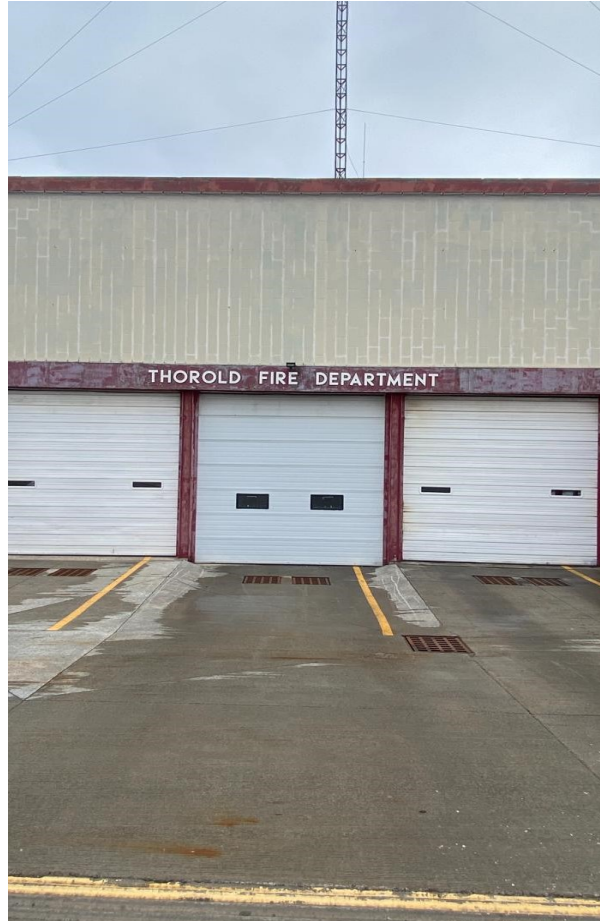
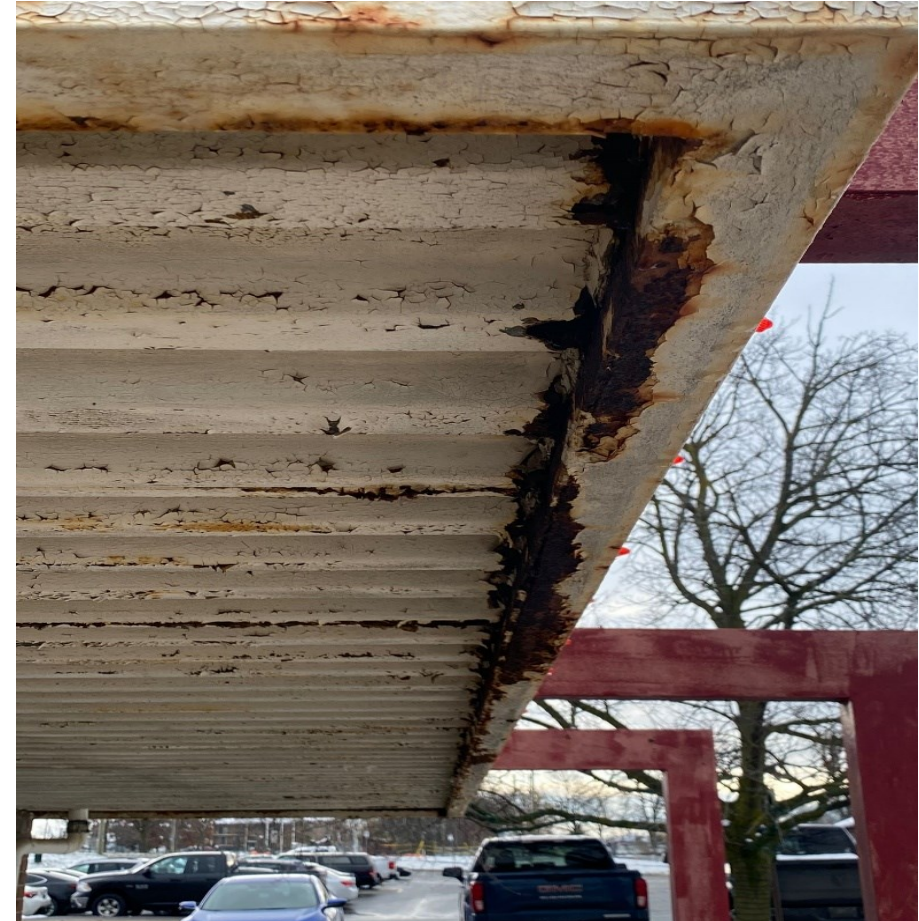
Front of Station 1

- Headquarters in downtown core
- Distressing public perception of city infrastructure
- Negative reflection of the fire service

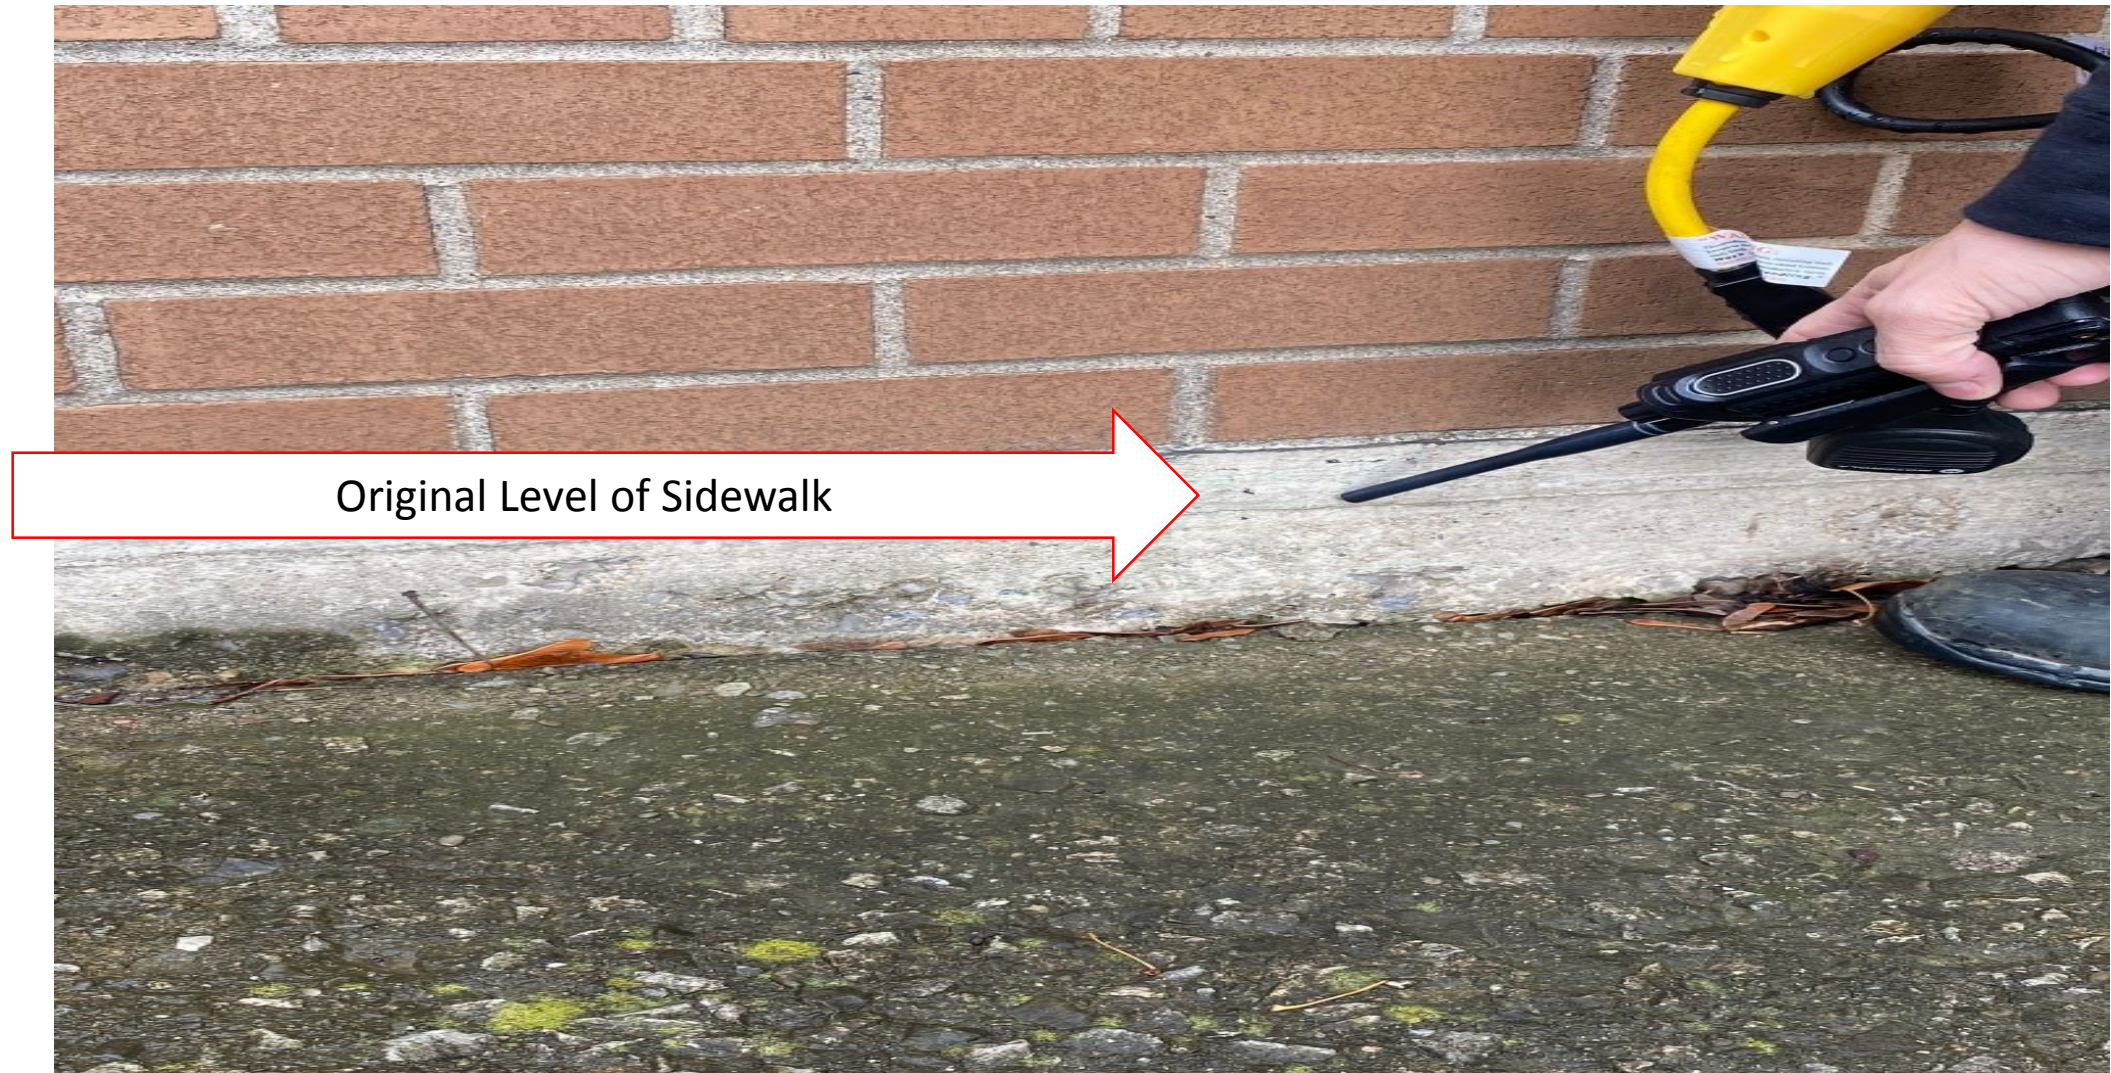
Sinking Sidewalk

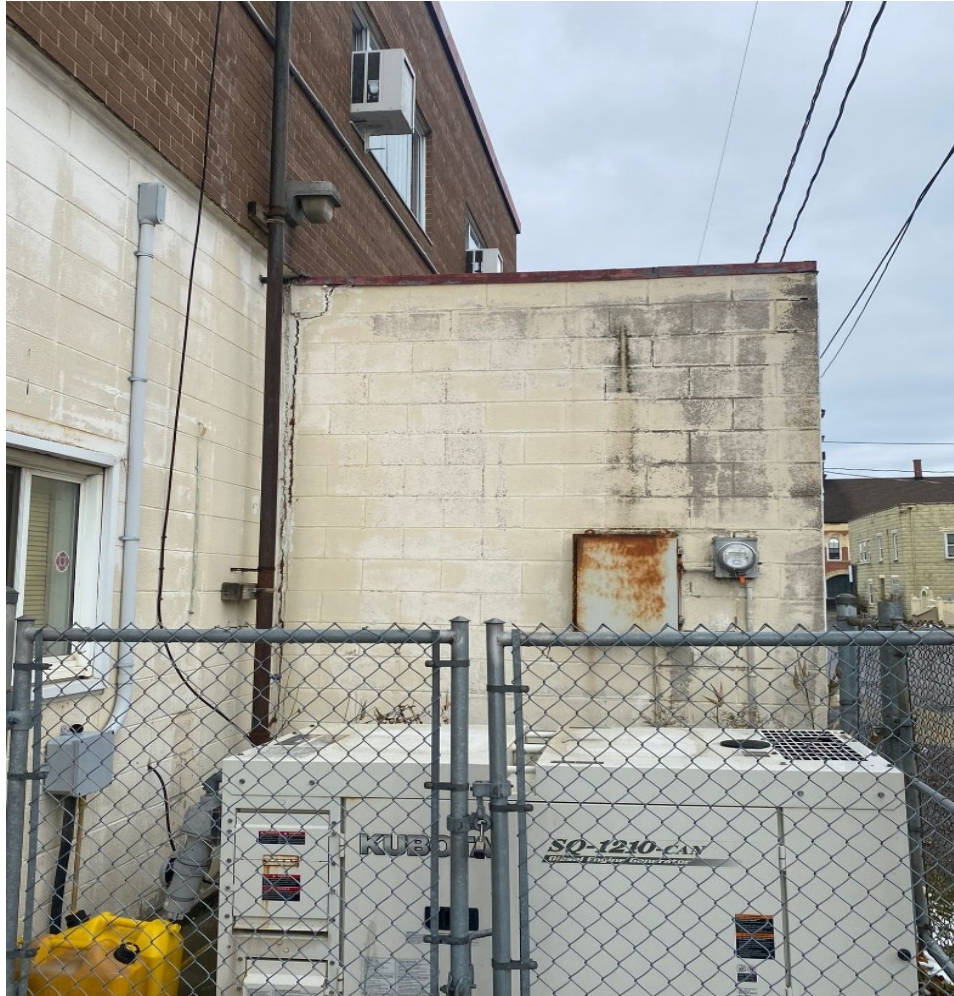
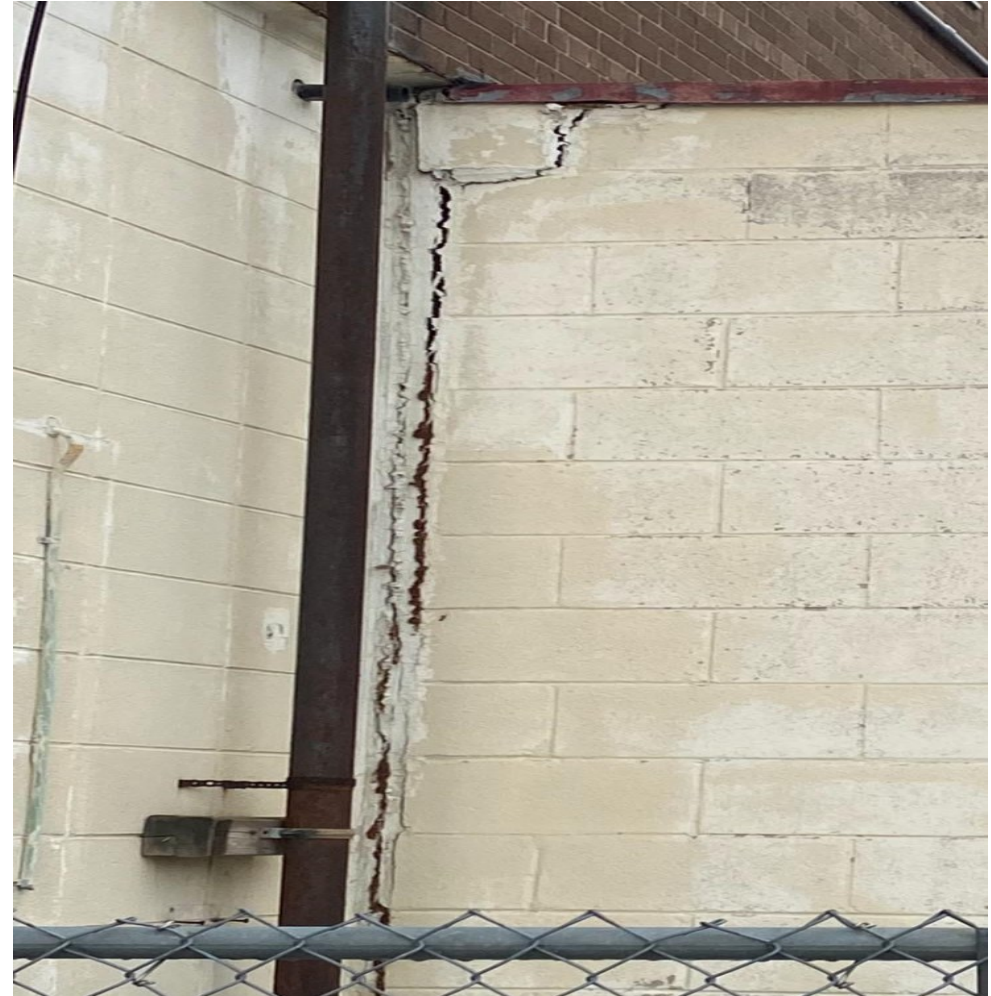
South Side

Store room falling away from building

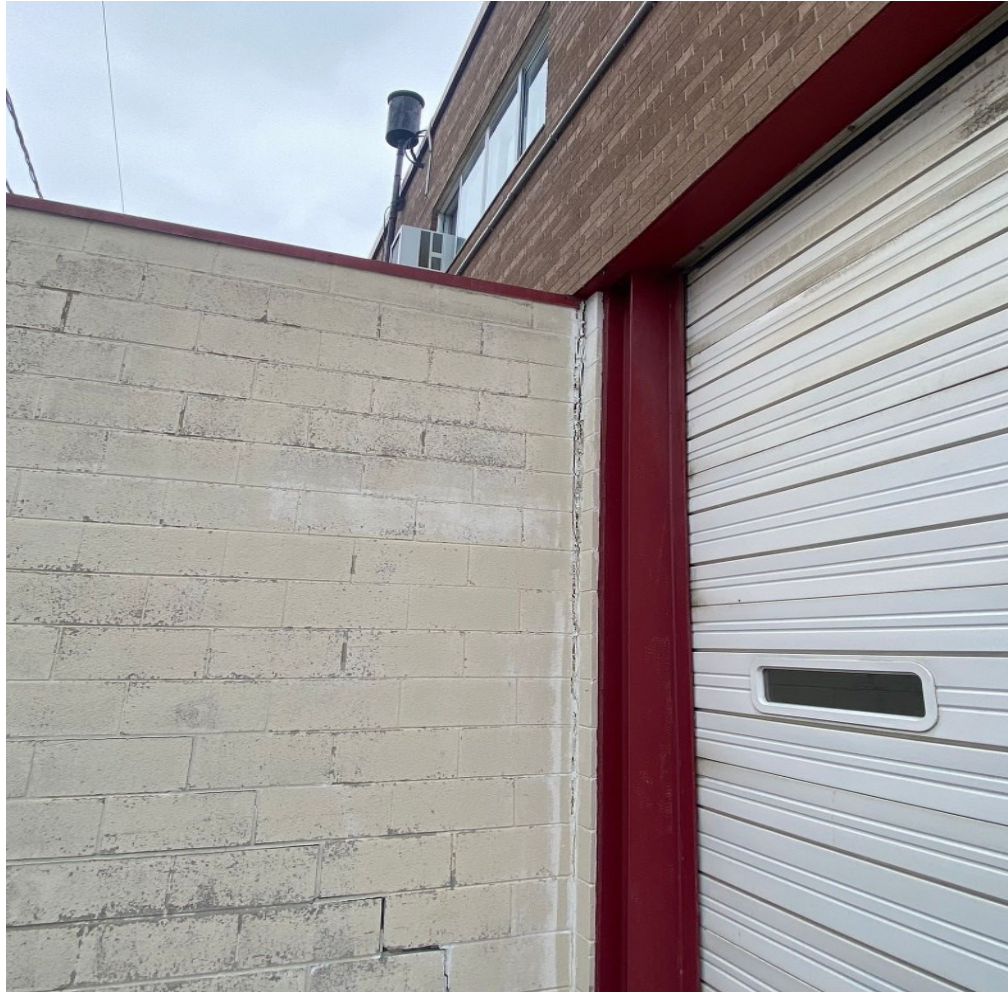
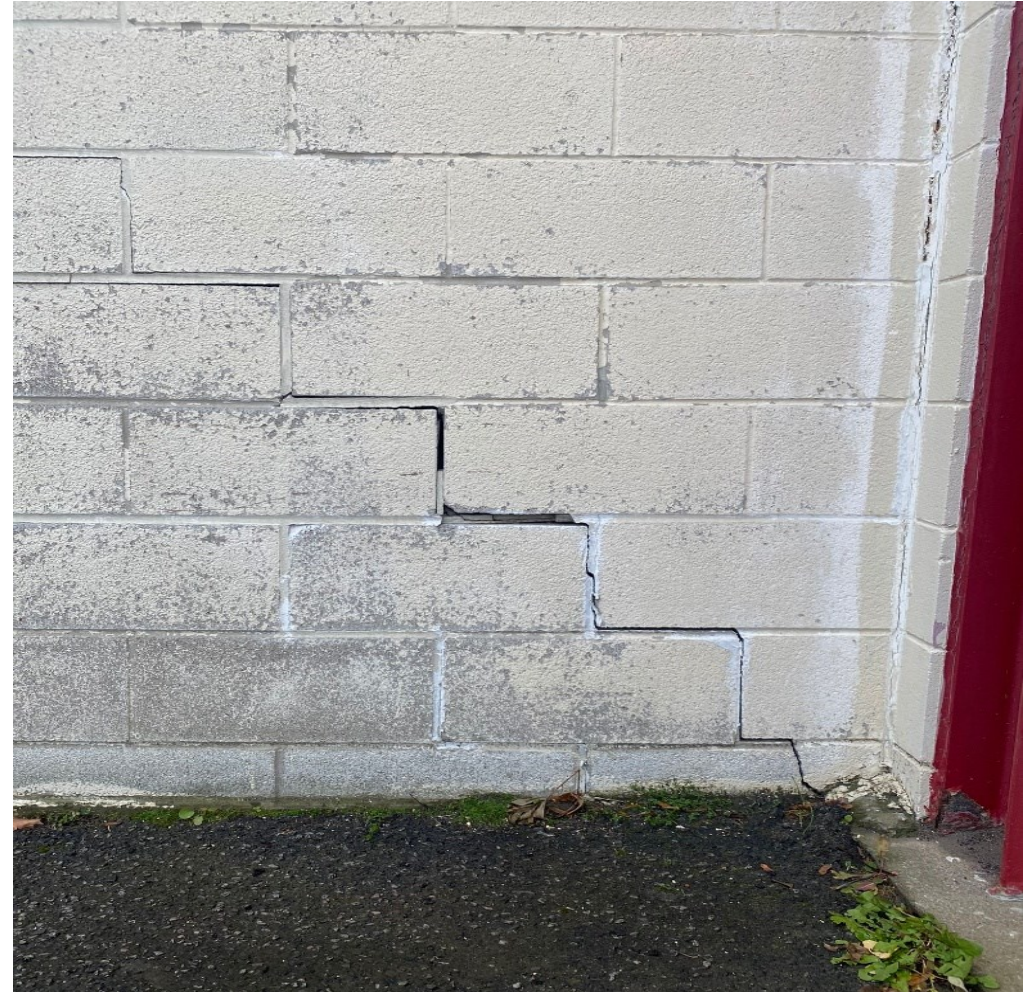
North Side

Store room falling away from building

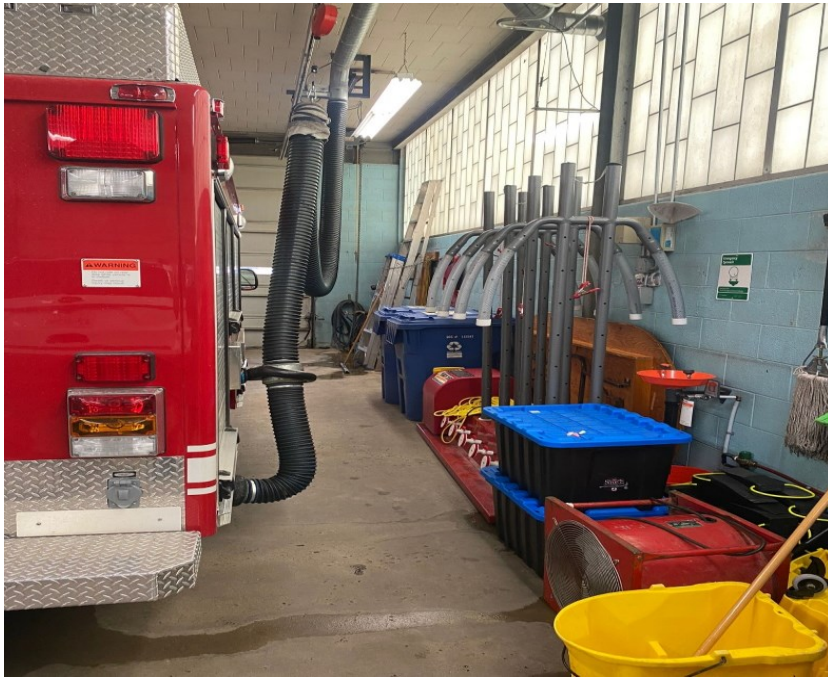
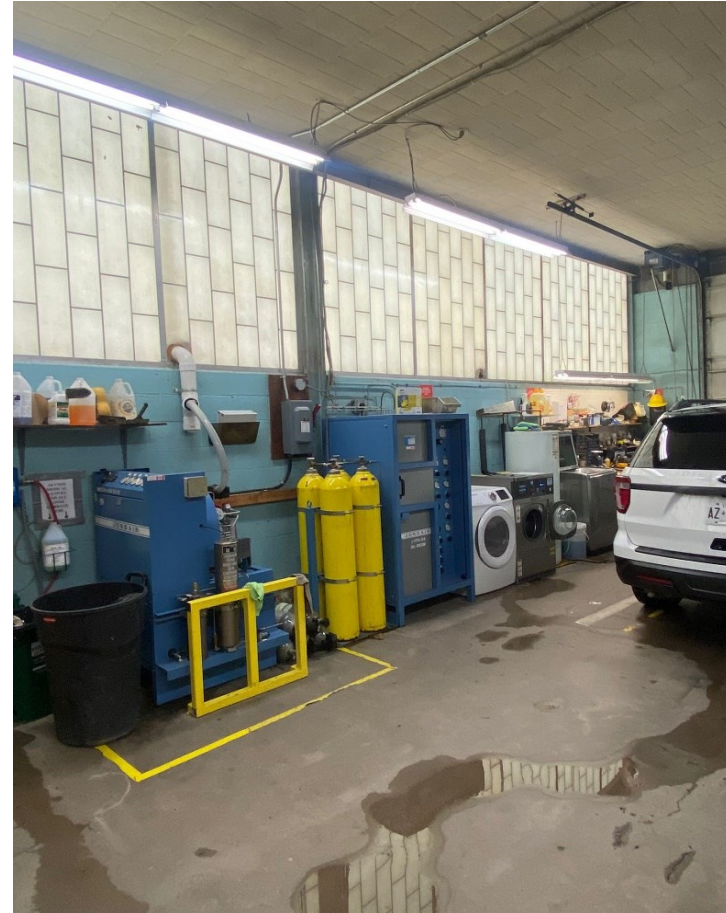
North Wall

-Station bursting at the seams....

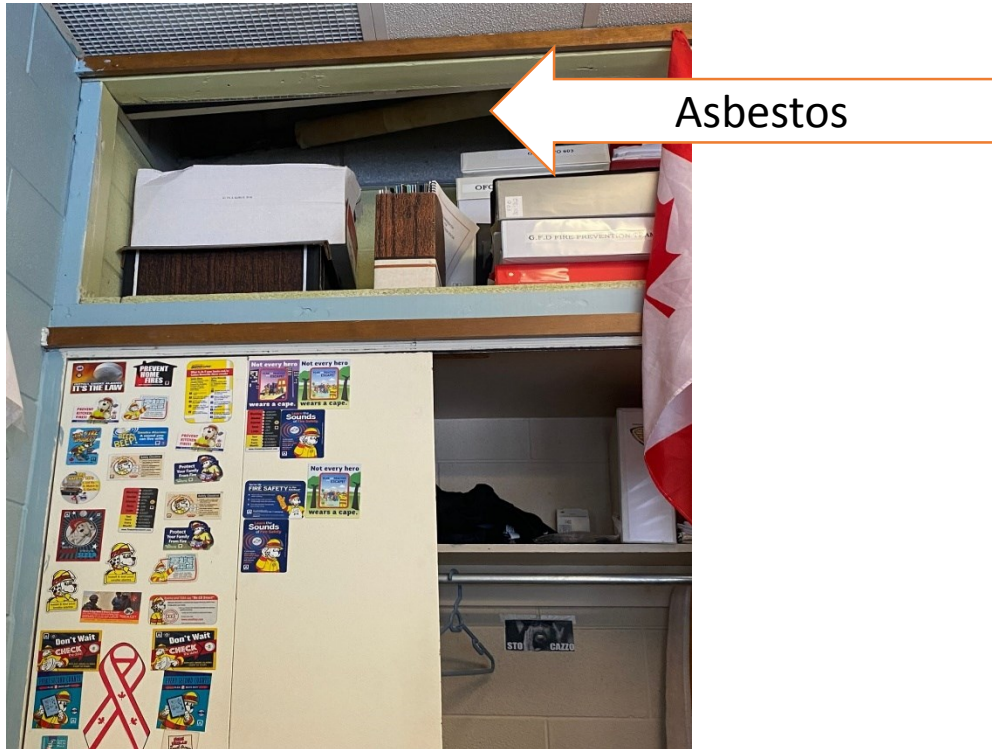
Asbestos in FPO Office

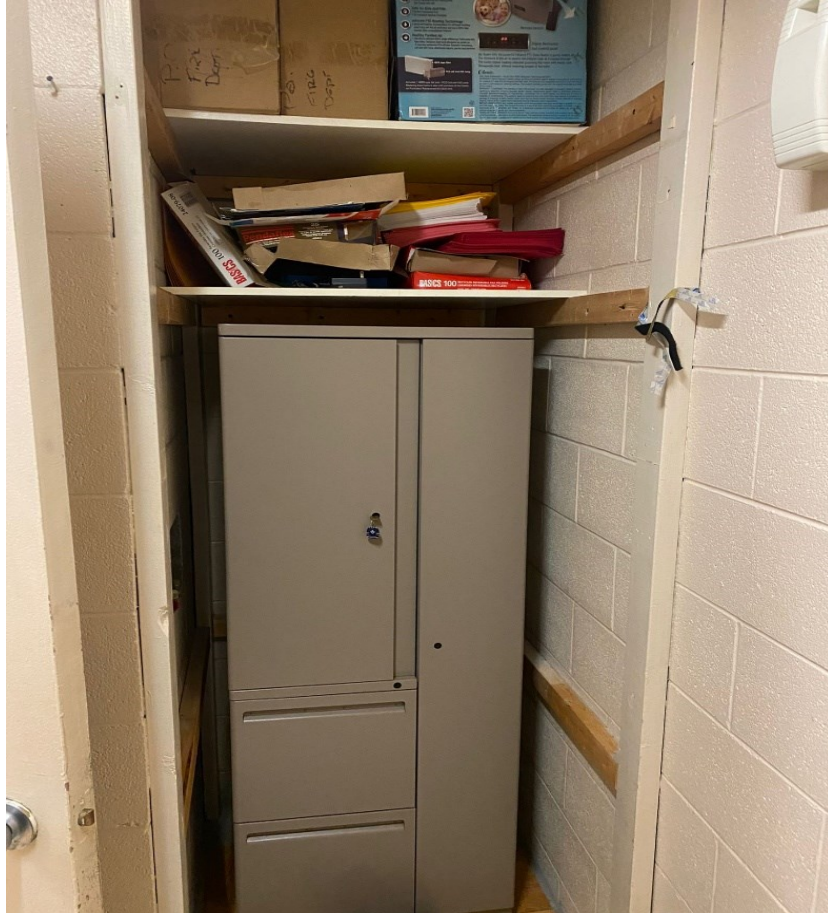
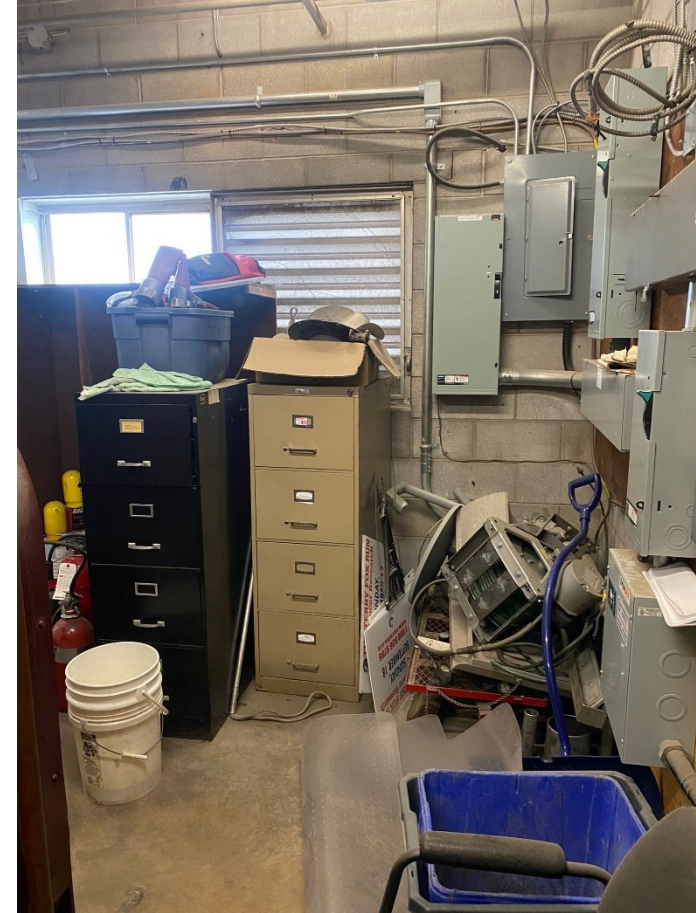
Storage

- Lockers in old shower in bathroom

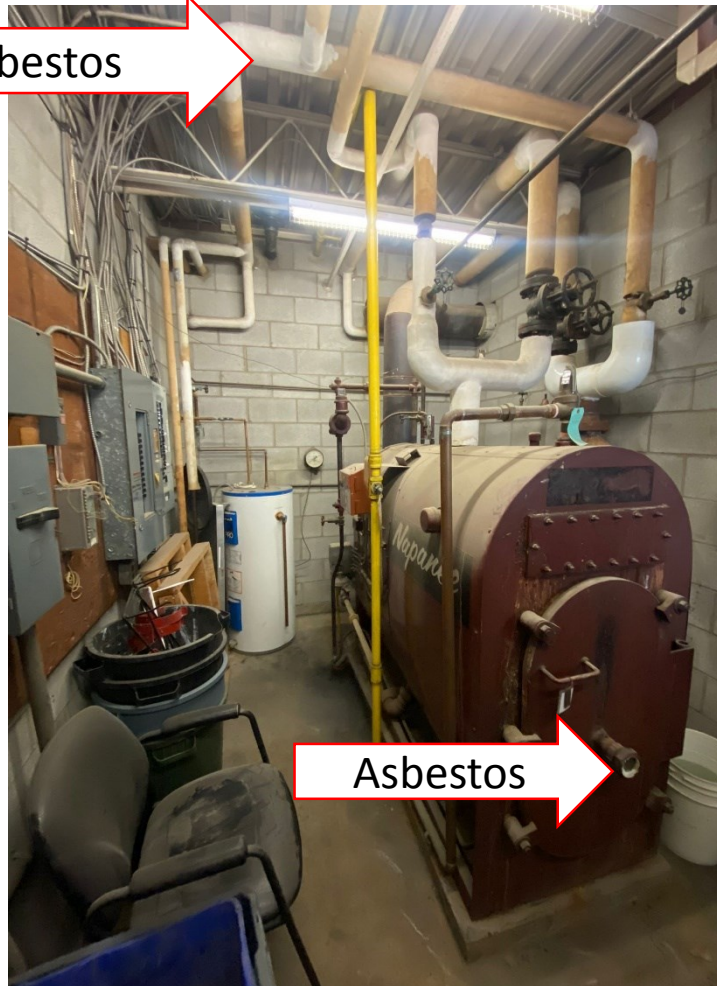
Asbestos

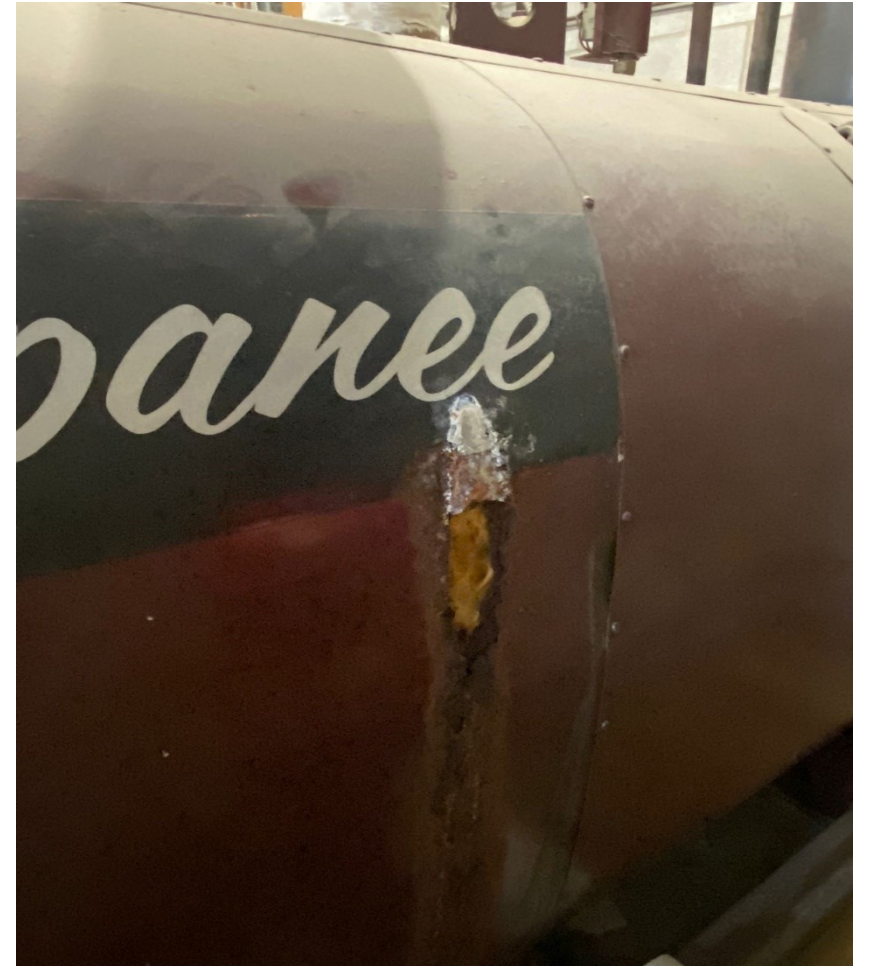
Asbestos
