Allanburg Area Whistle Cessation Study Report - Draft

City of Thorold

Whistle Cessation Study

Rail Crossing Existing Condition Assessment

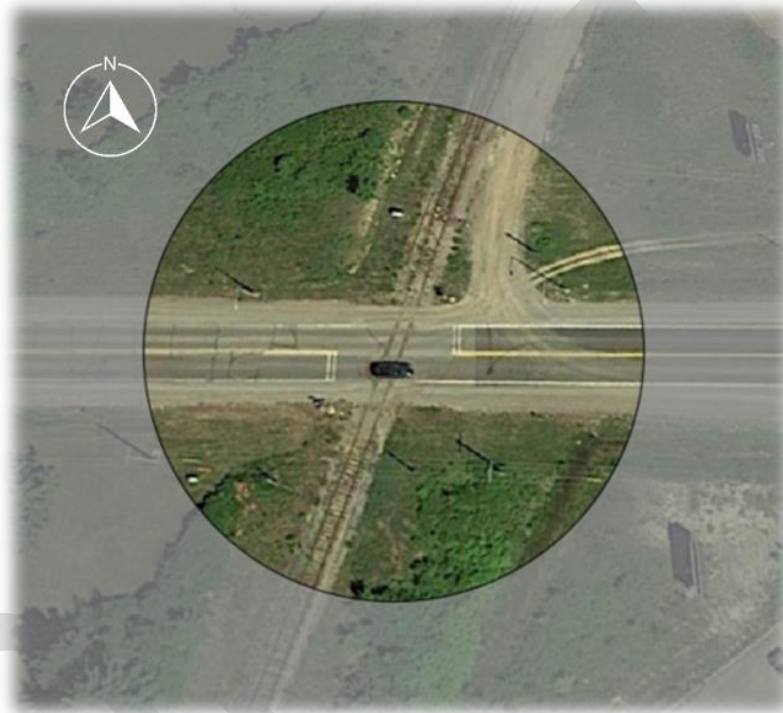
Figure 3.1 – Lundy's Lane Rail Crossing

The rail crossing along Lundy's Lane (RR 82) is located approximately 250m west of the intersection of Lundy's Lane at Allanport Road (RR 82). The speed limit along the roadway at this location is 50km/hr and has an AADT of 5750. The maximum train speed at this location is 10 mph (17km/hr). There is approximately 1 train a day that passes through this crossing location. Lundy's Lane (RR 20) is classified as a Rural Arterial Road. **Figure 3.1** is an aerial view of the subject crossing, indicated one rail track and a two-lane roadway (one lane in each direction).

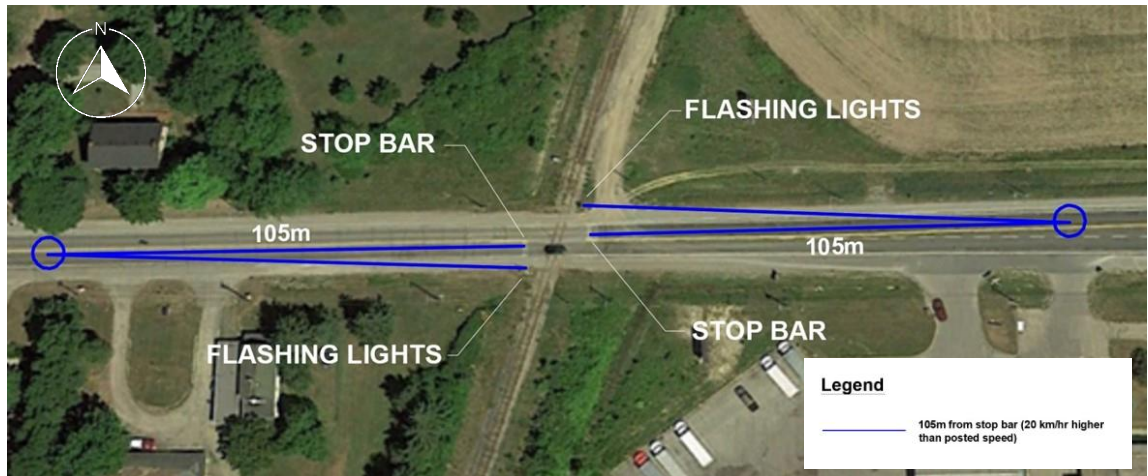
Figure 3.2 – Lundy's Lane Rail Crossing SSD

The posted speed along this roadway is 50km/hr. The assumed operating speed along this roadway was assumed to be 70km/h due to understood speeding concerns in the area. The required SSD at this location was determined to be 105m. **Figure 3.2** shows the resulting SSD sight triangle with the warning system at the crossing.

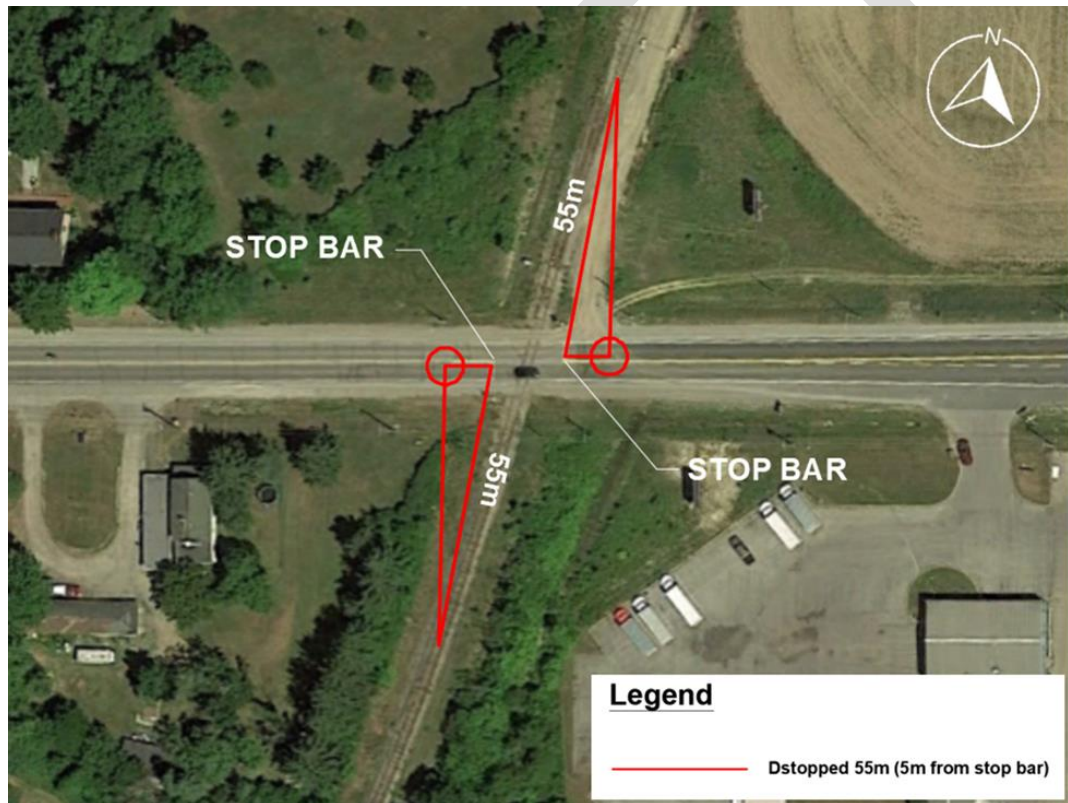
Figure 3.3 – Lundy's Lane Rail Crossing $D_{Stopped}$

The $D_{Stopped}$ was calculated at 55m as per Section 7 of the Grade Crossing Standards (2019). **Figure 3.3** shows the resulting $D_{Stopped}$ sight triangle along the train line.

As indicated in 21 (1) of Section 19 in the Grade Crossing Regulations, this crossing is not subjected to D_{SSD} requirements as it has an active warning system with flashing lights, and bells.

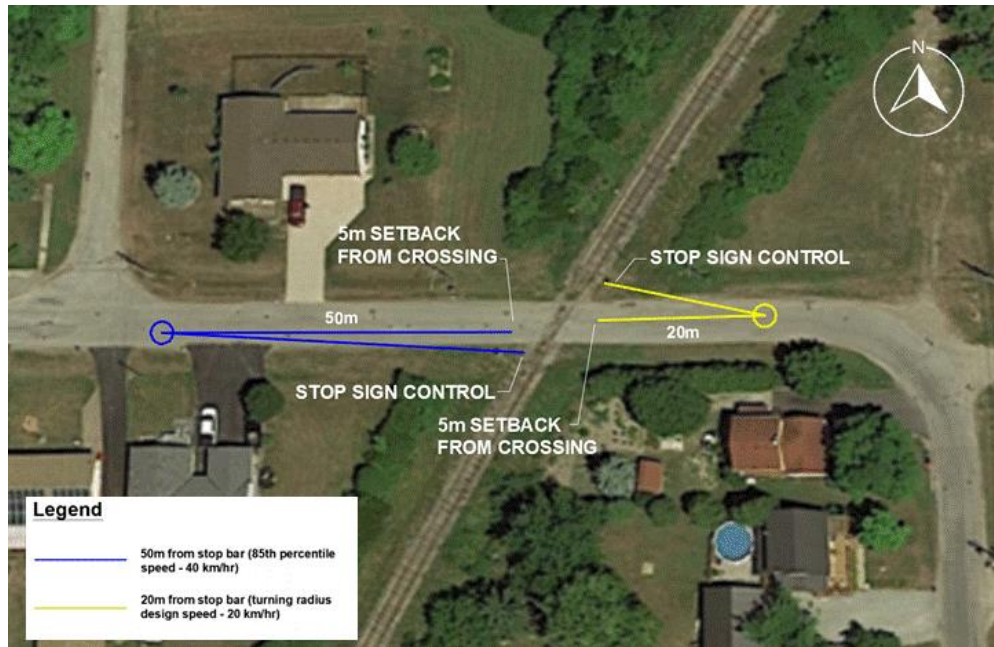
Figure 4.2 – Henderson Street Rail Crossing SSD

The speed limit along this roadway is 50km/h, however the operating speeds along this segment are expected to vary. The operating speeds were determined using the 85th percentile speeds based off a recent speed study that was completed in the Allanburg Area Transportation Planning Study by RVA.

Figure 4.2 shows the resulting SSD sight triangles with the warning system at the crossing.

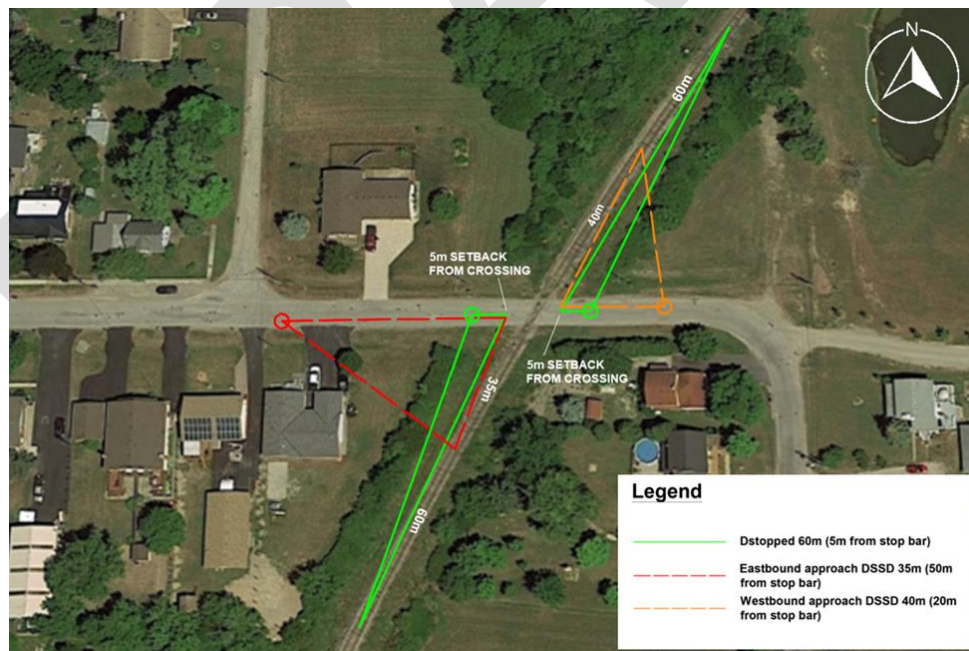
Figure 4.3 – Henderson Street Rail Crossing $D_{Stopped}$ and D_{SSD}

The $D_{Stopped}$ was calculated to be 50m in both directions. The D_{SSD} was calculated to be 31m and 40m in the eastbound and westbound directions, respectively. Figure 4.3, shows the resulting site triangles using the $D_{Stopped}$ and D_{SSD} values.

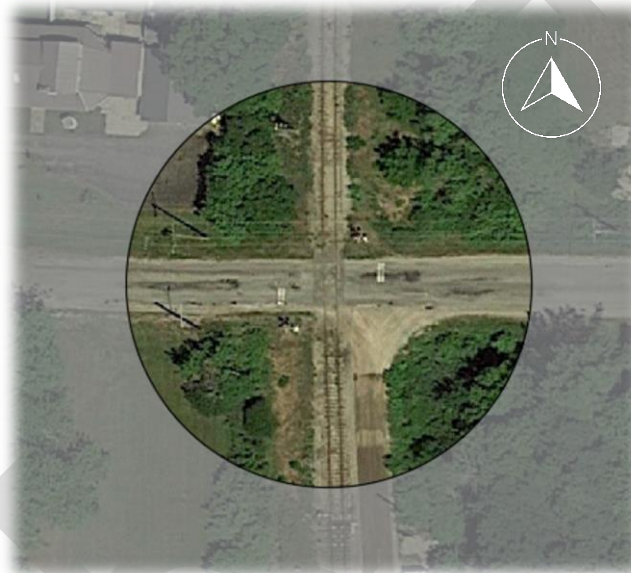
Figure 5.1 – Barron Road (W) Rail Crossing

The western rail crossing along Barron Road is located approximately 60m east of the T-intersection of Barron Road at Centre Street. The speed limit along the roadway at this location is 50km/hr and has a AADT of 800 vehicles per day. The maximum train speed at this location is 10 mph (17km/h). There is approximately 1 train a day that passes through this crossing location. Barron Road is classified as a Local Road. **Figure 5.1** is an aerial view of the subject crossing, indicating one rail track and a two-lane roadway (one lane in each direction).

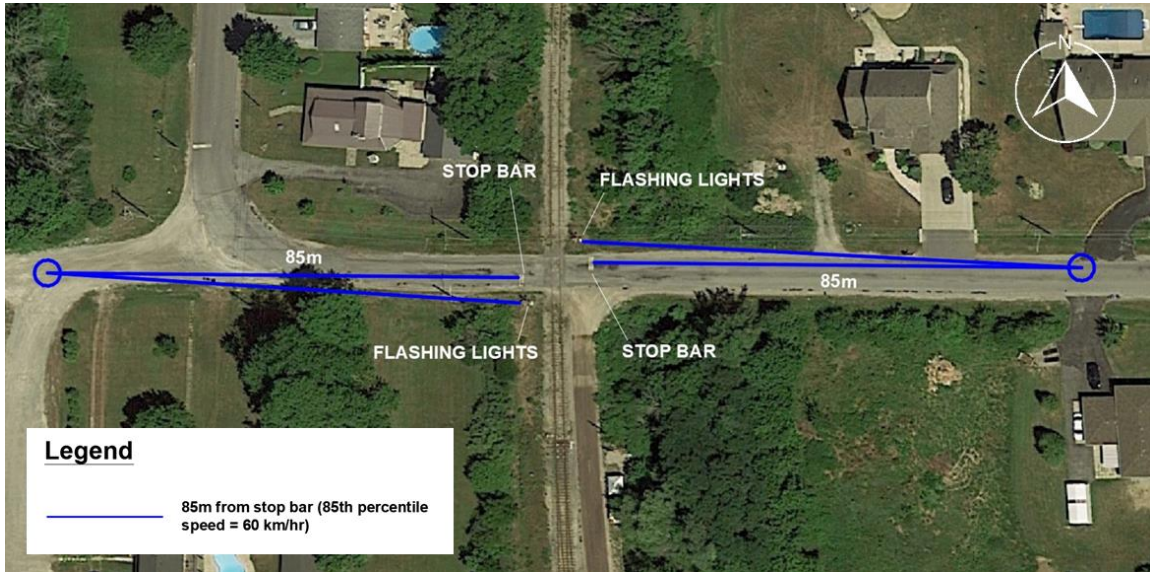
Figure 5.2 – Barron Road (W) Rail Crossing SSD

The speed limit along this roadway is 50km/h, however the operating speeds along this segment are expected to vary. The operating speeds were determined using the 85th percentile speeds based off a recent speed study that was completed in the Allanburg Area Transportation Planning Study by RVA. The 85th percentile speed along this segment was 60 km/h, thus the Stopping Sight Distance was determined to be 85m for both approaches. **Figure 5.2** shows the resulting SSD sight triangle with the warning system at the crossing.

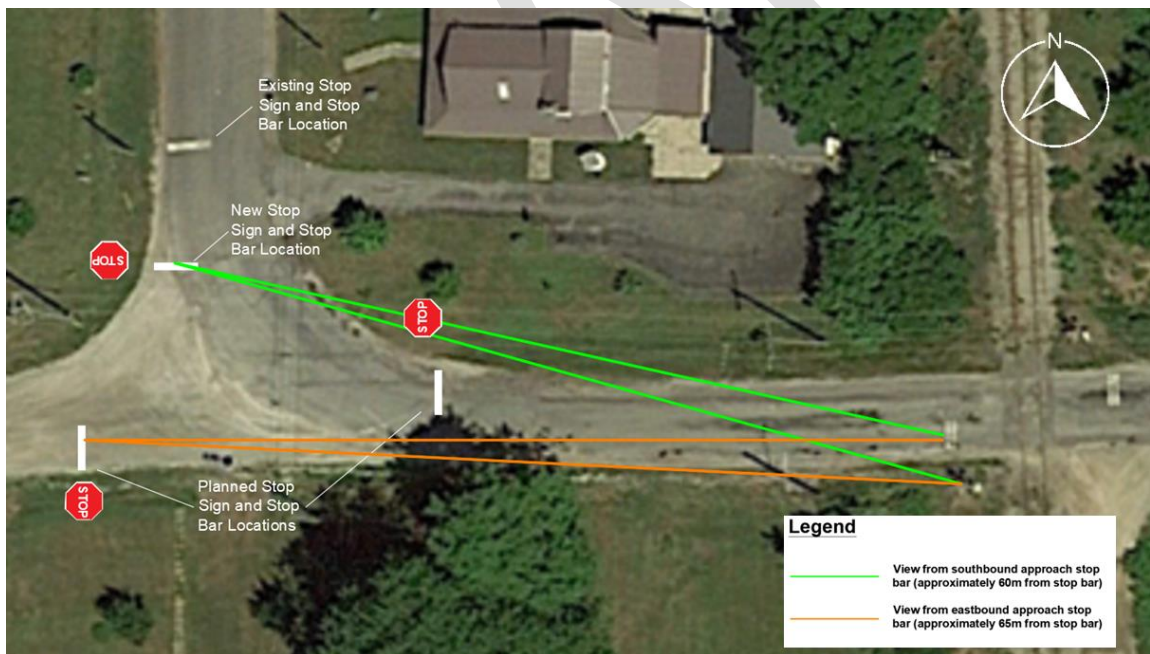
Figure 5.3 – Barron Road (W) Rail Crossing – Proposed Stop Bar Available Sightline

Figure 5.3, shows the available sightlines from the planned stop sign and stop bar locations from future developments.

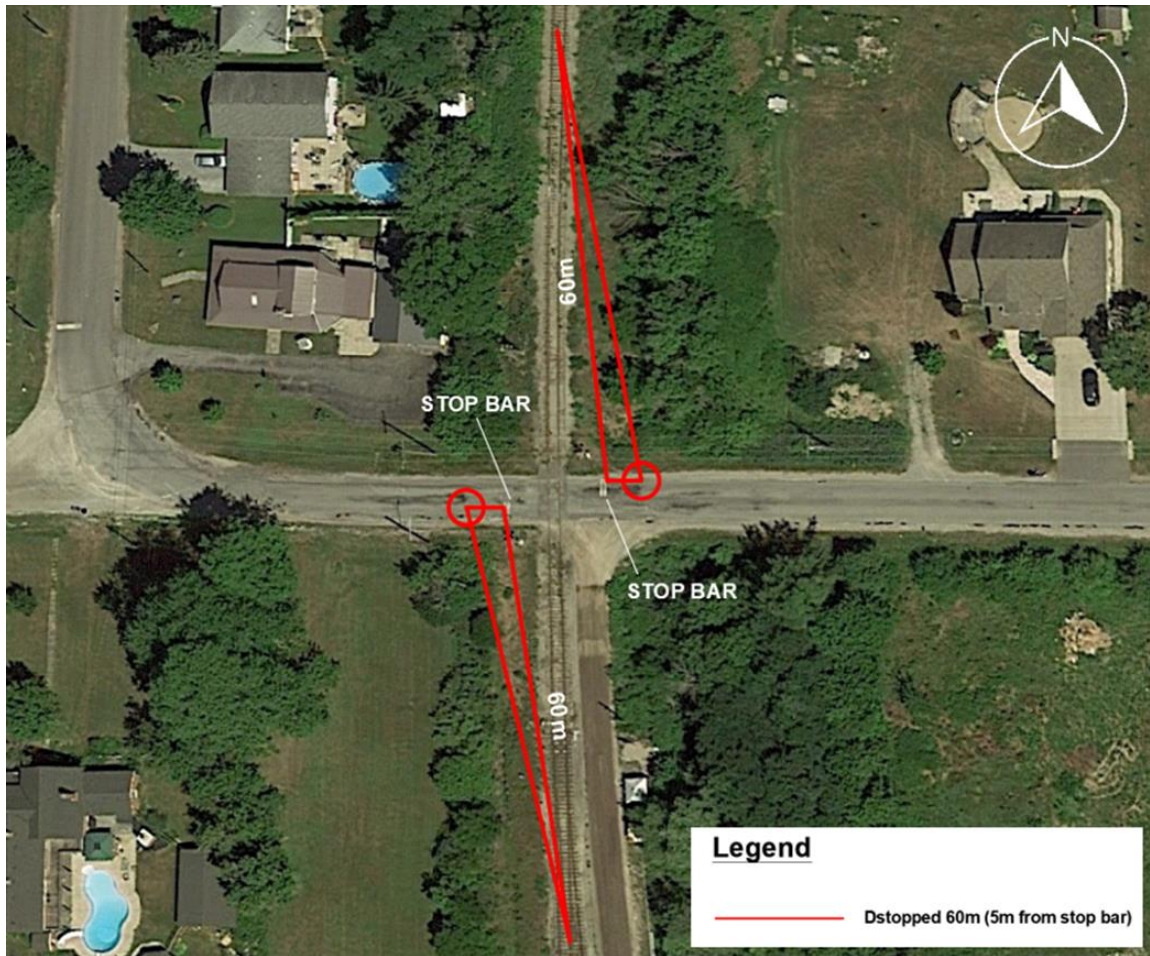
Figure 5.4 – Barron Road (W) Rail Crossing $D_{Stopped}$

The $D_{Stopped}$ was calculated at 60m as per section 7 of the Grade Crossing Standards (2019). **Figure 5.4**, shows the resulting site triangles using the $D_{Stopped}$ values.

As set out in 21 (1) of Section 19 in the Grade Crossing Regulations, this crossing is not subjected to D_{SSD} requirements as it has an active warning system with flashing lights, and bells.

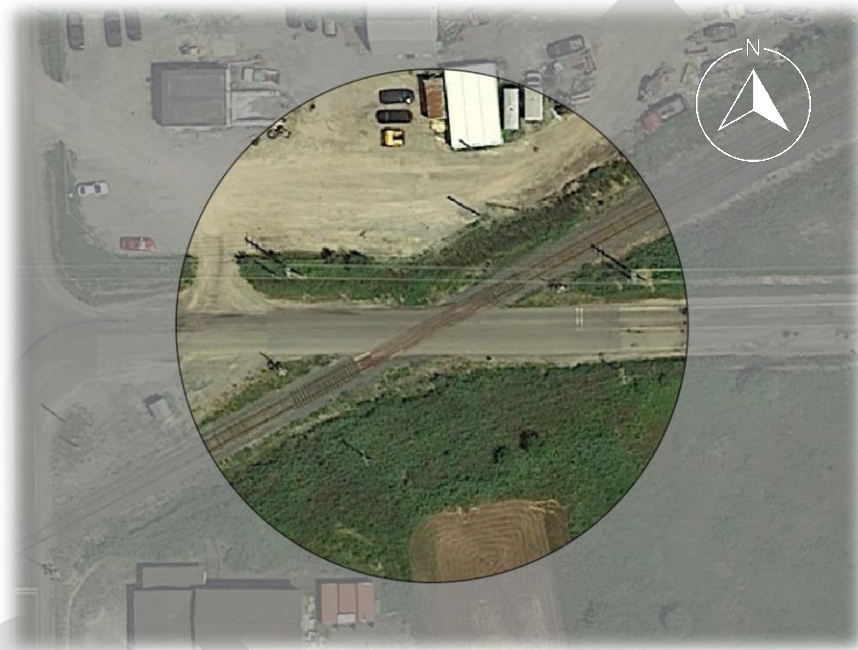
Figure 6.1 – Barron Road (E) Rail Crossing

The eastern rail crossing along Barron Road is located approximately 45m east of the intersection of Barron Road at Allanport Road. The speed limit along the roadway at this location is 50km/hr and has an AADT of 1500 vehicles. The maximum train speed at this location is 60 mph (97km/h). There are approximately 12 trains a day that pass through this crossing location. Barron Road is classified as a Local Road. Below in **Figure 6.1** is an aerial view of the subject crossing, indicating one rail track and a two-lane roadway (one lane in each direction).

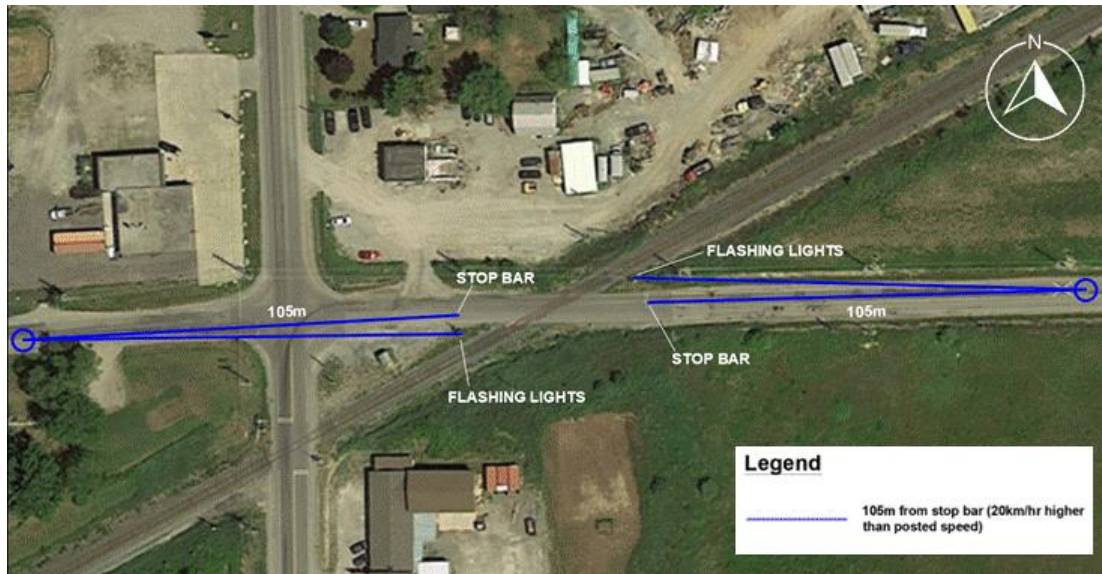
Figure 6.2 – Barron Road (E) Rail Crossing SSD

The speed limit along this roadway is 50km/hr, however, the Stopping Sight Distance was examined at 20 km/hr over (70km/hr) due to the rural nature of this crossing. **Figure 6.2** shows the resulting SSD sight triangle with the warning system at the crossing.

As set out in 21 (1) of Section 19 in the Grade Crossing Regulations, this crossing is not subjected to D_{SSD} and $D_{Stopped}$ requirements as it has an active warning system with flashing lights, bells, and gates.

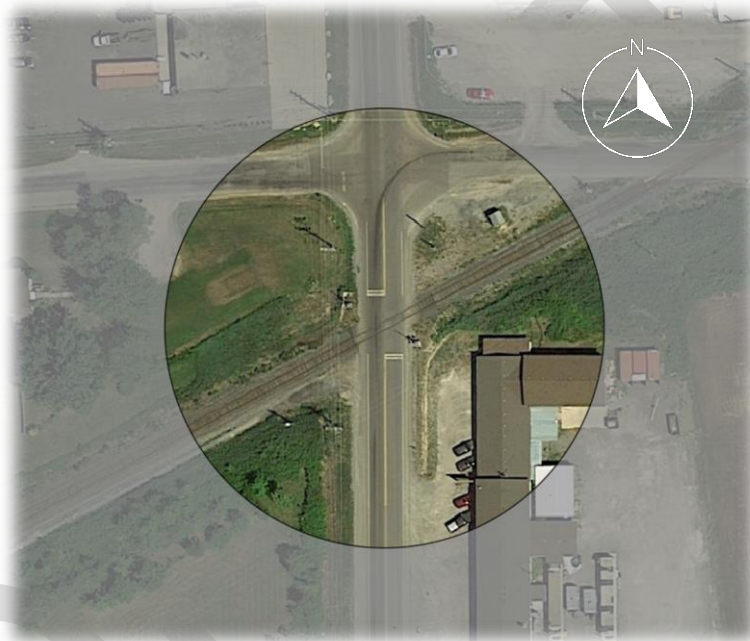
Figure 7.1 – Allanport Road Rail Crossing

The crossing along Allanport Road is located approximately 20m south of the intersection of Barron Road at Allanport Road. The speed limit along the roadway at this location is 80km/hr and has an AADT of 4300. The maximum train speed at this location is 60 mph (90km/hr). There are approximately 12 trains a day that pass through this crossing location. Allanport Road is classified as an Arterial Road. **Figure 7.1** is an aerial view of the subject crossing, indicating one rail track and a two-lane roadway (one lane in each direction).

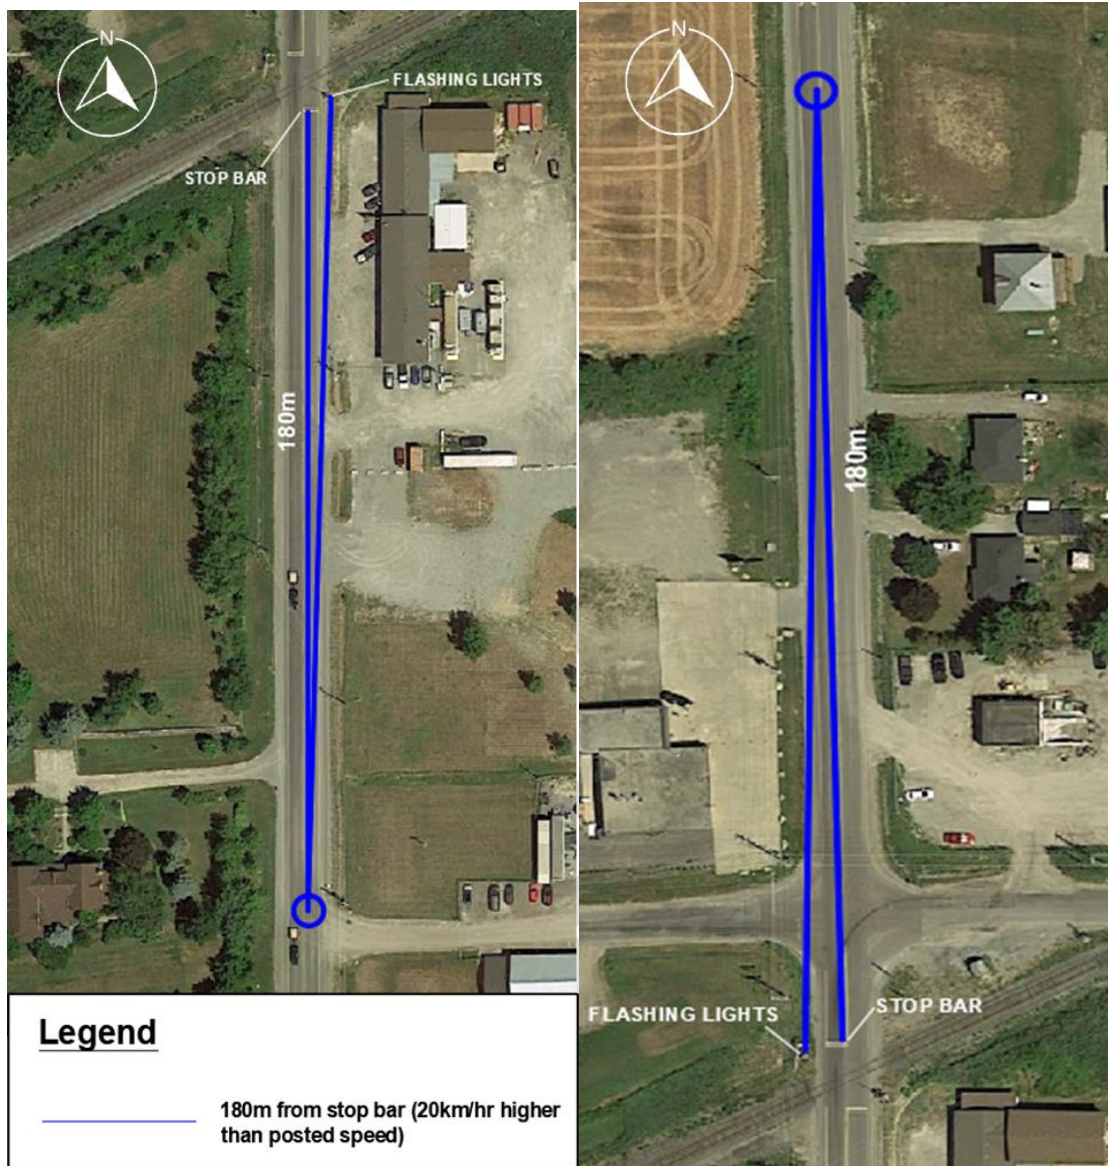
Figure 7.2 – Allanport Road Rail Crossing SSD

The speed limit along this roadway is 80km/hr, however, the Stopping Sight Distance was examined at 100km/hr. **Figure 7.2** shows the resulting SSD sight triangle with the warning system at the crossing.

As set out in 21 (1) of Section 19 in the Grade Crossing Regulations, this crossing is not subjected to D_{SSD} and $D_{Stopped}$ requirements as it has an active warning system with flashing lights, bells, and gates.

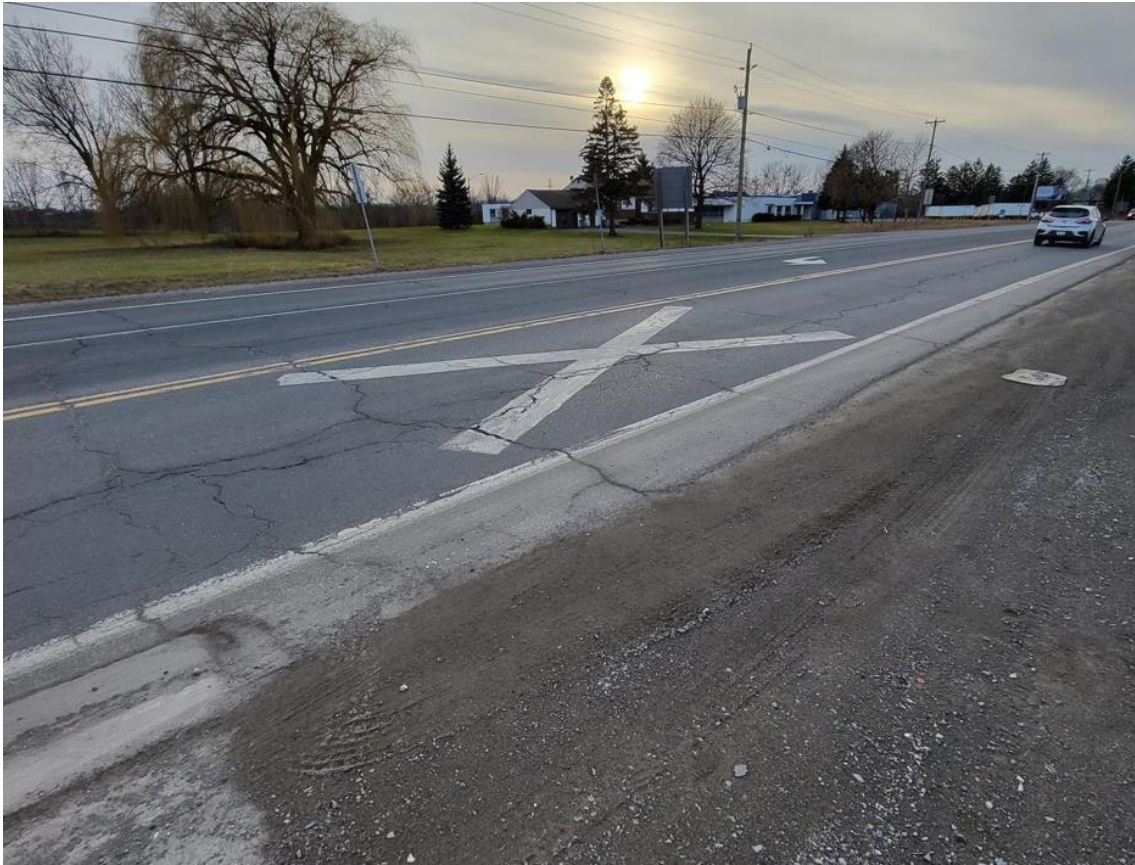
Figure A-16: Lundy's Lane Crossing Painted "X" – Westbound Approach

Criteria	Requirement	Lundy's Lane Existing Conditions	
		<ul style="list-style-type: none"> > Westbound: 213m from stop bar Figure A-16 > Eastbound: 203m from stop bar Figure A-17 	
Warning System	Warning System	<ul style="list-style-type: none"> • Flashing Lights and Bells, Figure A-18 	
	Location of Warning System	Eastbound <ul style="list-style-type: none"> • 2.7m from the edge of the roadway • 4.1m from the edge of the rail tracks 	Westbound <ul style="list-style-type: none"> • 3.1m from the edge of the roadway • 3.3m from the edge of the rail tracks
Fencing	Fencing	<ul style="list-style-type: none"> • None 	
	Evidence of Trespassing	<ul style="list-style-type: none"> • None 	
Additional Comments	Parking	<ul style="list-style-type: none"> • No parked cars within the vicinity of the crossing. • There is "No Parking" signage for the westbound approach (east of the tracks) only. • 	
	Lift Bridge	<ul style="list-style-type: none"> • There are issues regarding queuing for both directions as a result of the nearby lift bridge (located approximately 850m west of the tracks). Queues for the westbound approach back up beyond the rail crossing when the lift bridge is in operation. When the lift bridge comes down, the eastbound queues back up beyond the rail crossing from the signal control at Lundy's Lane at Highway 58/RR 82.

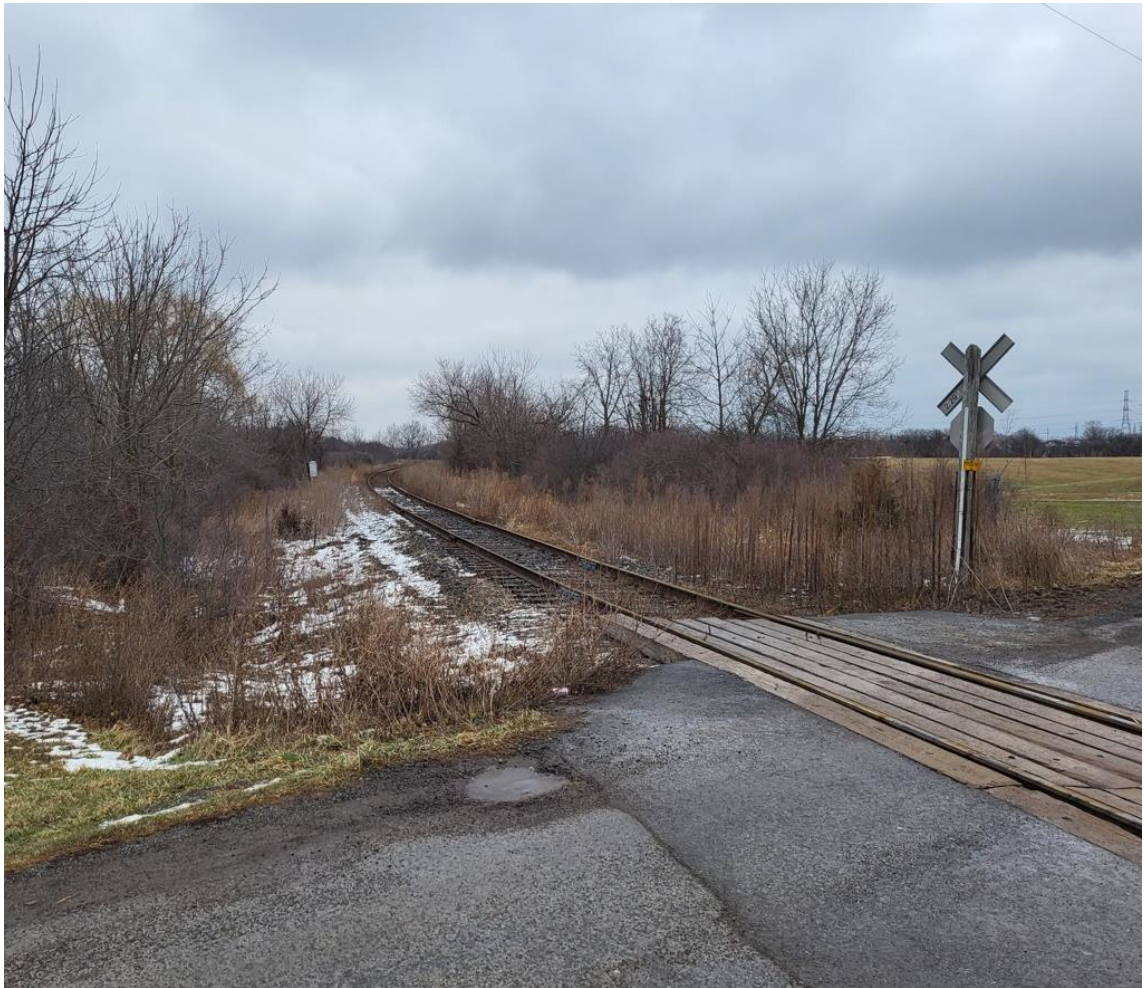
Figure B-6: Henderson Street Crossing (Dstopped) – Eastbound Approach (facing northbound)

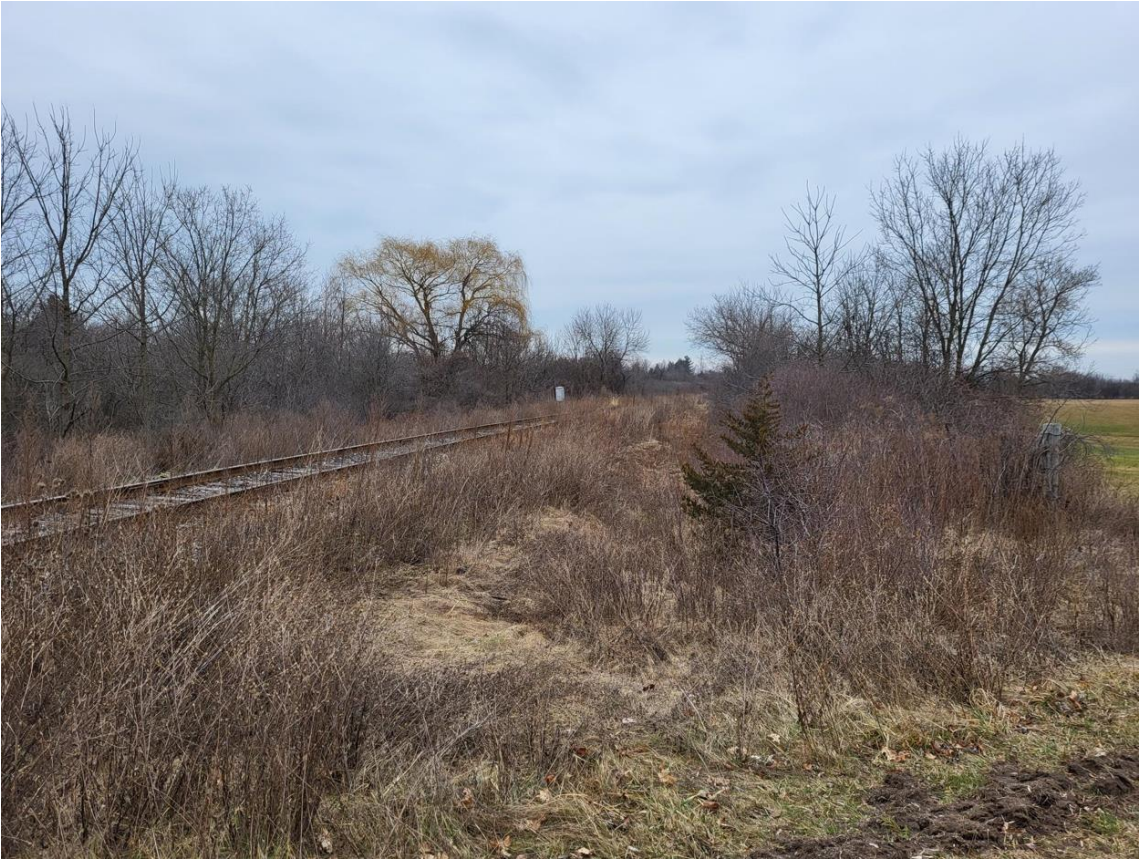
Criteria	Requirement	Henderson Street Existing Conditions	
	Roadway Width	<ul style="list-style-type: none"> 5.7m 	
	Shoulder	Eastbound (Width Varies, Figure B-2) <ul style="list-style-type: none"> North: 0.8m South: 0.6m 	Westbound <ul style="list-style-type: none"> North: 0.5m South: 0.6m
Sightlines	Calculation Parameters	<ul style="list-style-type: none"> Clearance Distance: 15m Railway Design Speed: 17km/h Roadway Design Speed: 40km/h (EB), 20km/h (WB) 	
	SSD	<ul style="list-style-type: none"> SSD = 50m (EB), 20m (WB) Eastbound and westbound sightlines exceed the required SSD, Figure B-3 & Figure B-4 	
	$D_{Stopped}$	Eastbound approach: <ul style="list-style-type: none"> $D_{Stopped} = 58m$ There are available sightlines for vehicles exceeding the required $D_{Stopped}$ in each direction. (Figure B-5, Figure B-6) 	Westbound approach: <ul style="list-style-type: none"> $D_{Stopped} = 58m$ There are available sightlines for vehicles exceeding the required $D_{Stopped}$ in the southern direction. (Figure B-7) Sightlines in the northern direction obstructed by foliage. (Figure B-8)

Figure B-8: Henderson Street Crossing (Dstopped) – Eastbound Approach (facing northbound)

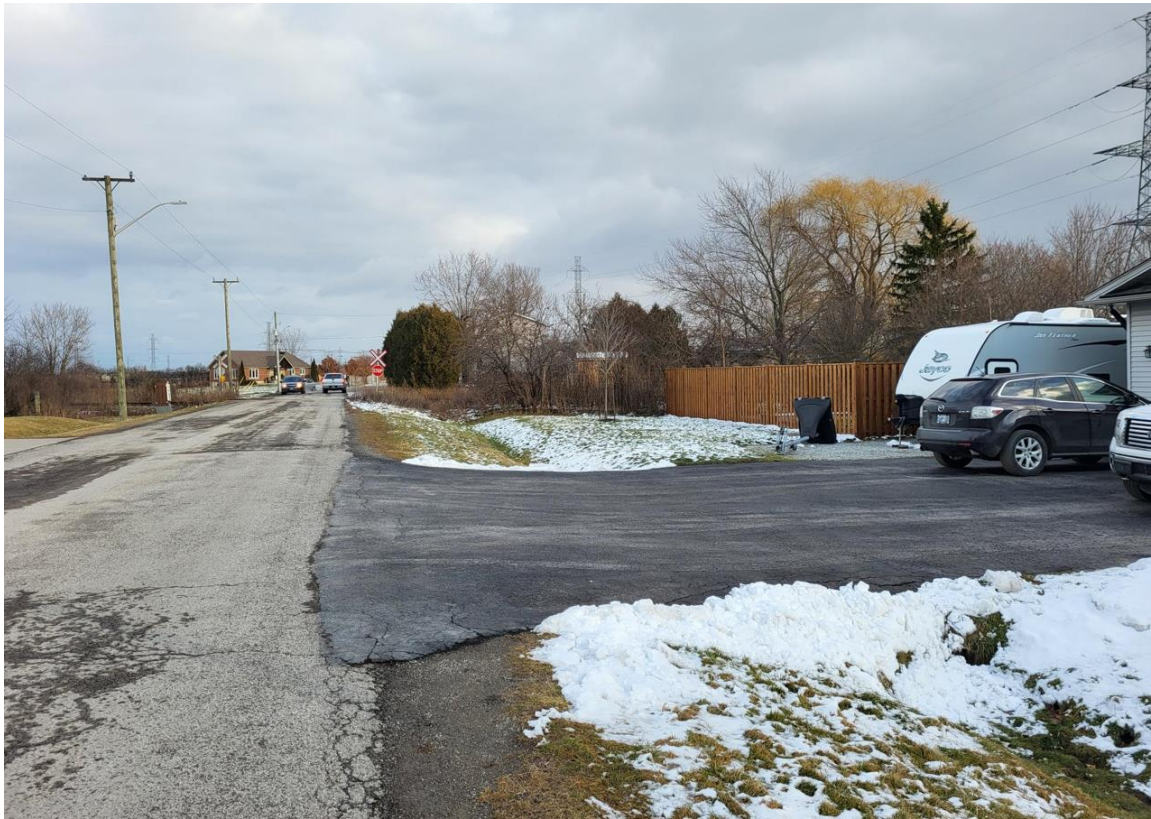
Criteria	Requirement	Henderson Street Existing Conditions	
		<ul style="list-style-type: none"> • $D_{SSD} = 40\text{m}$ • There are obstructed sightlines for vehicles in each direction. (Figure B-9, Figure B-10) 	<ul style="list-style-type: none"> • $D_{SSD} = 35\text{m}$ • There are available sightlines for vehicles exceeding the required D_{SSD} in the southern direction. (Figure B-11) • There are obstructed sightlines for vehicles in the northern direction. (Figure B-12)
	Other	<p>Movable or Immovable objects</p> <ul style="list-style-type: none"> • Community Mailbox east of rail-crossing <p>Visibility of warning system</p> <ul style="list-style-type: none"> • Visible from the intersection of Henderson Street at Clifton Street (60m from crossing) (Figure B-13) • Intersection of Henderson Street at Centre Street (180m from crossing) (Figure B-14) 	
Signage and Pavement Markings	Warning Signage	› None

Figure B-9: Henderson Street Crossing (Dssd) – Eastbound Approach (facing southbound)

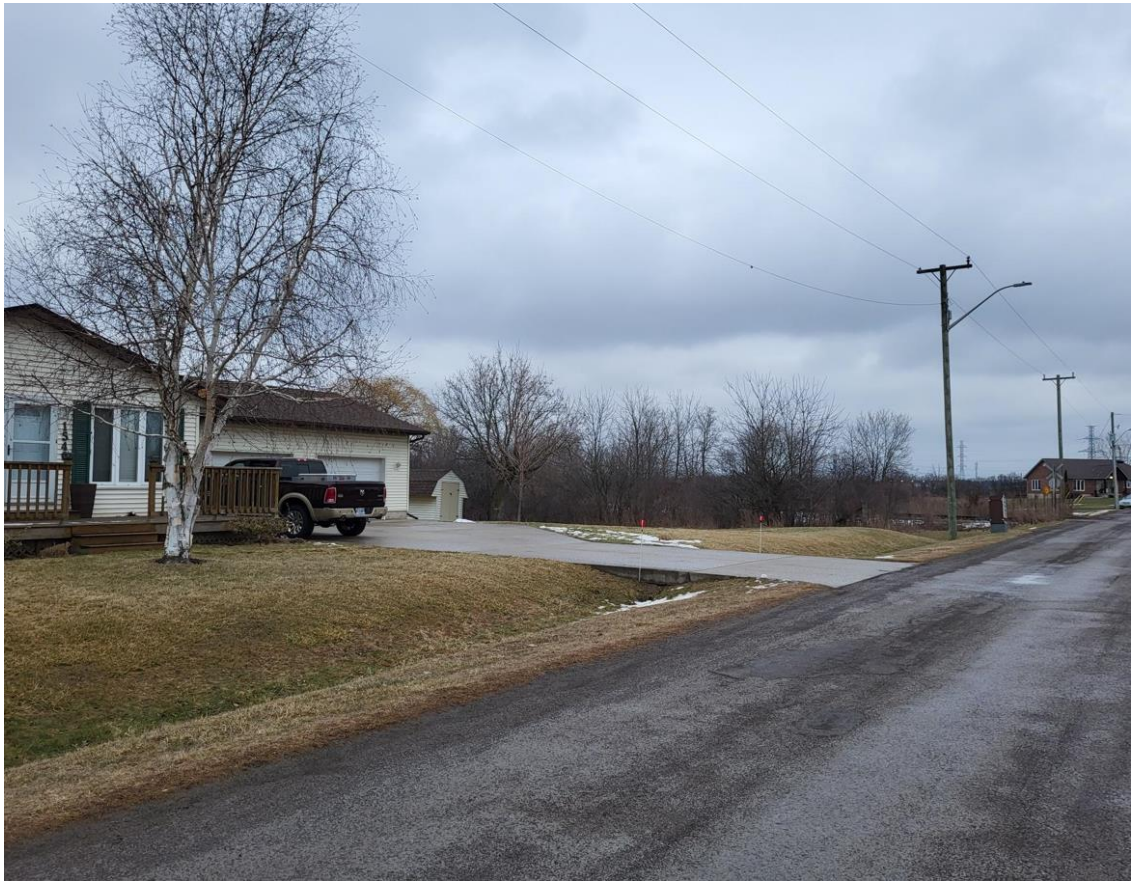
Figure B-10: Henderson Street Crossing (DSSD) – Eastbound Approach (facing northbound)

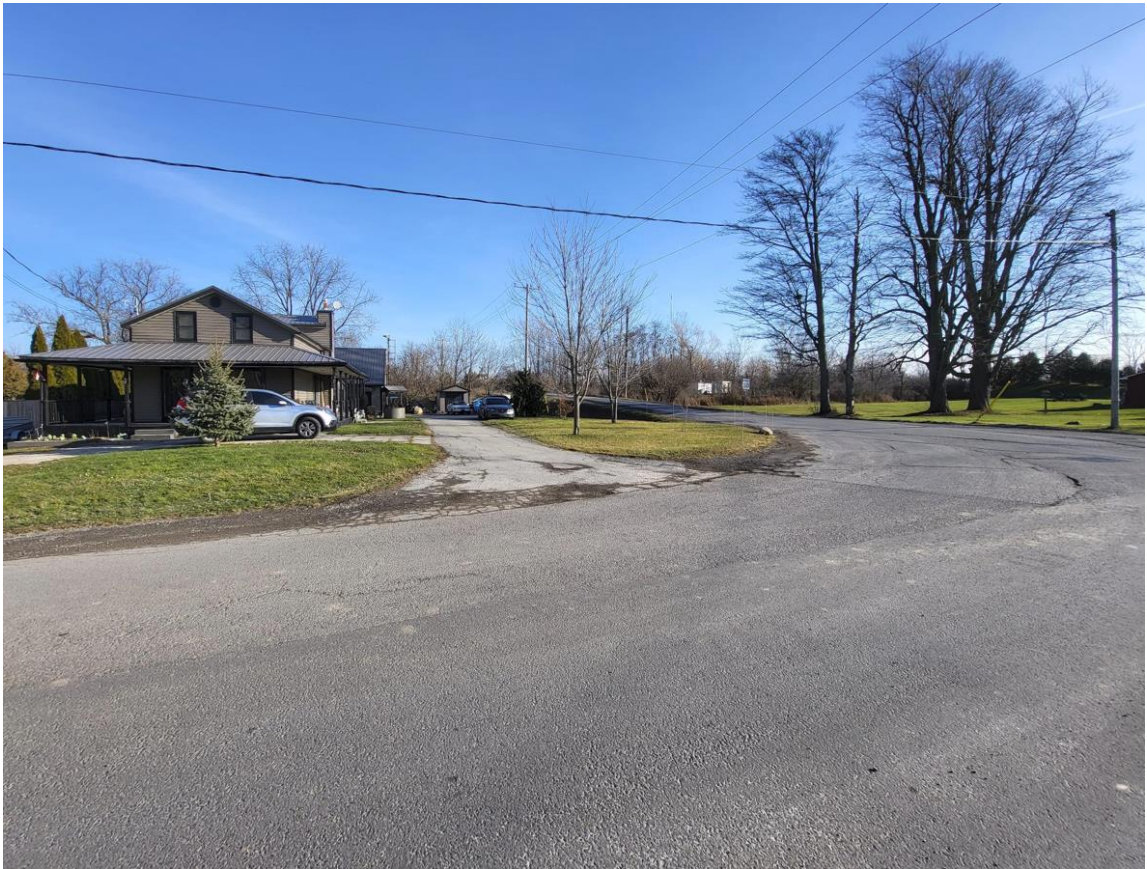
Figure C-1: Barron Road (West) Crossing – View from Stop Bar at Barron Road and Centre Street)

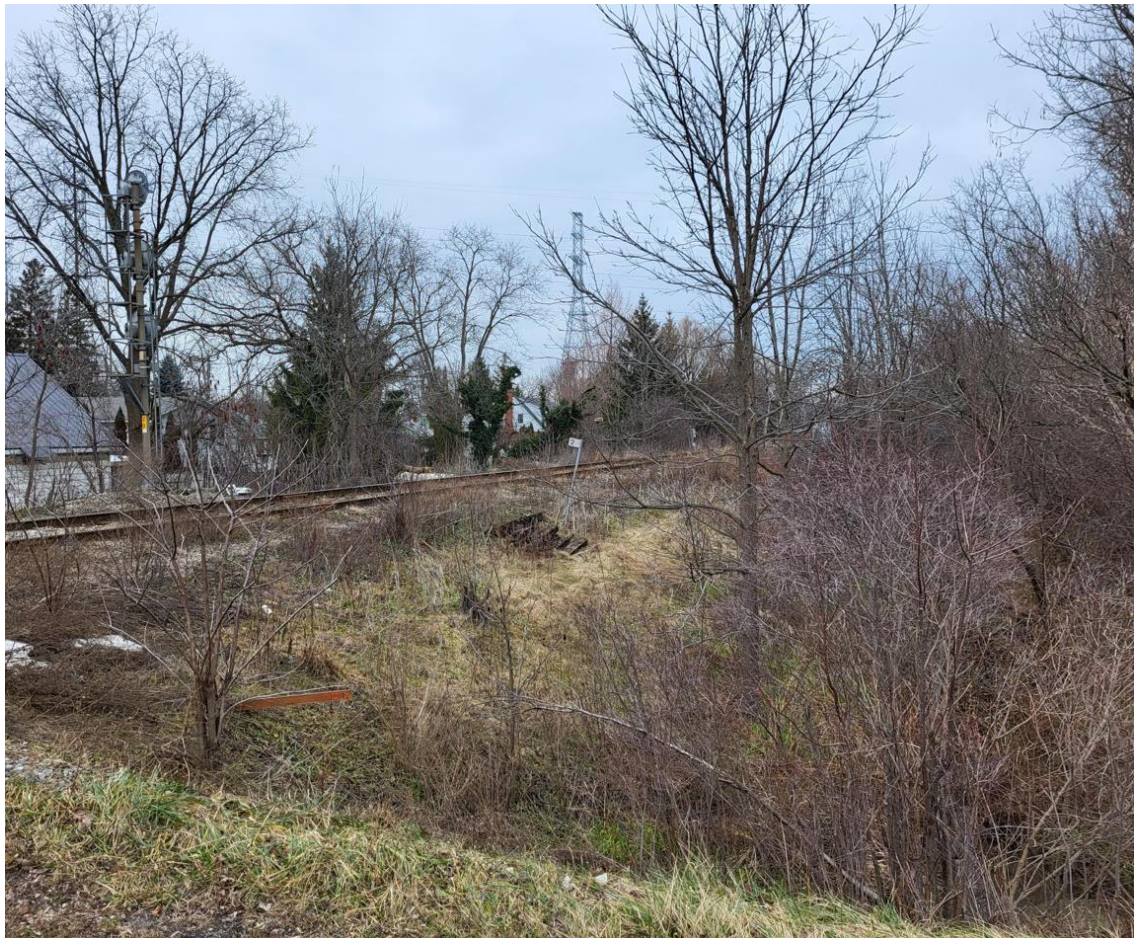
Criteria	Requirement	Barron Road (W) Existing Conditions	
	Shoulder	Eastbound (Width Varies, Figure C-5) <ul style="list-style-type: none"> North: 0.7m South: 0.9m 	Westbound <ul style="list-style-type: none"> North: 1.1m South: 1.8m
Sightlines	Calculation Parameters	<ul style="list-style-type: none"> Clearance Distance: 14.8m Railway Design Speed: 17km/h Roadway Design Speed: 60km/h 	
	SSD	<ul style="list-style-type: none"> SSD = 85m Eastbound and westbound sightlines exceed the required SSD, Figure C-6 & Figure C-7 	
	$D_{Stopped}$	<ul style="list-style-type: none"> $D_{Stopped} = 60m$ Eastbound approach: <ul style="list-style-type: none"> There are available sightlines for vehicles exceeding the required $D_{Stopped}$ in each direction. (Figure C-8, Figure C-9) 	Westbound approach: <ul style="list-style-type: none"> There are available sightlines for vehicles exceeding the required $D_{Stopped}$ in each direction. (Figure C-10, Figure C-11)

Figure C-10: Barron Road (West) Crossing (Dstopped) – Westbound Approach (facing northbound)

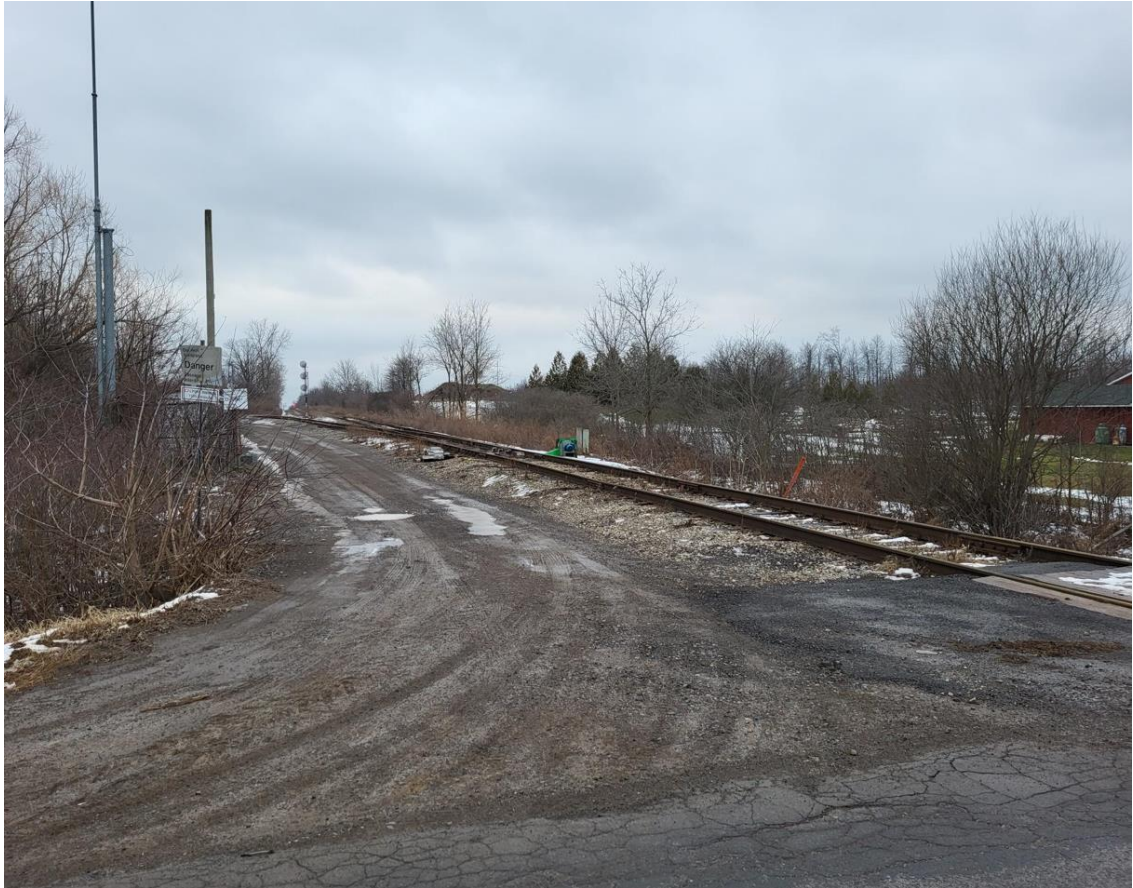
Figure C-11: Barron Road (West) Crossing (Dstopped) – Westbound Approach (facing southbound)

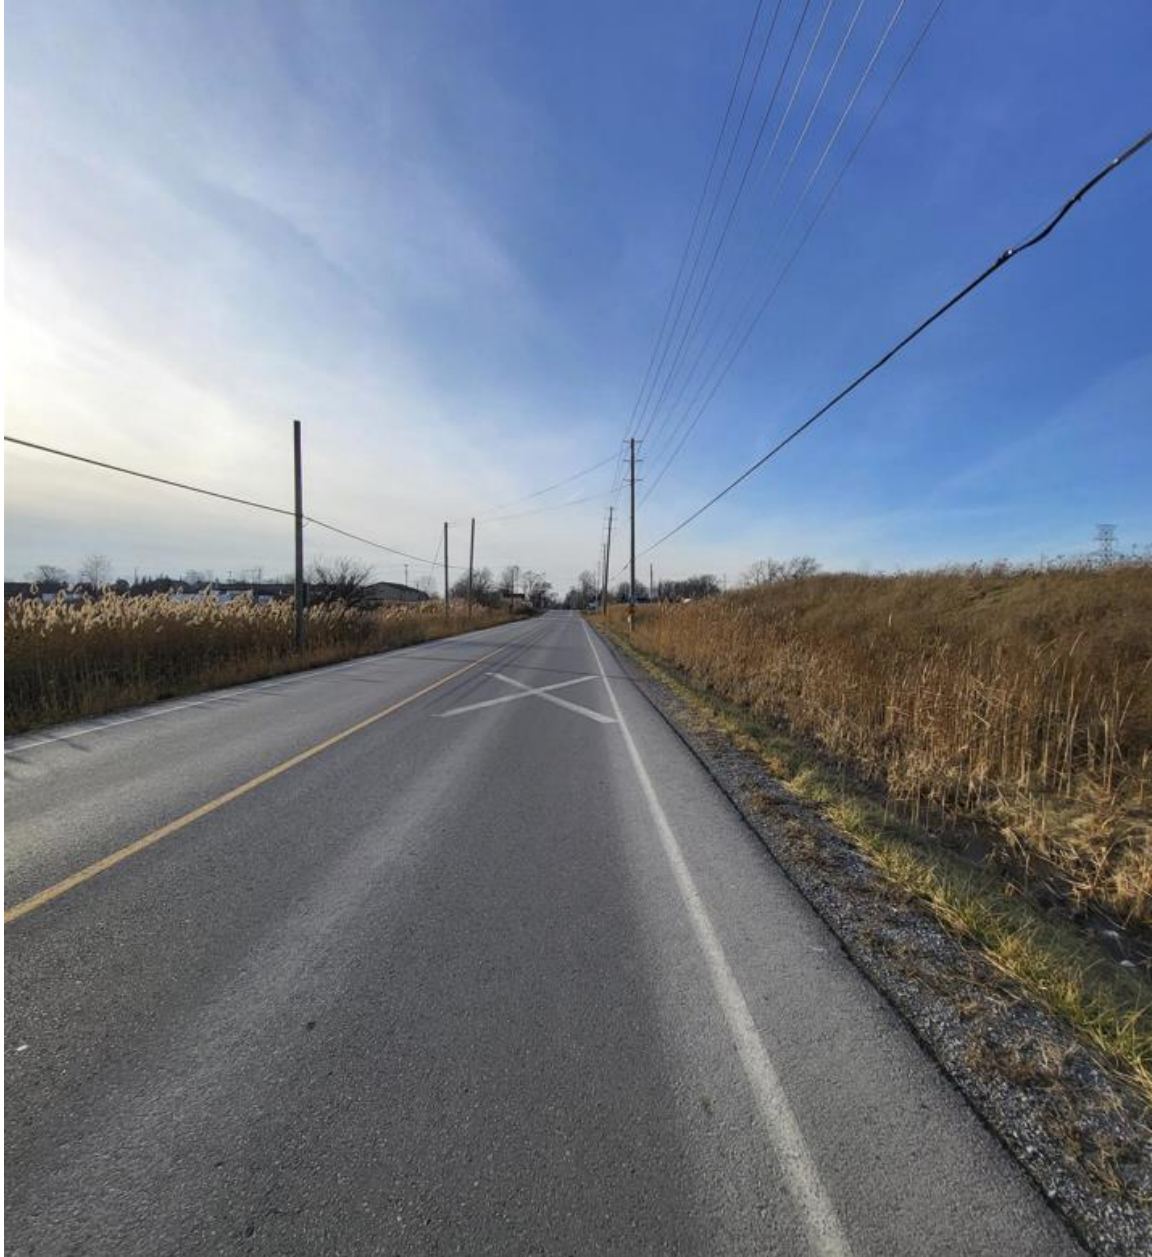
Figure D-5: Barron Road (East) Crossing Sightline Visibility – Westbound Approach (105m)

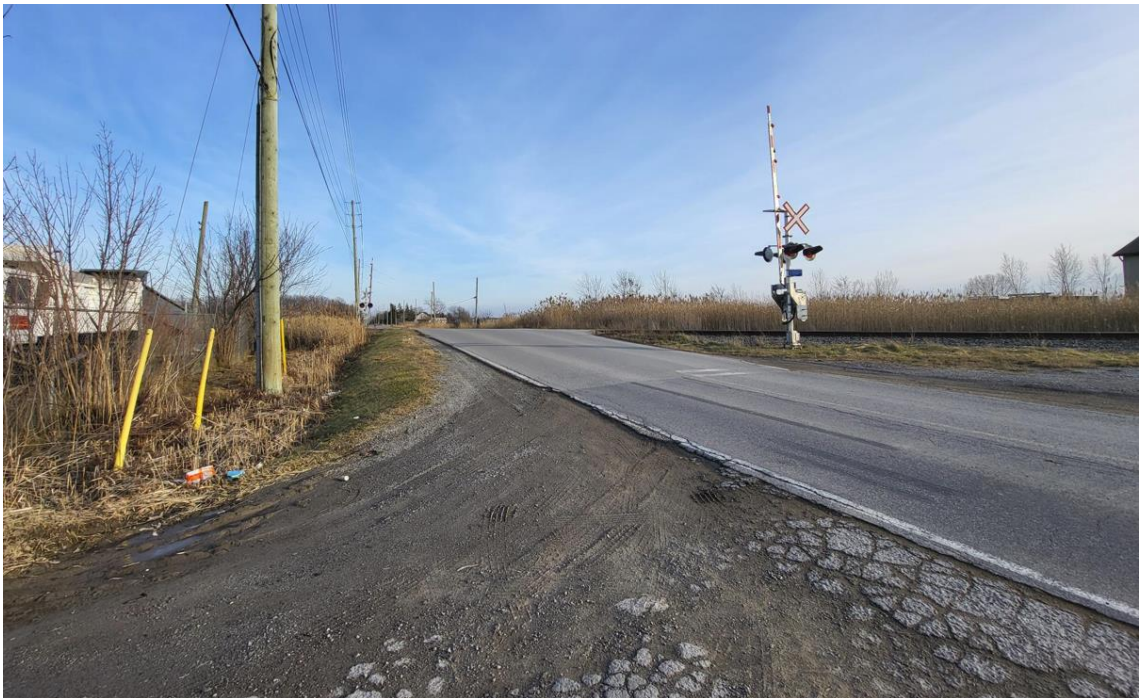
Criteria	Requirement	Barron Road (E) Existing Conditions	
	Shoulder	Eastbound (Width Varies, Figure D-4) <ul style="list-style-type: none"> • North: 0.7m • South: 0.9m 	Westbound <ul style="list-style-type: none"> • North: 1.1m • South: 1.8m
Sightlines	Calculation Parameters	<ul style="list-style-type: none"> • Clearance Distance: 32m • Railway Design Speed: 97km/h • Roadway Design Speed: 70km/h 	
	SSD	<ul style="list-style-type: none"> • SSD = 105m • Eastbound and westbound sightlines exceed the required SSD, Figure D-5 & Figure D-6 	
	$D_{Stopped}$	<ul style="list-style-type: none"> • $D_{Stopped} = 710m$ • Not applicable due to the presence of a warning system with gates. 	
	D_{SSD}	<ul style="list-style-type: none"> • $D_{SSD} = 210m$ • Not applicable due to the presence of a warning system with flashing lights and bells. 	
	Other	Visibility of warning system <ul style="list-style-type: none"> • Visible from driveway – approximately 20m west of crossing, Figure D-7

Figure D-7: Barron Road (East) Crossing – View from Driveway 20m West of Crossing
