Allanburg Area Whistle Cessation Study Report - Draft

City of Thorold

Whistle Cessation Study

Rail Crossing Existing Condition Assessment

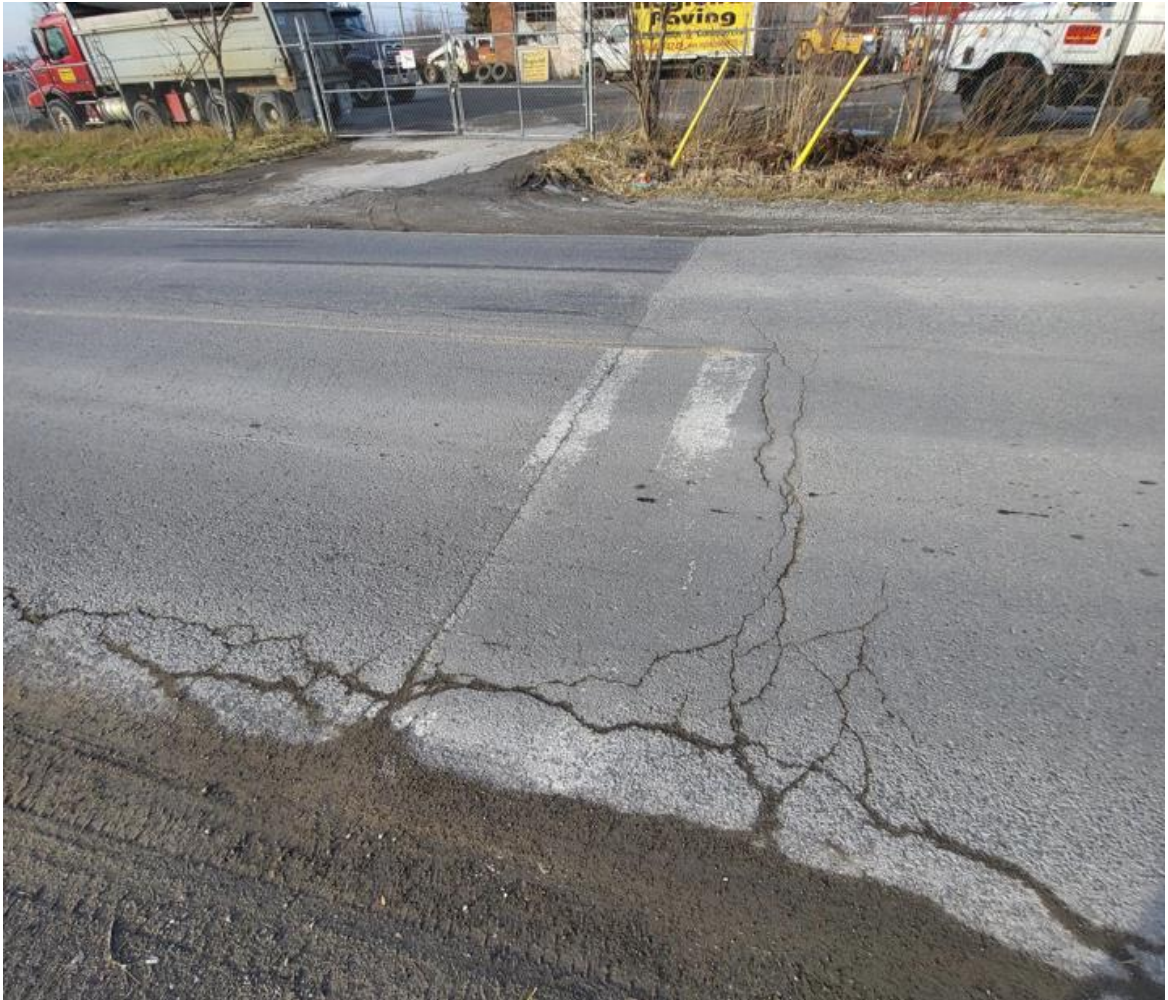
Signage and Pavement Markings	Warning Signage	<ul style="list-style-type: none"> • W-10a located 102m from stop bar, good condition, Figure D-8 	
	Pavement Markings	<ul style="list-style-type: none"> • Painted 'X' on westbound approach located 93m from stop bar, Poor condition and faded, Figure D-9 • Road Centreline, good condition • Road Edge Markings, good condition

Figure D-9: Barron Road (East) Stop Bar – Eastbound Approach

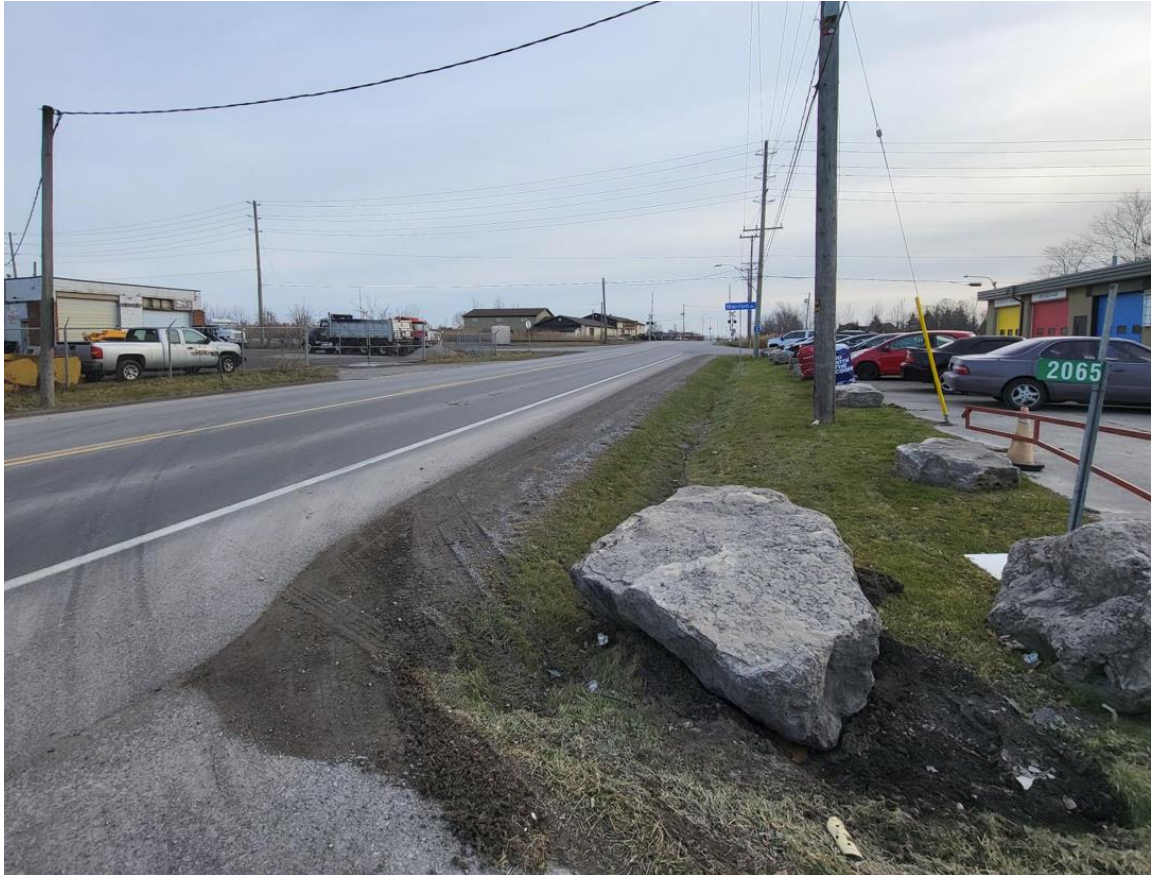
Criteria	Requirement	Allanport Road Existing Conditions	
	Shoulder	Northbound (Width Varies) <ul style="list-style-type: none"> • East: 2.2m • West: 2.3m 	Southbound (Width Varies) <ul style="list-style-type: none"> • East: 2.5m • West: 1.9m
Sightlines	Calculation Parameters	<ul style="list-style-type: none"> • Clearance Distance: 12.2m • Railway Design Speed: 97km/h • Roadway Design Speed: 100km/h 	
	SSD	<ul style="list-style-type: none"> • SSD = 185m • Eastbound and westbound sightlines exceed the required SSD, Figures E-4 & E-5 	
	$D_{Stopped}$	<ul style="list-style-type: none"> • $D_{Stopped} = 310m$ • Not applicable due to the presence of a warning system with flashing lights and bells 	
	D_{SSD}	<ul style="list-style-type: none"> • $D_{SSD} = 205m$ • Not applicable due to the presence of a warning system with flashing lights and bells 	
	Other	Visibility of warning system <ul style="list-style-type: none"> • Good sightlines from driveway approximately 82m north of the rail crossing (Figure E-6) • Good sightlines from eastbound leg of Barron Road intersection (Figure E-7)

Figure E-6: Allanport Road Crossing – View of Crossing Facing Southbound from Driveway at 2065 Allanport Road

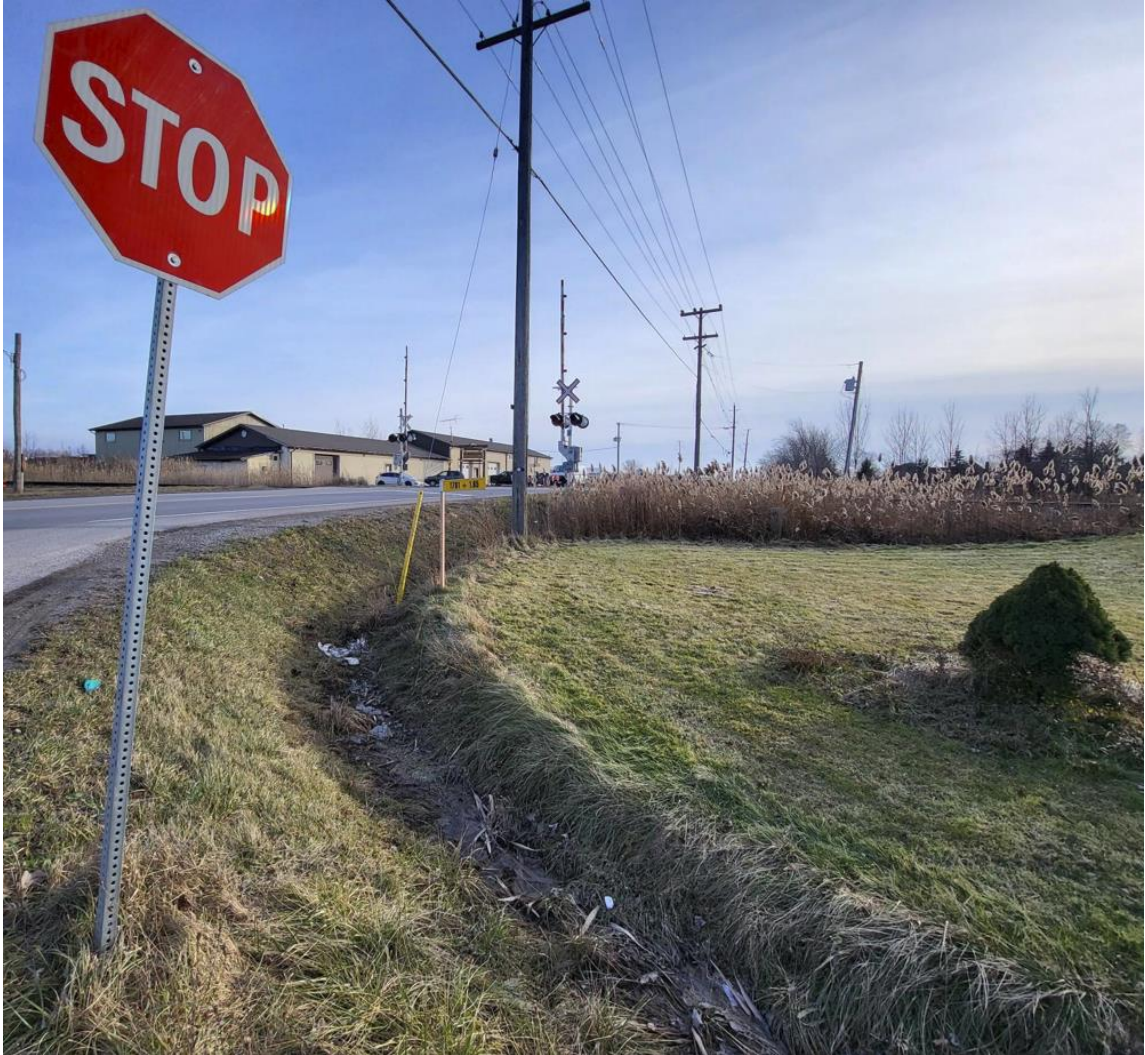
Figure E-7: Allanport Road Crossing - View of Crossing from Eastbound Approach Facing Southbound

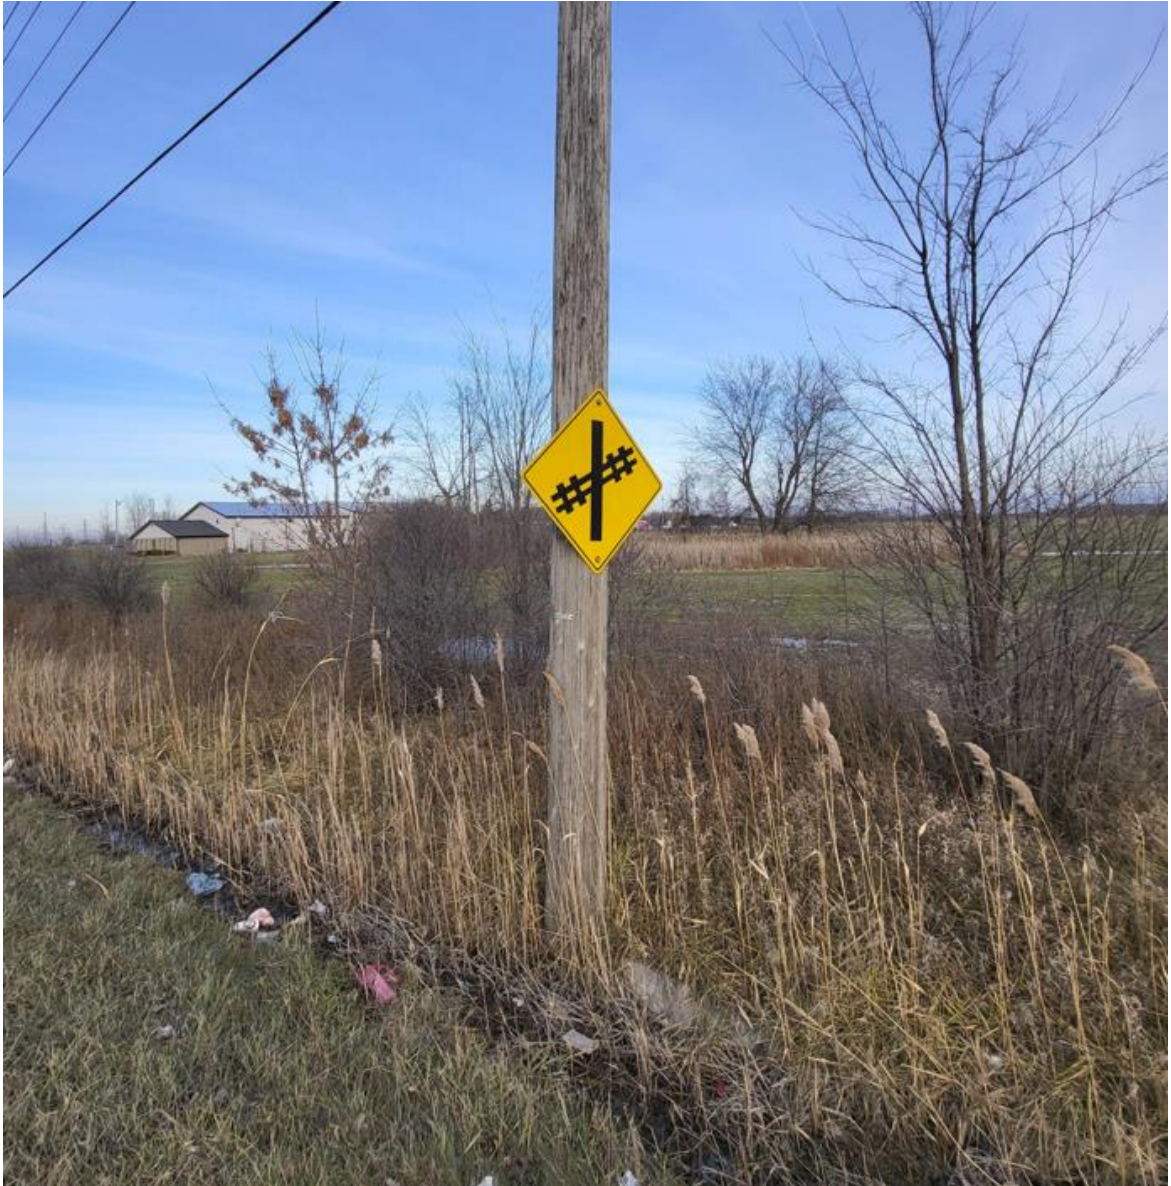
Criteria	Requirement	Allanport Road Existing Conditions	
Signage and Pavement Markings	Warning Signage	<ul style="list-style-type: none"> W-10a Signage located 207m (NB) and 285m (SB) from stop bar, good condition, Figure E-8, E-9, E-10, E-11 	
	Pavement Markings	<ul style="list-style-type: none"> Stop Bar, Figure E-12 & E-13 <ul style="list-style-type: none"> Northbound: 5.3 from edge of tracks Southbound: 5.0m from edge of tracks Painted 'X' located 217m (NB) and 293m (SB) from stop bar, good condition, Figure E-14 & E-15 Road Centreline, Good Condition Road Edge, Good Condition 	
Warning System	Warning System	<ul style="list-style-type: none"> Warning System with Flashing Lights, Bells, and Gates, Figure E-16 	
	Location of Warning System	Northbound <ul style="list-style-type: none"> 1.8m from the edge of the roadway 6.2m from the edge of the tracks 	Westbound <ul style="list-style-type: none"> 2.1m from the edge of the roadway 6.1m from the edge of the rail tracks

Figure E-10: Allanport Road Crossing Northbound Approach – Warning Signage

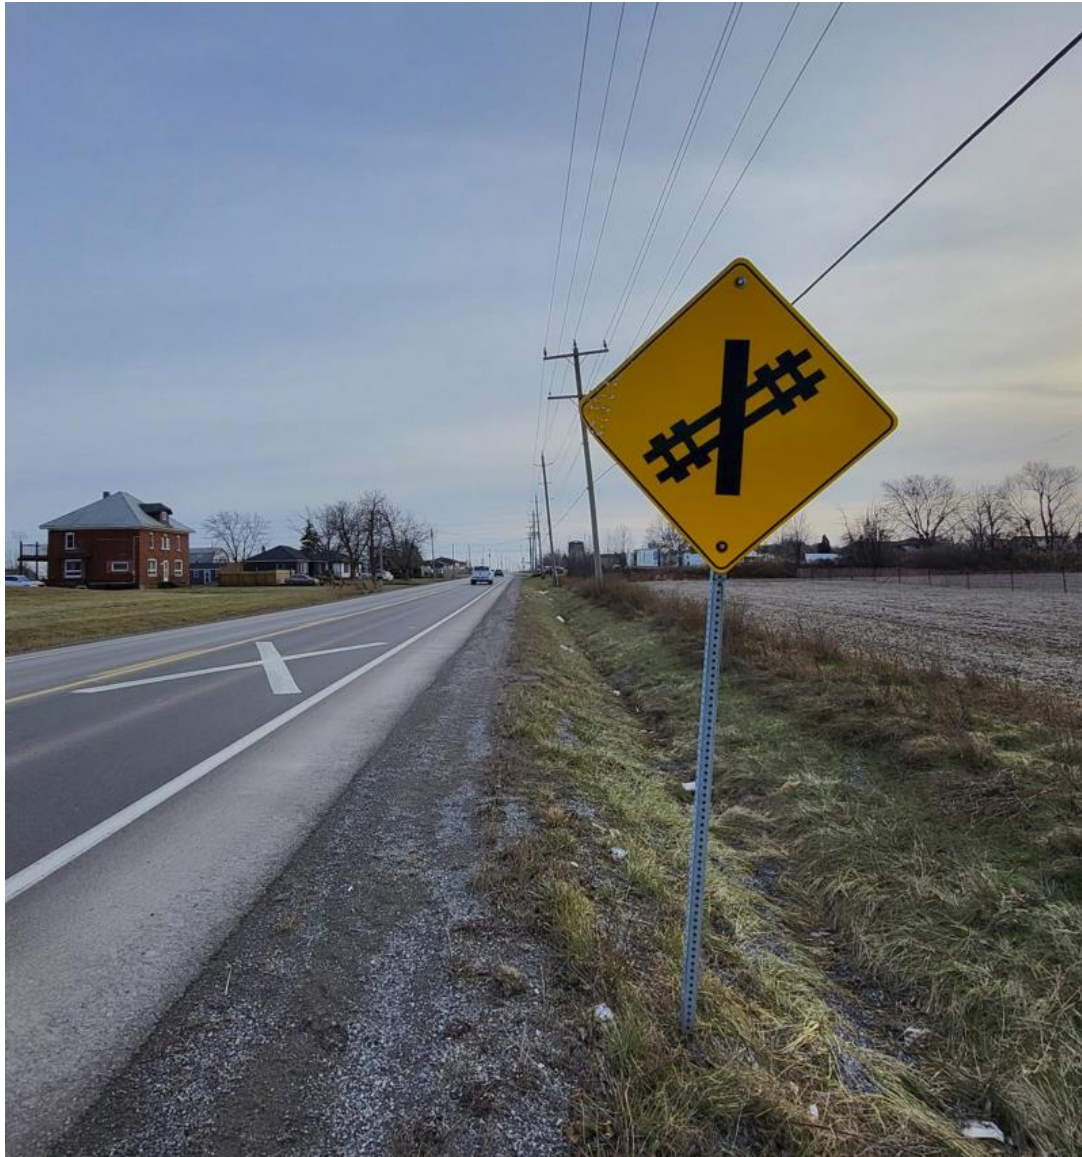
Figure E-11: Allanport Road Crossing Southbound Approach – Warning Signage

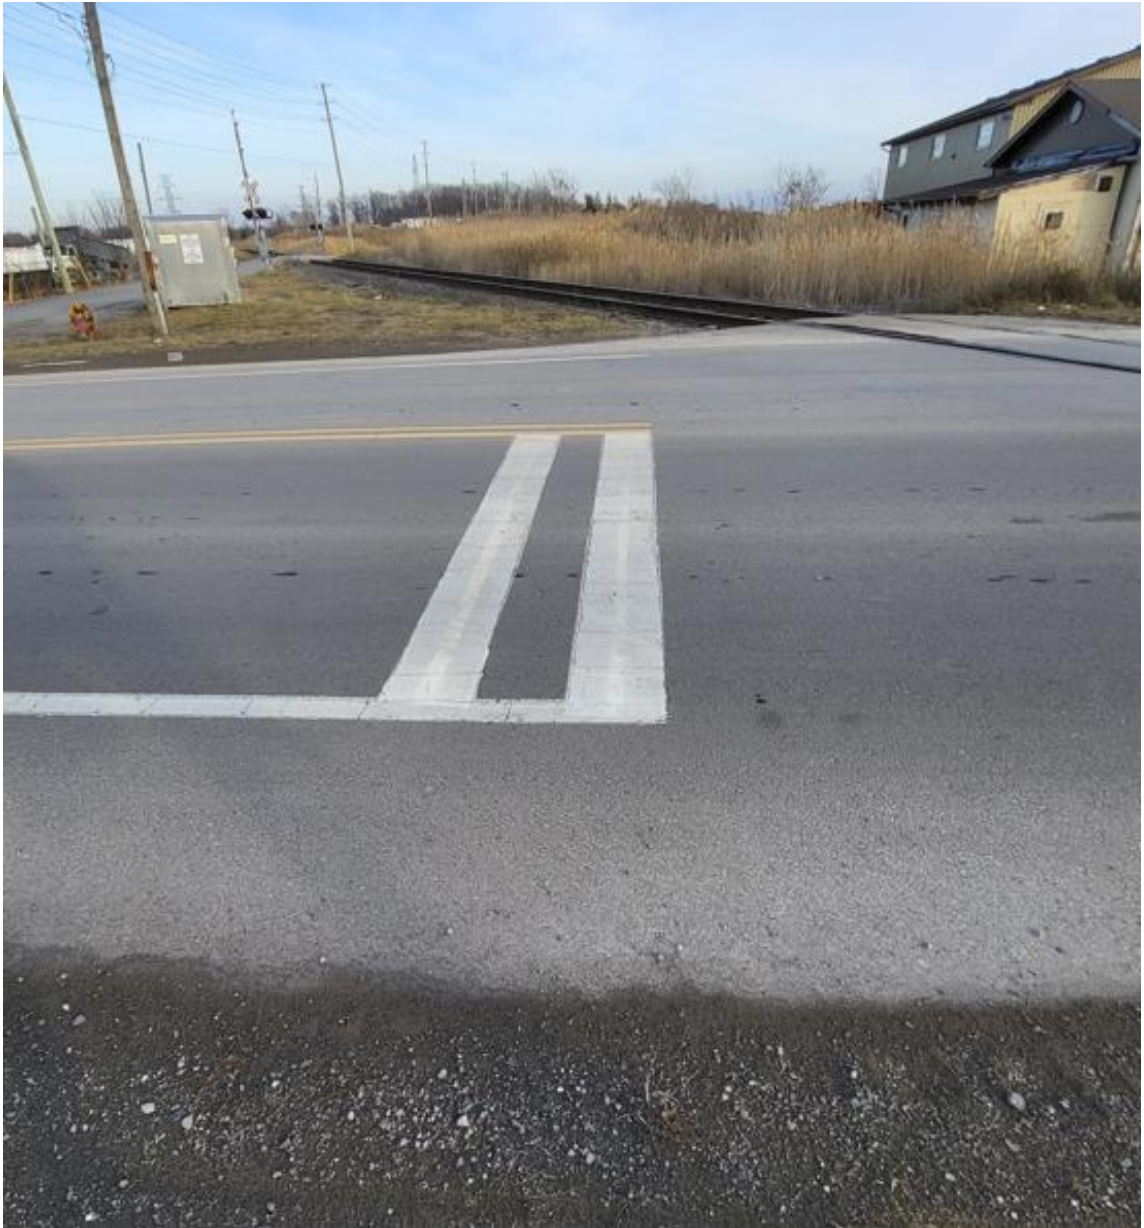
Figure E-12: Allanport Road Crossing Stop Bar – Northbound Approach

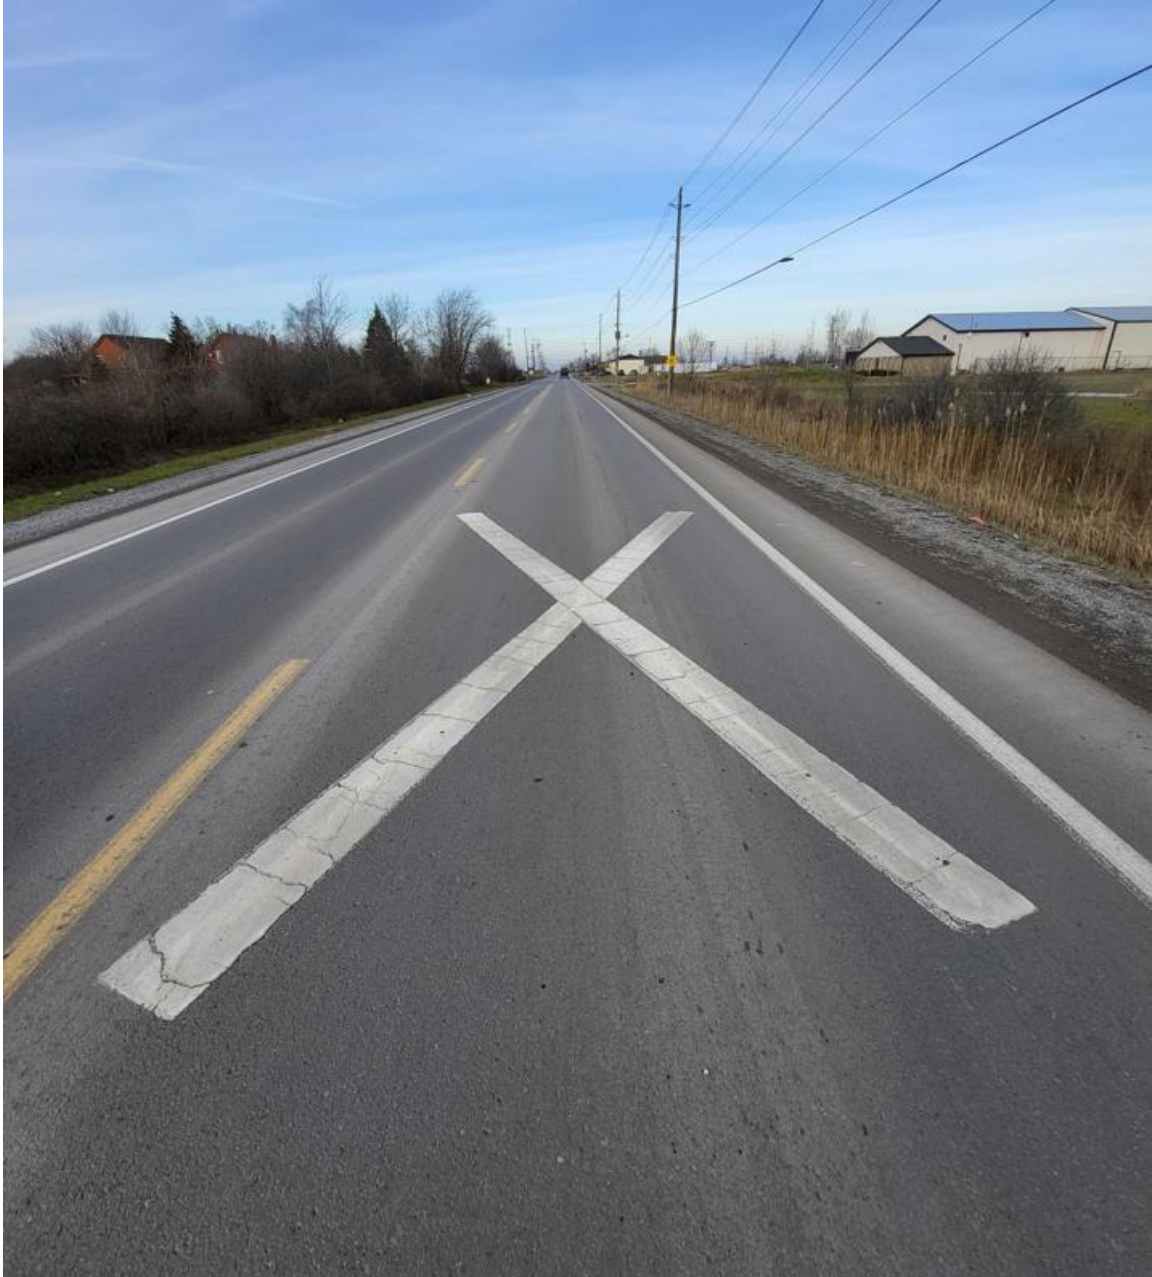
Figure E-13: Allanport Road Crossing Stop Bar – Southbound Approach

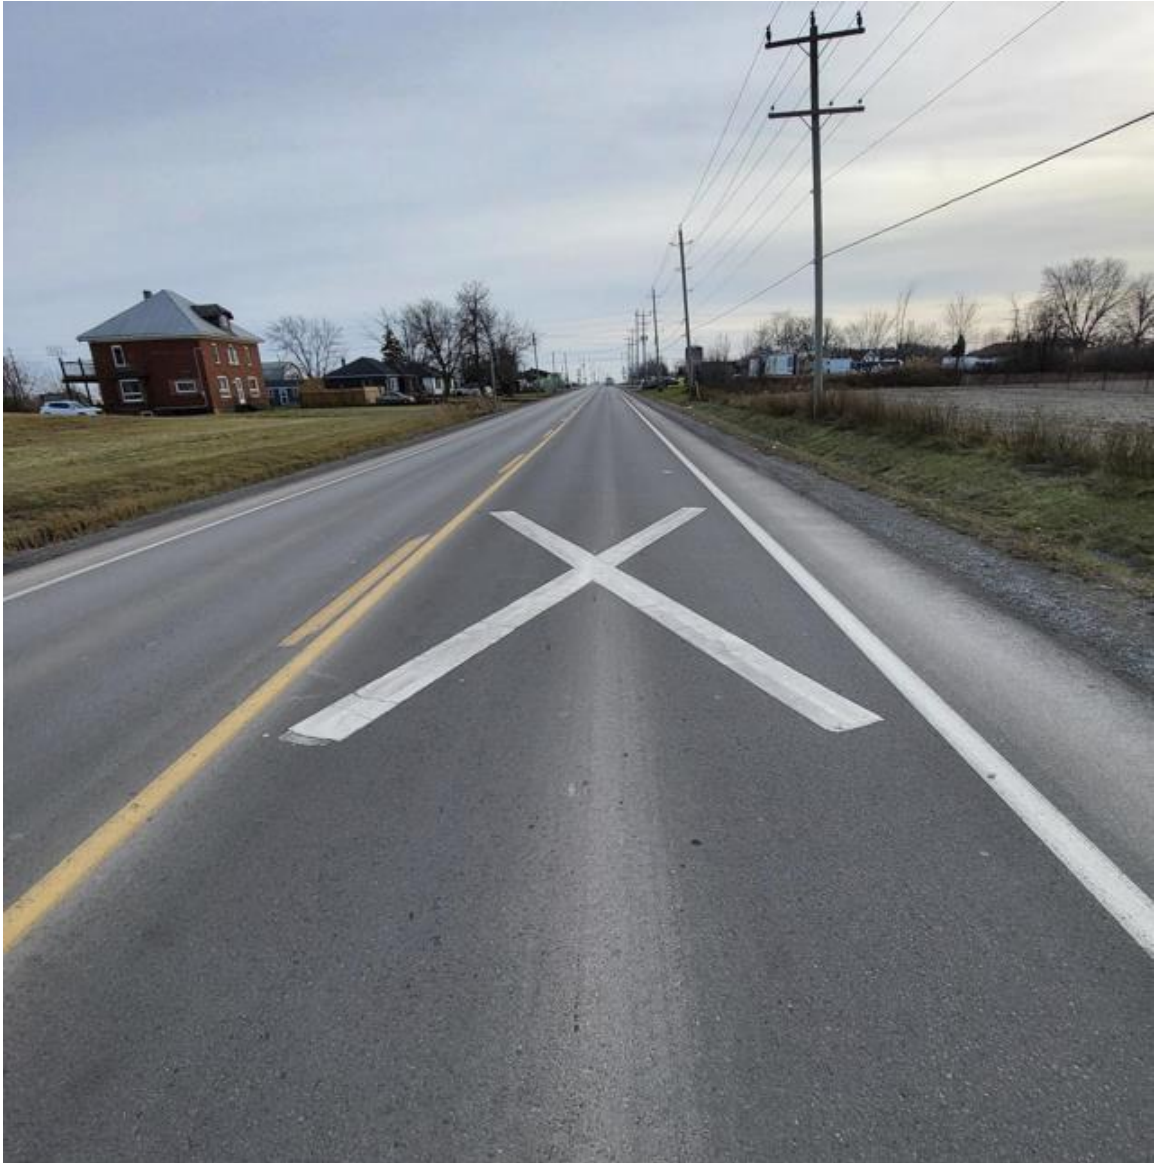
Figure E-14: Allanport Road Crossing Northbound Approach – Painted “X”
